**Building Information - Troy City (44925) - Concord Elementary**

Program Type	Classroom Facilities Assistance Program (CFAP) - Regular
Setting	Small City
Assessment Name	Concord Elementary School (7161) FINAL
Assessment Date (on-site; non-EEA)	2016-08-17
Kitchen Type	Warming Kitchen
Cost Set:	2016
Building Name	Concord Elementary
Building IRN	7161
Building Address	3145 W State Route 718
Building City	Troy
Building Zipcode	45373
Building Phone	(937) 332.6730
Acreage	9.38
Current Grades:	K-5
Teaching Stations	36
Number of Floors	3
Student Capacity	600
Current Enrollment	595
Enrollment Date	2016-08-08
Enrollment Date is the date in which the current enrollment was taken.	
Number of Classrooms	30
Historical Register	<b>NO</b>
Building's Principal	Mr. Dan Hake
Building Type	Elementary

**Building Construction Information - Troy City (44925) - Concord Elementary (7161)**

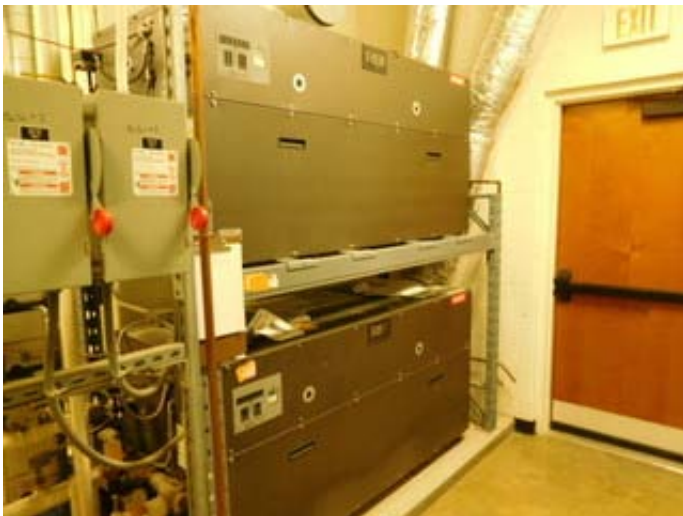
**Description:** The existing system for the 1919 Original Construction is a natural gas fired steam boiler type system, installed in 1919 with incremental upgrades, and is in fair condition. The systems in the 1939, 1952, and 1972 Additions are an extension of that found in the 1919 Original Construction. The existing system for the 2006 Addition is a natural gas fired heated water boiler type system, installed in 2006, and is in good to fair condition. 2-pipe vs. 4-pipe designations are not applicable in this facility, as no central air conditioning is provided. The 1919 Original Construction is equipped with (2) steam boilers, were manufactured by Superior, were installed in 1919, and are in fair condition. The 2006 Original Construction is equipped with (2) heated water boilers, were manufactured by RBI, were installed in 2006, and are in good to fair condition. Steam and heating water is distributed to terminal units consisting of fin tubes, unit ventilators, cabinet heaters, unit heaters, and air handlers. The terminal equipment is original to each addition and is in fair condition. The system does not appear to comply with the 15 CFM per person fresh air requirements of the Ohio Building Code mechanical code and Ohio School Design Manual. The pneumatic and electric type system temperature controls are original to each addition and are in fair to poor condition. The system does not feature individual temperature controls in all spaces required by the OSDM. The overall system does not feature any central energy recovery systems. The 1972 Addition is equipped with widespread louvered interior doors to facilitate Corridor utilization as return air plenums. The remainder of the overall facility is not equipped with louvered interior doors to facilitate Corridor utilization as return air plenums. The existing system is ducted in the 2006 Addition, but the ductwork cannot be integrated into a possible future system due to arrangement, air volume, and routing of existing ductwork. The existing system is not ducted in the remainder of the overall facility, and floor to structural deck heights will accommodate the installation of properly sized ductwork for a future Ohio School Design Manual approved system. The overall heating system for the most part is evaluated as being unsafe and in inefficient working order, and long term life expectancy of the existing system is not anticipated. The structure is not equipped with central air conditioning. The site does not contain underground fuel tanks.

**Rating:** 3 Needs Replacement

Natural Gas Fired Heated Water Boiler

**Recommendations:** Provide new overall heating, ventilating, and air conditioning system to achieve compliance with Ohio Building Code and Ohio School Design Manual standards. Replace existing ductwork in the 2006 Addition to facilitate efficient exchange of conditioned air. Convert to ducted system the remainder of the overall facility to facilitate efficient exchange of conditioned air.

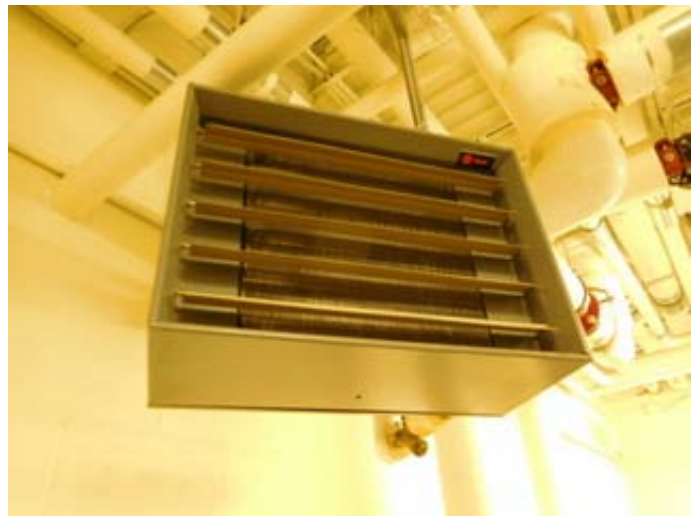
Unit Heater

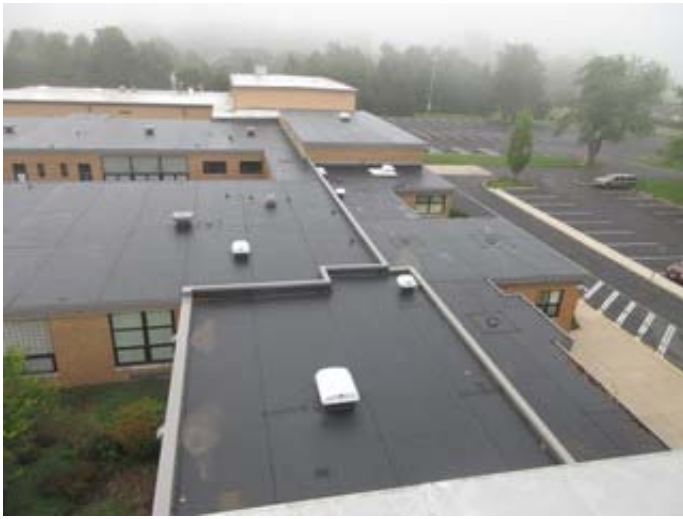
EPDM and TPO Membrane Roofs

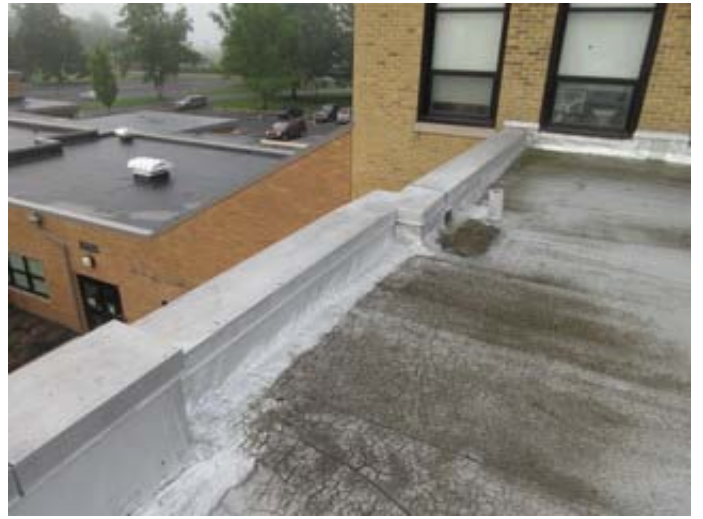
The roof over the Original Construction is a ballasted modified bitumin system by Tremco that was installed in 2001, is out of warranty, and is in poor condition. There are District reports of current leaking. Blisters form in the roofing system and burst. Burst blisters adjacent to seams cause leaks. Signs of past leaking were observed during the physical assessment. Access to the roof was gained by access ladder and access door that are in good condition. Fall safety protection cages are not required, and are not provided. The roof over the 1939 Gymnasium Addition is a modified bitumin system by Tremco that was installed in 2006, is under a 15-year warranty, and is in poor condition. There are District reports of current leaking. Blisters form in the roofing system and burst. Burst blisters adjacent to seams cause leaks. Signs of past leaking were observed during the physical assessment. The scupper drains also leak, causing large areas of paint on the interior walls to peel off. Access to the roof was gained by the access door of the Original Construction that is in fair condition. The roof over the 1952 Classroom Addition and the 1972 Classroom Addition is an EPDM system that was installed in 2012, is under a 20-year warranty, and is in good condition. There are no District reports of current leaking. No signs of past leaking were observed during the physical assessment. Access to the roof was gained by access hatch and access ladder in the 2006 Addition. The roof over the 2006 Cafeteria and Media Center Addition is a TPO system that was installed in 2006, and is in good condition. There are no District reports of current leaking. No signs of past leaking were observed during the physical assessment. Access to the roof was gained by access hatch and access ladders that are in good condition. Fall safety protection cages are not required, and are not provided. There were no observations of standing water on the roof of the Original Construction. Metal cap flashings and copings are in poor condition. Roof storm drainage is addressed through a system of roof drains, which are properly located, and in good condition. The roof is not equipped with overflow roof drains though they will be required in areas of roof replacement. There were no observations of standing water on the roof of the 1939 Gymnasium Addition. Metal cap flashings and copings are in poor condition. Roof storm drainage is addressed through a system of gutters, downspouts, and through-wall scuppers, which are properly located, and in poor condition. The roof is not equipped with overflow roof drains and they are not required. There were observations of standing water on the roof of the 1952 Classroom Addition and 1972 Classroom Addition. Metal cap flashings and copings are in good condition. Roof storm drainage is addressed through a system of gutters, through-wall scuppers and downspouts, which are properly located, and in good condition. The roof is not equipped with overflow roof drains and they are not required as there are no parapets. There were no observations of standing water on the roof of the 2006 Cafeteria and Media Center Addition. Metal cap flashings and copings are in good condition. Roof storm drainage is addressed through a system of gutters and downspouts, which are properly located, and in good condition. The roof is not equipped with overflow roof drains and they are not required. No problems requiring attention were encountered with any roof penetrations. There are not any covered walkways attached to this structure.

3 Needs Replacement

Tremco Roofing and Coping of the 1939 Gymnasium Addition

The roof over the Original Construction and the 1939 Gymnasium Addition requires replacement to meet Ohio School Design Manual guidelines due to condition and age of system and projected lifecycle. The flashing and coping at the Original Construction and 1939 Gymnasium Addition require replacement due to condition and age of system and projected lifecycle. Due to existing conditions gutters and downspouts require replacement at the 1939 Gymnasium Addition. Install overflow drains for the Original Construction. Install tapered insulation to correct ponding at the 1952 Classroom Addition and the 1972 Classroom Addition. Install insulation in areas where the roof is being replaced throughout the overall facility.

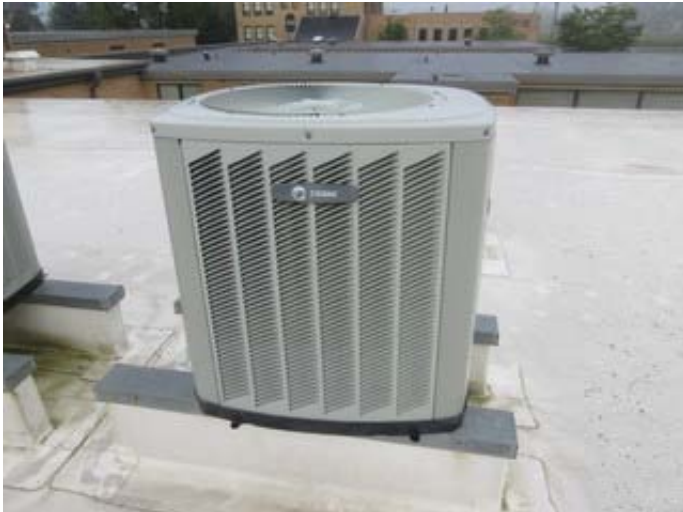
**Description:** The overall facility is not equipped with a central air conditioning system. Window units are present in the overall facility. Isolated room systems consisting of thru-wall PTAC units are located in the Administrative Offices. Isolated room systems consisting of ducted split AC units (with condensing units pad-mounted on the roof of the overall facility) are located in the Computer Lab and various other locations throughout the overall facility. Isolated room system consisting of ducted packaged roof top HVAC unit is located in the 2006 Addition. The ventilation system in the overall facility consists of unit ventilators, original to each addition and in fair condition, providing fresh air to Classrooms and Media Center and air handlers, original to each addition and in fair condition, providing fresh air to other miscellaneous spaces such as the Gymnasium and Student Dining areas. Relief air venting is provided by louvered interior doors, unit ventilators, transfer grilles to corridors, central relief fans, and air handlers. The ventilation system does not appear to meet the Ohio Building Code 15 CFM per occupant fresh air requirement. The overall system is not compliant with Ohio Building Code and Ohio School Design Manual requirements. Dust collection systems are not required in this facility. The Art program is equipped with a kiln and the kiln ventilation system is inadequate. General building exhaust systems for Restrooms, Storage Rooms, Art Rooms, and Custodial Closets do not appear to be inadequately placed, and in fair condition.

**Rating:** 2 Needs Repair

Roof Top Mounted Condensing Unit

**Recommendations:** Provide an air conditioning system to meet with Ohio Building Code and Ohio School Design Manual requirements. Replace general building exhaust systems located in Restrooms, Storage Rooms, Art Rooms, and Custodial Closets. Pricing included in Item A. Provide the Art program with a kiln ventilation system to meet Ohio Building Code and Ohio School Design Manual requirements.

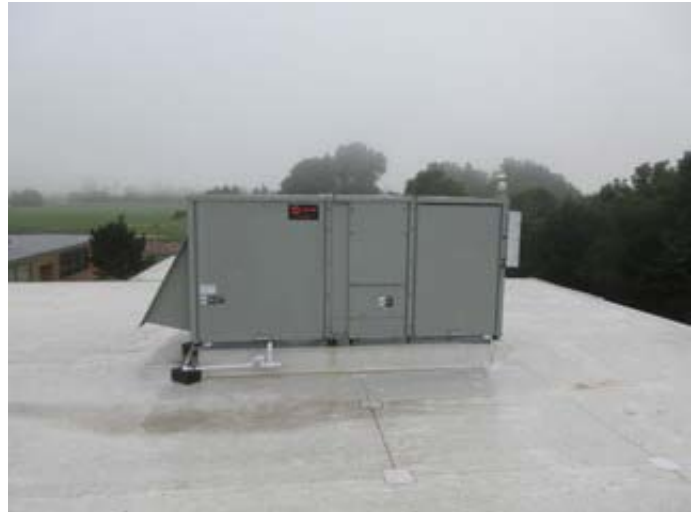
Roof Top HVAC Unit

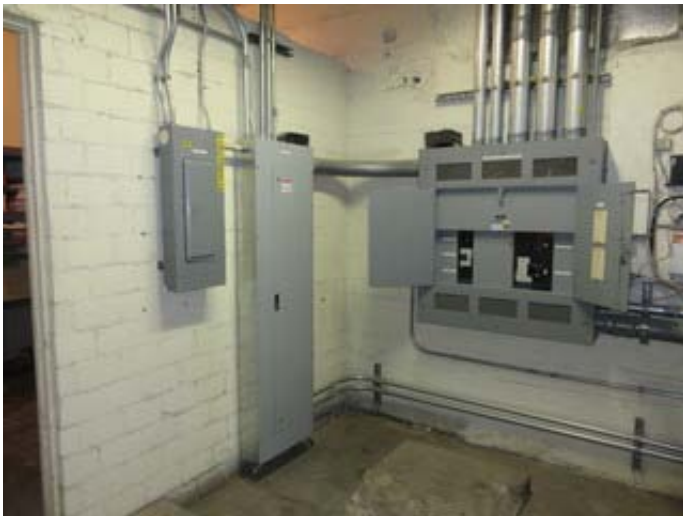
**Description:** The electrical system provided to the 1919 Original Construction is a 240 volts, 1,200 amp, 3 phase and 4 wire system installed in 1919 with upgrades in 1992 and 2006, and is in fair condition. The systems in the 1939, 1952, and 1972 Additions are an extension of that found in the 1919 Original Construction. The electrical system provided to the 2006 Addition is a 208Y/120V volts, 1,200 amp, 3 phase and 4 wire system installed in 2006, and is in good to fair condition. Power is provided to the school by multiple utility owned, pad-mounted transformers located outside the Mechanical Rooms of the 1919 Original Construction and the 2006 Addition, and appear to be in fair condition. The Square D and Eaton panel systems, original to each addition with upgrades in 2006, are in fair condition, and for the most part cannot be expanded to add additional capacity. The Classrooms are not equipped with adequate electrical outlets. The typical Classroom contains (5) general purpose outlets, (0) dedicated outlets for each Classroom computer, and (1) dedicated outlet for each Classroom television. Some Classrooms are equipped with as many as (6) general purpose outlets, while others are equipped with as few as (4) general purpose outlets. There are not any spaces that have no electrical outlets. The Corridors appear to be equipped with adequate electrical outlets for servicing. Adequate GFI protected exterior outlets are not provided around the perimeter of the building. The facility is not equipped with an emergency generator. Adequate lightning protection safeguards do not appear to be provided. Stage lighting power system including control panel, breakers, and dimmers is inadequately provided, in fair condition and does not meet OSDM requirements. The overall electrical system does not fully meet Ohio School Design Manual requirements in supporting the current needs of the school, and will be inadequate to meet the facility's future needs.

**Rating:** 3 Needs Replacement

Main Electrical Distribution Panel

**Recommendations:** The entire electrical system requires replacement to meet Ohio School Design Manual guidelines for overall capacity and due to lack of OSDM-required features and to accommodate the addition of an air conditioning system. Provide an emergency generator, with funding included in the electrical system replacement. Provide adequate lightning protection safeguards in the overall facility, including associated grounding system, with funding included in the electrical system replacement. Provide control panel, dimmers, and breakers to support the Stage lighting system, with funding included in the electrical system replacement.

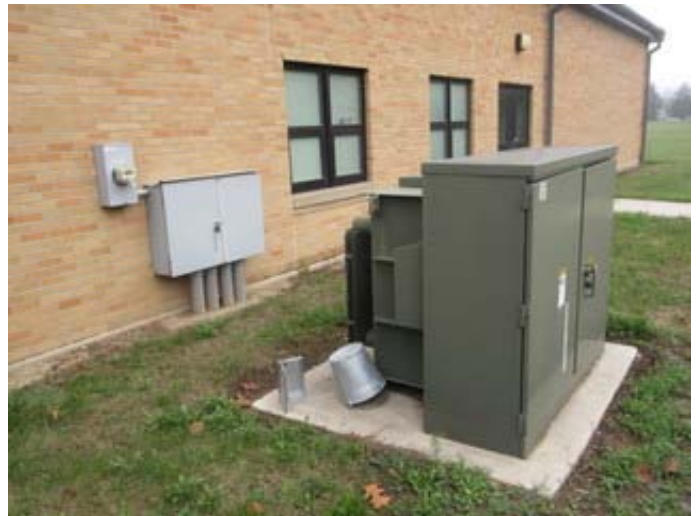
Pad Mounted Transformer

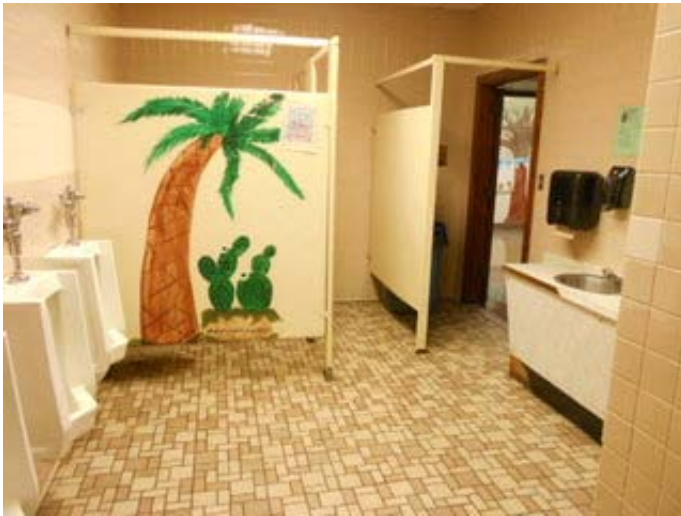
**Rating:** 3 Needs Replacement

Large Group Restroom-Boys-1919 Original Construction

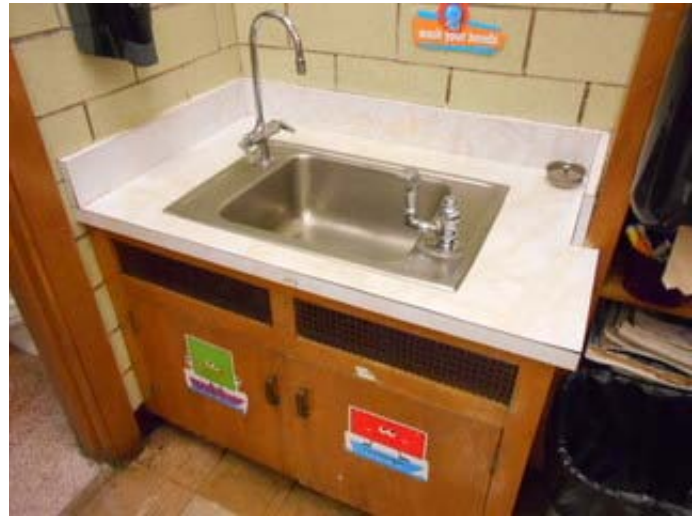
Classroom Sink With Deck Mounted Drinking Fountain

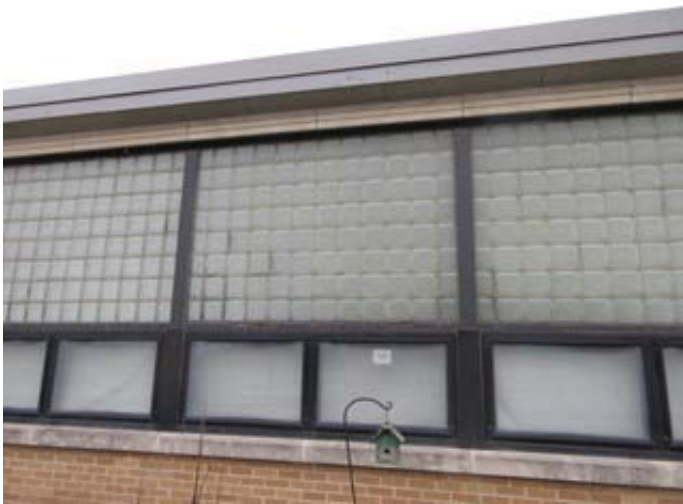
**Rating:** 3 Needs Replacement

Typical Aluminum and Glass Block Windows of the 1952 Classroom Addition

**Recommendations:** Provide a new insulated window system with integral blinds in the Original Construction, 1952 Classroom Addition and 1972 Classroom Addition to meet with Ohio School Design Manual requirements. Replace the existing glass block in the 1939 Gymnasium Addition and the 1952 Classroom Addition with a new insulated window system to match existing insulated system and comply with Ohio School Design Manual requirements. Cost is included with the other window replacement costs.

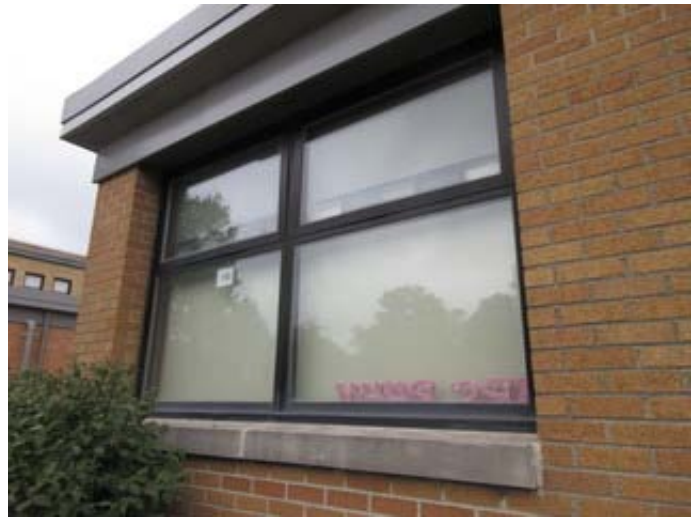
Typical Aluminum Window

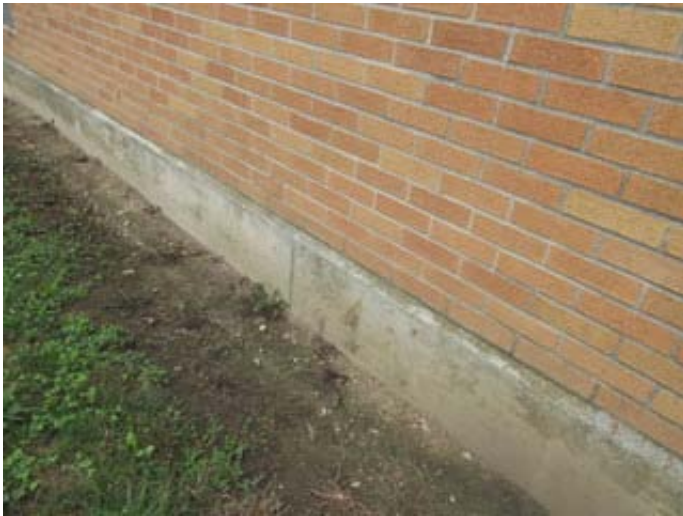
Typical Concrete Foundation

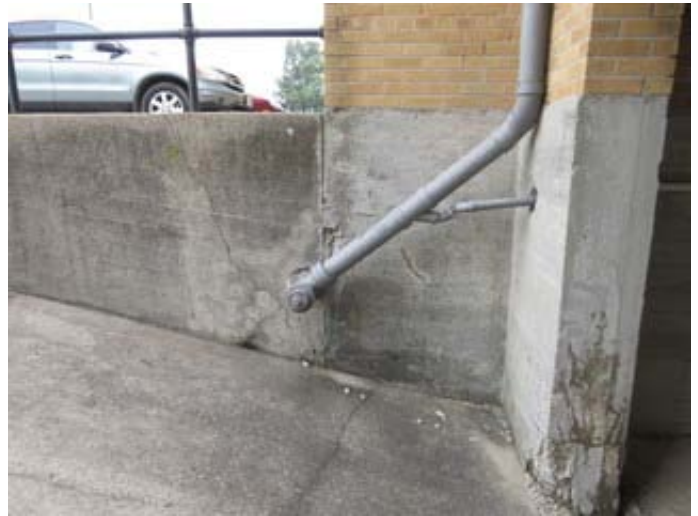
**Rating:** 2 Needs Repair

Foundation Repair at 1939 Gymnasium Addition

**Recommendations:** Provide sprayed on waterproofing system for the 1939 Gymnasium Addition. Provide drainage tile system at the 1939 Gymnasium Addition due to basement leaking. Repair areas of cracking and spalling through the overall facility.

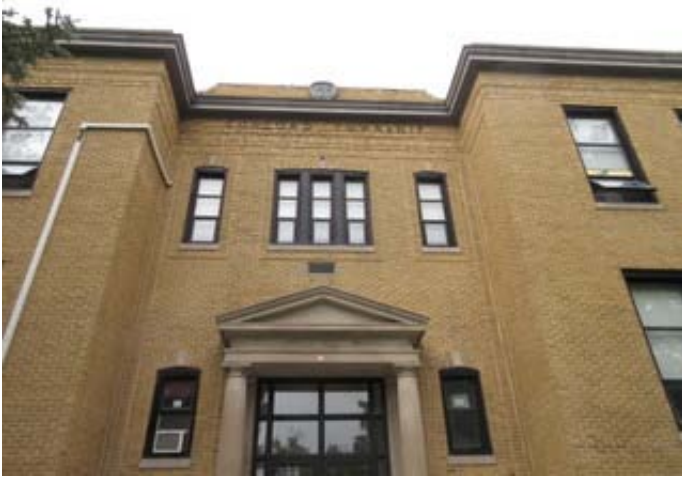
Masonry of the Original Construction

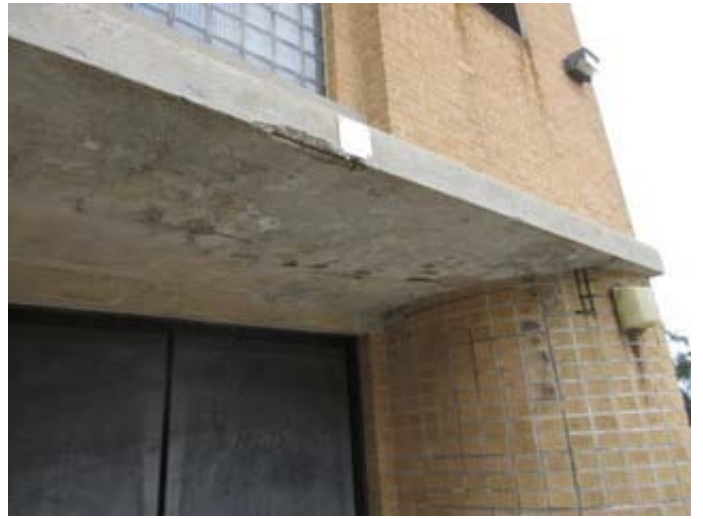
**Rating:** 2 Needs Repair

Concrete Repair of the 1939 Gymnasium Addition

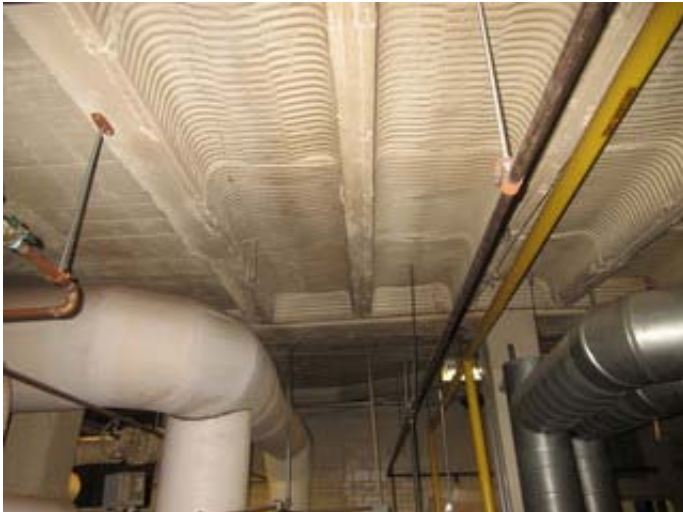
Typical Concrete Floor Structure of the 1939 Gymnasium Addition

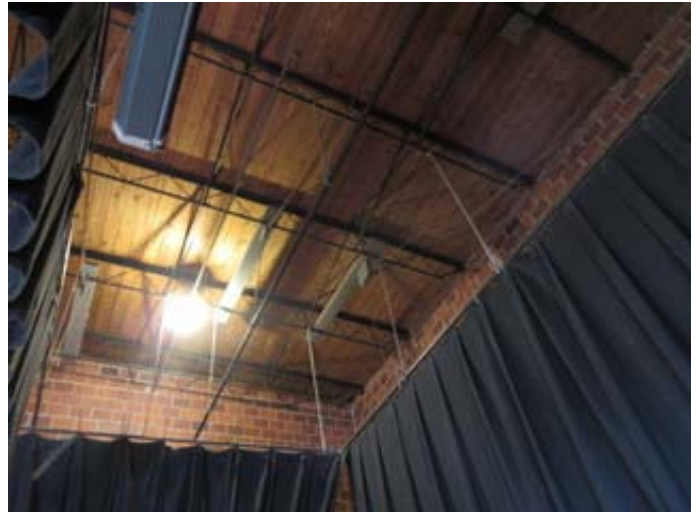
Wood Roof Deck of the 1939 Gymnasium Addition

**Recommendations:** Provide fire separation assembly for wood roof structure in the 1939 Gymnasium Addition at the Stage only. Refer to Item U for pricing of fire suppression system for wood structures.

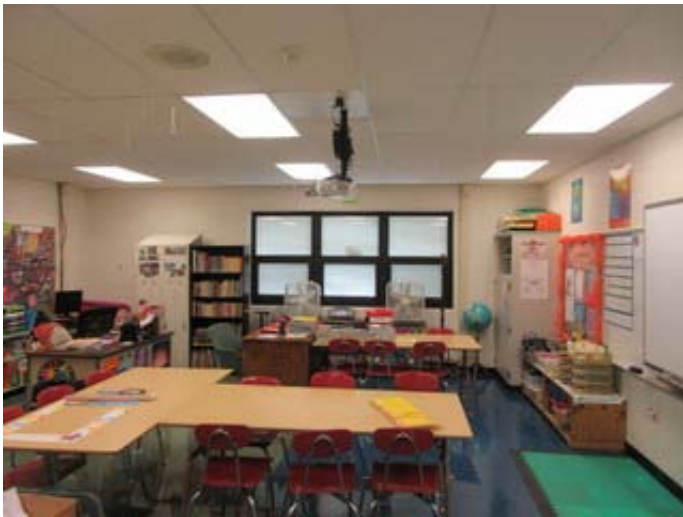
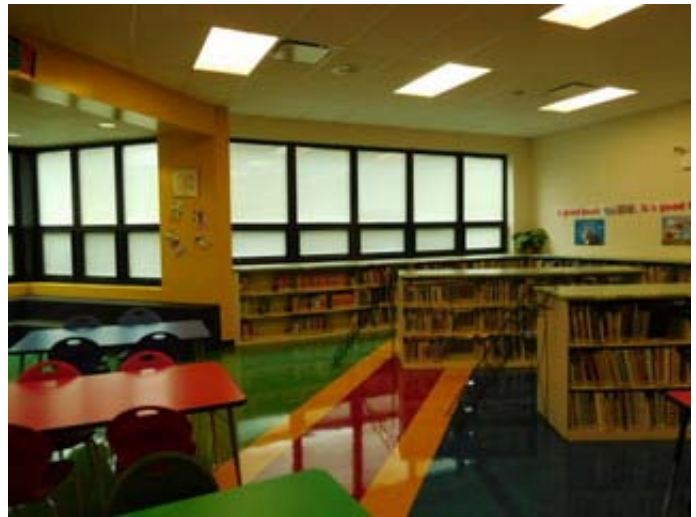
Classroom Fluorescent Light Fixtures

Media Center Fluorescent Light Fixtures

**Recommendations:** Provide complete replacement of lighting system due to age, condition, lighting levels, lack of multilevel switching, and installation of systems outlined in Items A, C, J, and U.

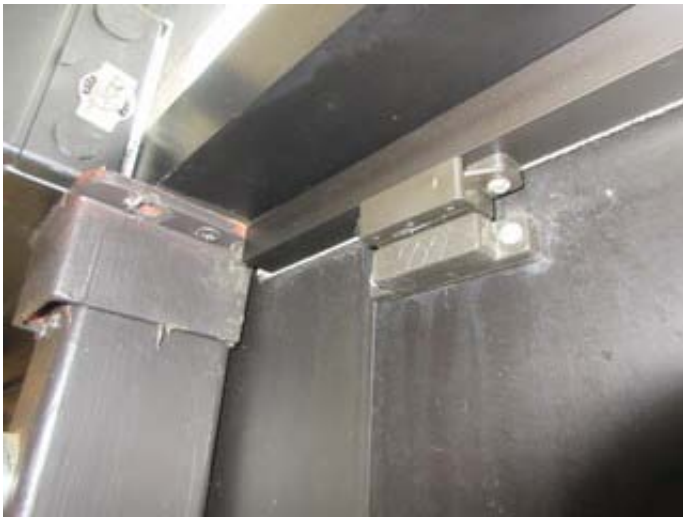
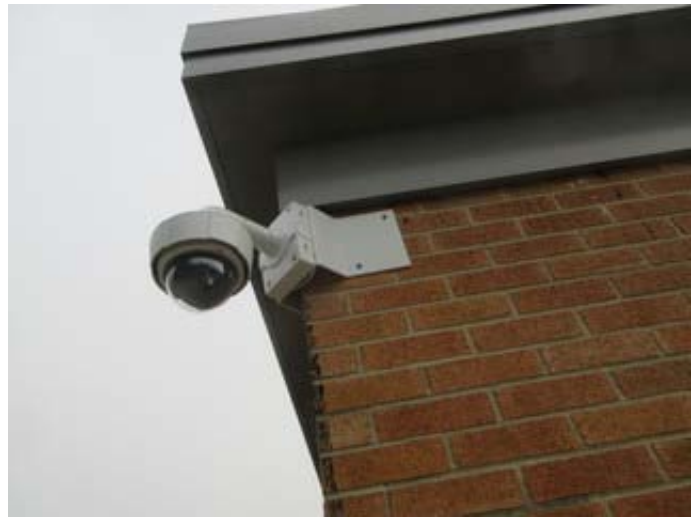
Security System Door Contacts

Security System CCTV Camera

**Recommendations:** Provide complete replacement of security system to meet Ohio School Design Manual guidelines. Provide complete replacement of exterior site lighting system to meet Ohio School Design Manual guidelines.

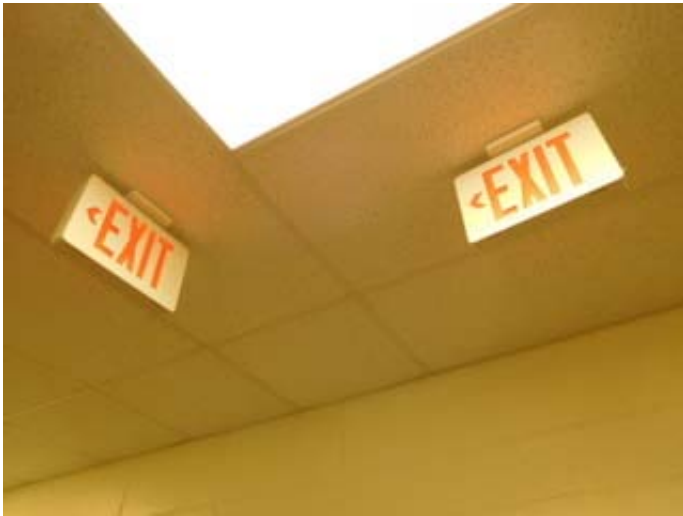
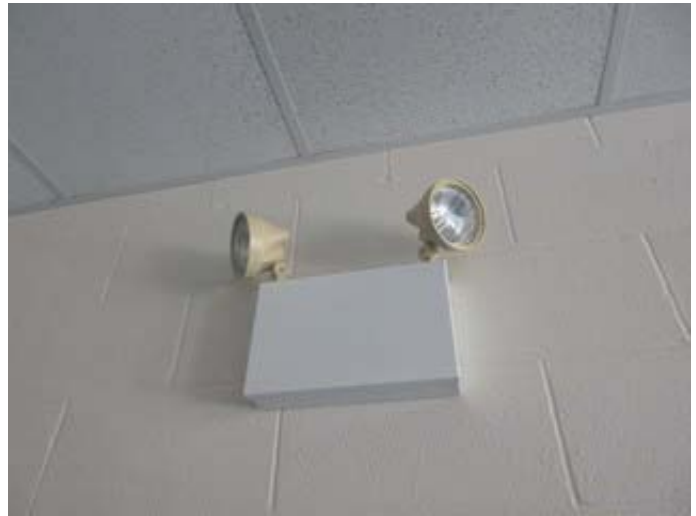
Exit Signs

Emergency Egress Light Fixtures

**Recommendations:** Provide complete replacement of emergency / egress lighting system to meet Ohio School Design Manual and Ohio Building Code guidelines.

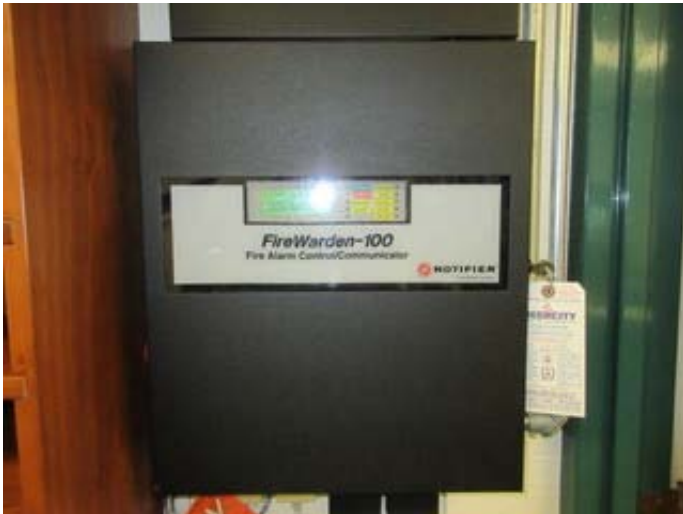
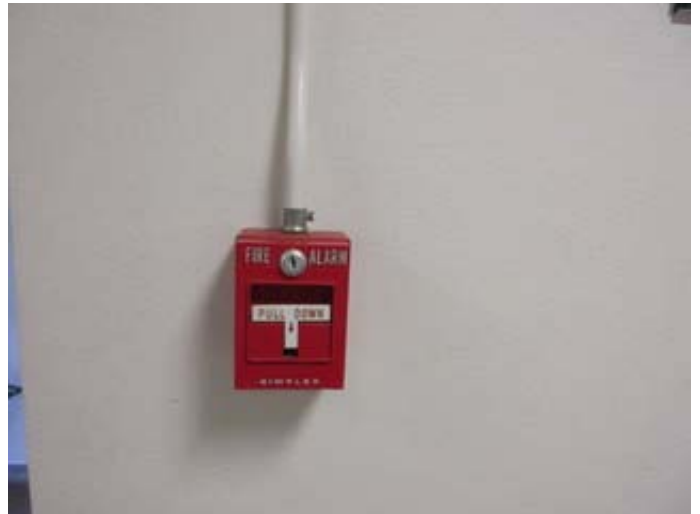
Fire Alarm System Control Panel

Fire Alarm System Manual Pull Station

**Recommendations:** Provide complete replacement of fire alarm systems to meet OBC, NFPA, and Ohio School Design Manual guidelines.

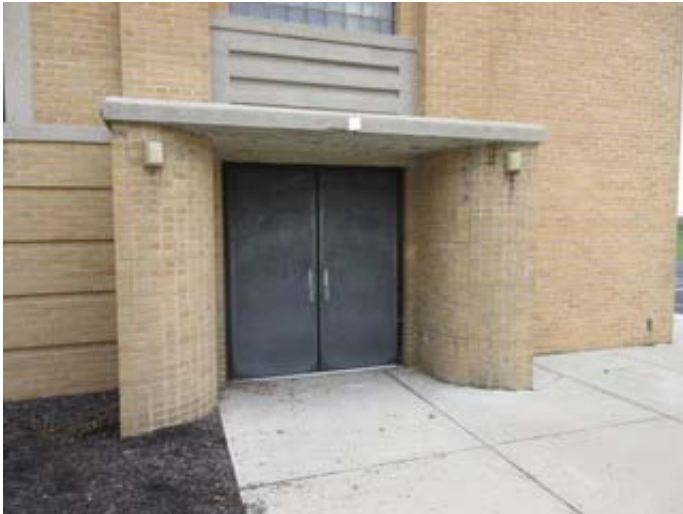
Fiber-Reinforced Plastic Doors of the 1939 Gymnasium Addition

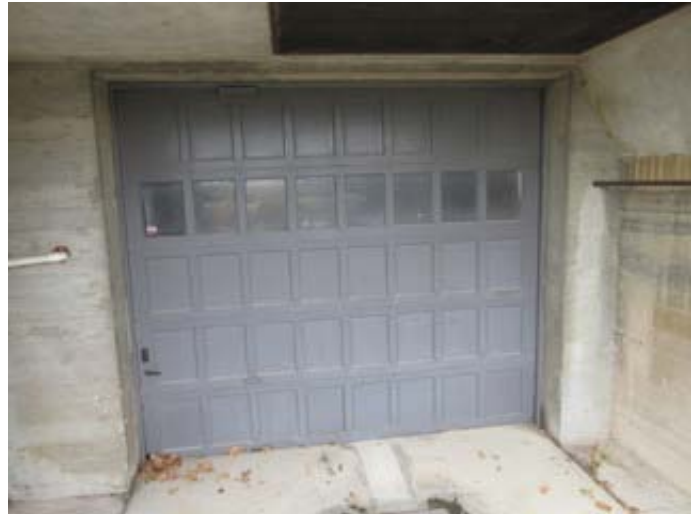
Wood Overhead Door of the 1939 Gymnasium Addition

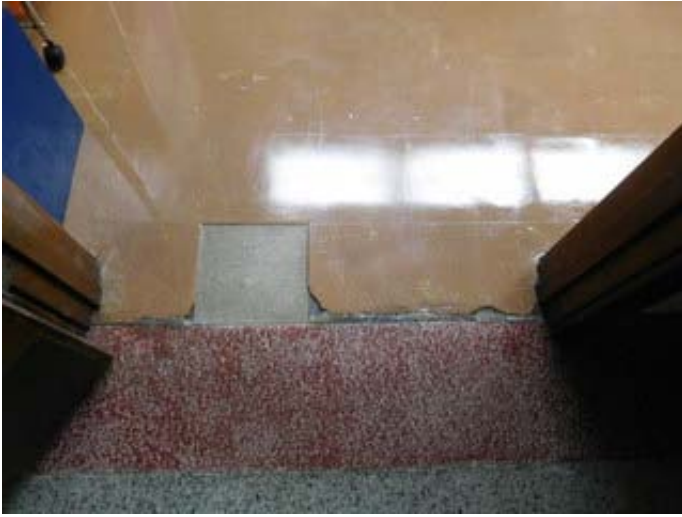
VAT Flooring

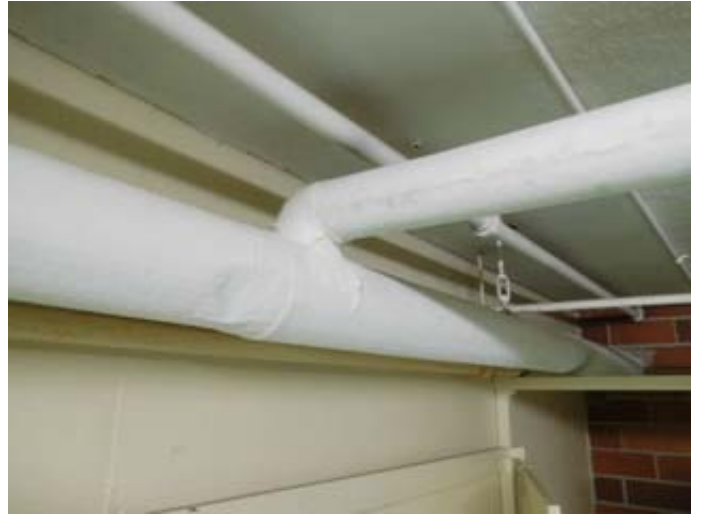
Pipe Insulation

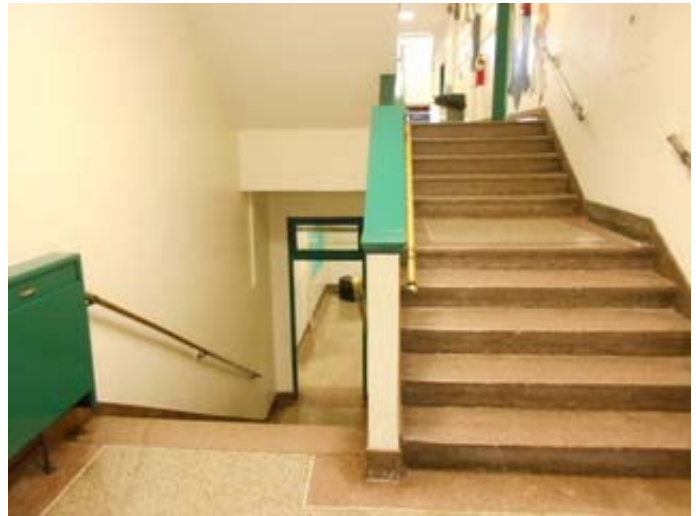
Non-Compliant Stair Tower
