**Building Information - Troy City (44925) - Cookson Elementary**

Program Type	Classroom Facilities Assistance Program (CFAP) - Regular
Setting	Small City
Assessment Name	Cookson Elementary School (7294) FINAL
Assessment Date (on-site; non-EEA)	2016-08-06
Kitchen Type	Warming Kitchen
Cost Set:	2016
Building Name	Cookson Elementary
Building IRN	7294
Building Address	921 Mystic Lane
Building City	Troy
Building Zipcode	45373
Building Phone	(937) 332.6740
Acreage	5.82
Current Grades:	K-5
Teaching Stations	27
Number of Floors	1
Student Capacity	480
Current Enrollment	319
Enrollment Date	2016-08-06
Enrollment Date is the date in which the current enrollment was taken.	
Number of Classrooms	24
Historical Register	<b>NO</b>
Building's Principal	Ms. Stephanie Johnson
Building Type	Elementary

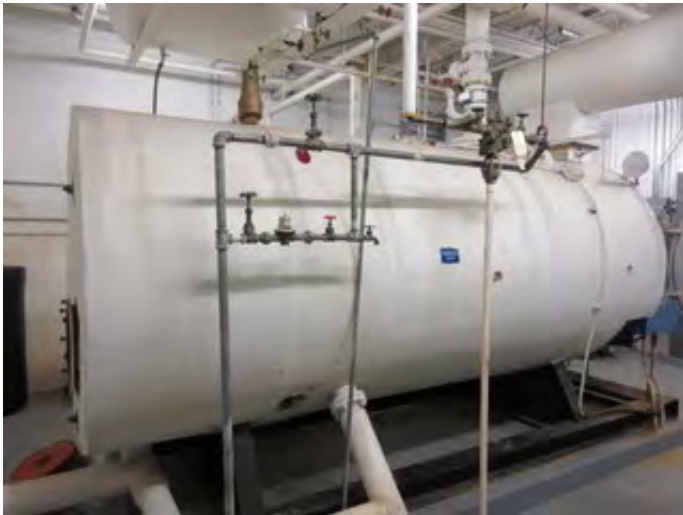
**Description:** The existing system for the 1964 Original Construction is a natural gas fired heated water boiler type system, installed in 1964, and is in fair condition. The system in the 1968 Addition is an extension of that found in the 1964 Original Construction. 2-pipe vs. 4-pipe designations are not applicable in this facility, as no central air conditioning is provided. The single heated water boiler, manufactured by Kewanee, was installed in 1964 and is in fair condition. Heating water is distributed to terminal units consisting of unit ventilators, cabinet heaters, unit heaters, fin tubes, and air handlers. The terminal equipment is original to each addition and is in fair condition. The system does not appear to comply with the 15 CFM per person fresh air requirements of the Ohio Building Code mechanical code and Ohio School Design Manual. The pneumatic type system temperature controls are original to each addition and are in fair condition. The system does not feature individual temperature controls in all spaces required by the OSDM. The overall system does not feature any central energy recovery systems. The facility is not equipped with louvered interior doors to facilitate Corridor utilization as return air plenums. The existing system is not ducted, and floor to structural deck heights will not accommodate the installation of properly sized ductwork for a future Ohio School Design Manual approved system. The overall heating system is evaluated as not being in safe and efficient working order, and long term life expectancy of the existing system is not anticipated. The structure is not equipped with central air conditioning. The site does not contain underground fuel tanks.

**Rating:** 3 Needs Replacement

Natural Gas Fired Heated Water Boiler

**Recommendations:** Provide new overall heating, ventilating, and air conditioning system to achieve compliance with Ohio Building Code and Ohio School Design Manual standards. Convert to ducted system to facilitate efficient exchange of conditioned air. Provide architectural soffits to accommodate the installation of ductwork.

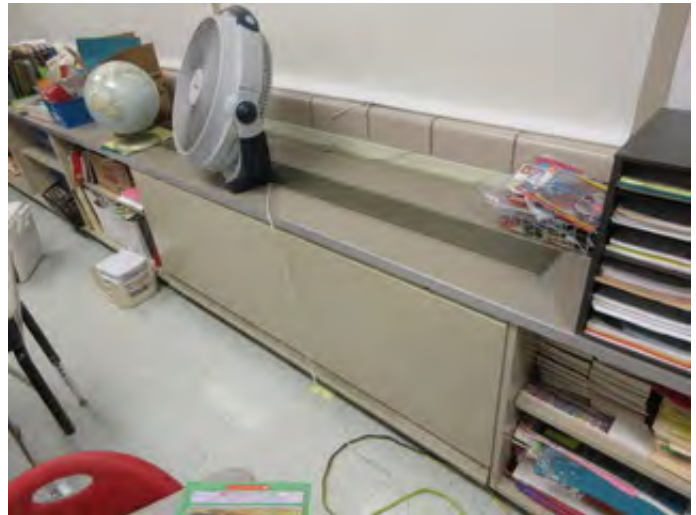
Unit Ventilator

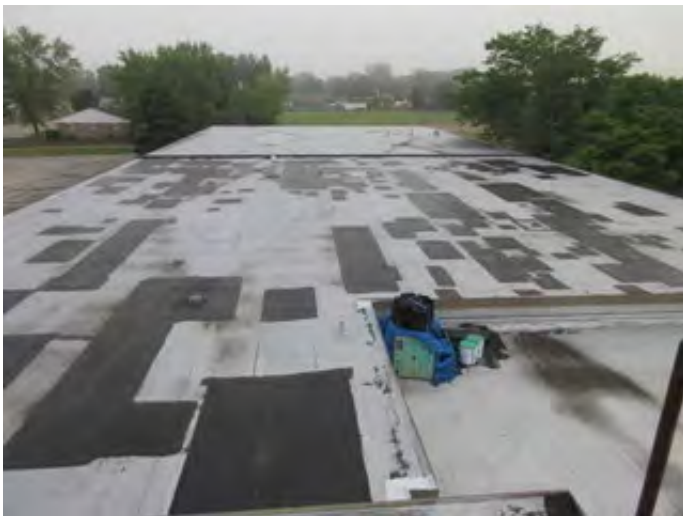
**Description:** The roof over the overall facility is a modified bitumin system by Tremco that was installed in 2006, and is in poor condition. There are District reports of current leaking. One section of the roof is approximately 50% covered with patches, and there is patch material left on the roof to be installed for the next area that leaks. Blisters form in the roofing system and burst. Burst blisters adjacent to seams cause leaks. Signs of past leaking were observed during the physical assessment. Access to the roof was gained by access hatch and access ladder that are in fair condition. One portion of the roof was not accessible. Fall safety protection cages are not required, and are not provided. There were no observations of standing water on the roof. Metal cap flashings and copings are in fair condition. Roof storm drainage is addressed through a system of roof drains, which are properly located, and in fair condition. The roof is not equipped with overflow roof drains though they are not required as there are no parapets. No problems requiring attention were encountered with any roof penetrations. There are not any covered walkways attached to this structure.

**Rating:** 3 Needs Replacement

Excessive Patching and Stored Patching Materials

**Recommendations:** The roof over the overall facility requires replacement to meet Ohio School Design Manual guidelines due to condition. The flashing and coping on the overall facility require replacement due to condition. Replace all roof drains in the overall facility. Provide once access ladder for the inaccessible section of the roof. Paint one existing roof access ladder. Install insulation in areas where the roof is being replaced throughout the overall facility.

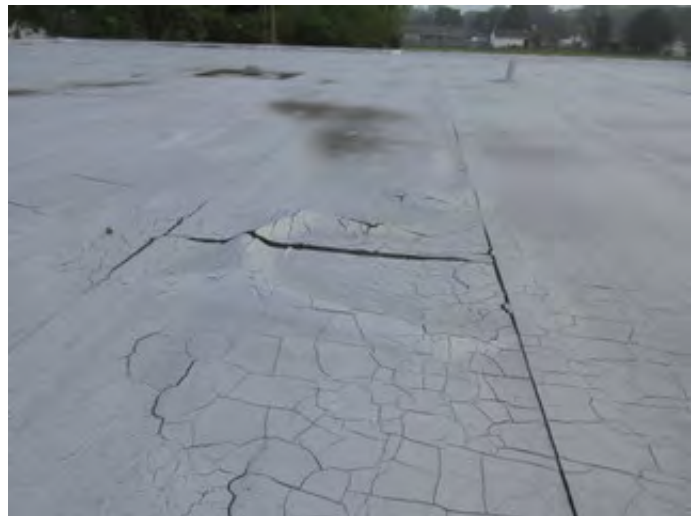
Typical Blisters and Cracking

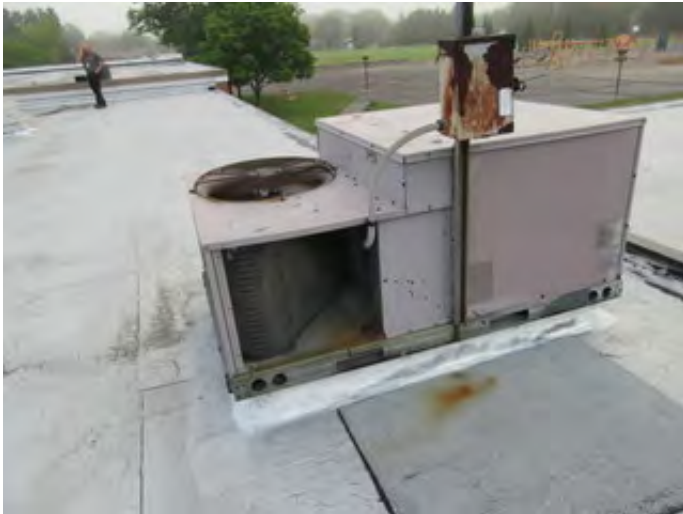
**Description:** The overall facility is not equipped with a central air conditioning system. Window units are located in the Teacher's Lounge and a Classroom location. Isolated room systems consisting of multiple ducted split and packaged roof top units with DX cooling are located in the Administrative Offices, Computer Lab, and Media Center. The ventilation system in the overall facility consists of unit ventilators, original to each addition and in fair condition, providing fresh air to Classrooms and the Media Center, and air handlers, original to each addition and in fair condition, providing fresh air to other miscellaneous spaces such as the Multi-Purpose Room (Gymnasium and Student Dining). Relief air venting is provided by transfer grilles to corridors, ceiling plenums, unit ventilators, central relief fans, and air handlers. The ventilation system does not appear to meet the Ohio Building Code 15 CFM per occupant fresh air requirement. The overall system is not compliant with Ohio Building Code and Ohio School Design Manual requirements. Dust collection systems are not required in this facility. The Art program is not equipped with a kiln. General building exhaust systems for Restrooms, Storage Rooms, Art Rooms, and Custodial Closets do not appear to be inadequately placed, and in fair condition.

Roof Top Unit

**Recommendations:** Provide an air conditioning system to meet with Ohio Building Code and Ohio School Design Manual requirements. Replace general building exhaust systems located in Restrooms, Storage Rooms, Art Rooms, and Custodial Closets. Pricing included in Item A. Provide the Art program with a kiln ventilation system to meet Ohio Building Code and Ohio School Design Manual requirements.

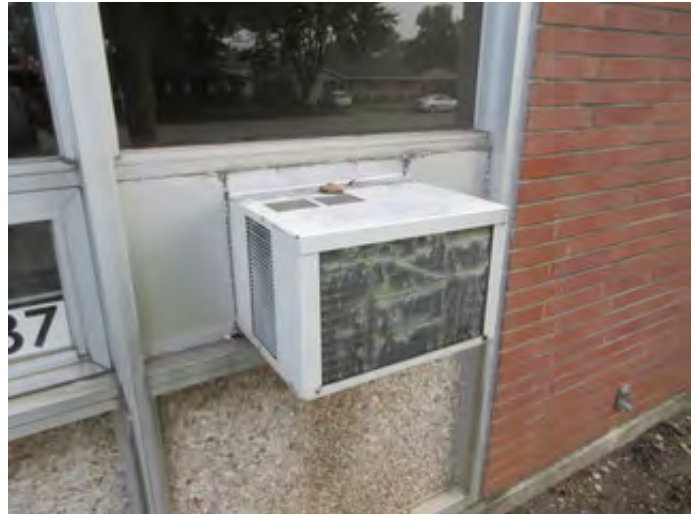
Window AC

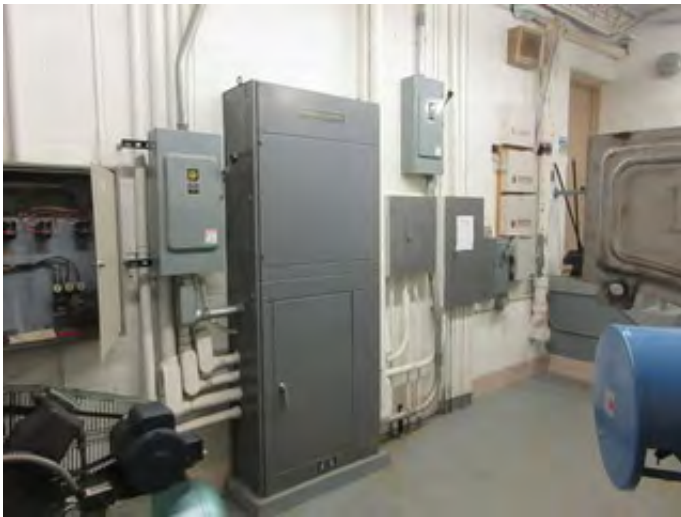
**Description:** The electrical system provided to the 1964 Original Construction is a 120/208 volts, 800 amp, 3 phase and 4 wire system installed in 1964, and is in fair condition. The system in the 1968 Addition is an extension of that found in the 1964 Original Construction. Power is provided to the school by a single utility owned, pad-mounted transformer located outside the Mechanical Room in a utility company Electrical Room, and is presumed to be in fair condition. The Square D panel systems, original to each addition, are in fair condition, and for the most part cannot be expanded to add additional capacity. The Classrooms are not equipped with adequate electrical outlets. The typical Classroom contains (5) general purpose outlets, (0) dedicated outlets for each Classroom computer, and (1) dedicated outlet for each Classroom television. Some Classrooms are equipped with as many as (6) general purpose outlets, while others are equipped with as few as (4) general purpose outlets. There are not any spaces that have no electrical outlets. The Corridors appear to be equipped with adequate electrical outlets for servicing. Adequate GFI protected exterior outlets are not provided around the perimeter of the building. The facility is not equipped with an emergency generator. Adequate lightning protection safeguards are not provided. Stage lighting power system including control panel, breakers, and dimmers is inadequately provided, in fair condition and does not meet OSDM requirements. The overall electrical system does not fully meet Ohio School Design Manual requirements in supporting the current needs of the school, and will be inadequate to meet the facility's future needs.

**Rating:** 3 Needs Replacement

Main Electrical Distribution Panel

**Recommendations:** The entire electrical system requires replacement to meet Ohio School Design Manual guidelines for overall capacity and due to age, condition, lack of OSDM-required features, and to accommodate the addition of an air conditioning system. Provide an emergency generator, with funding included in the electrical system replacement. Provide adequate lightning protection safeguards in the overall facility, including associated grounding system, with funding included in the electrical system replacement. Provide control panel, dimmers, and breakers to support the Stage lighting system, with funding included in the electrical system replacement.

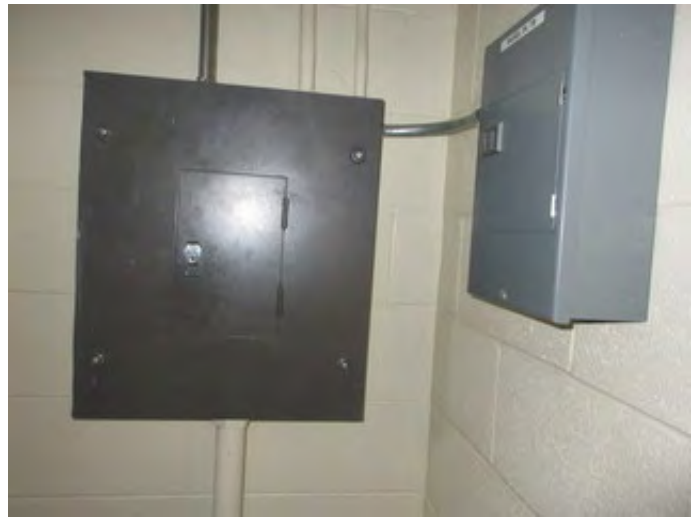
Electrical Sub-Panel

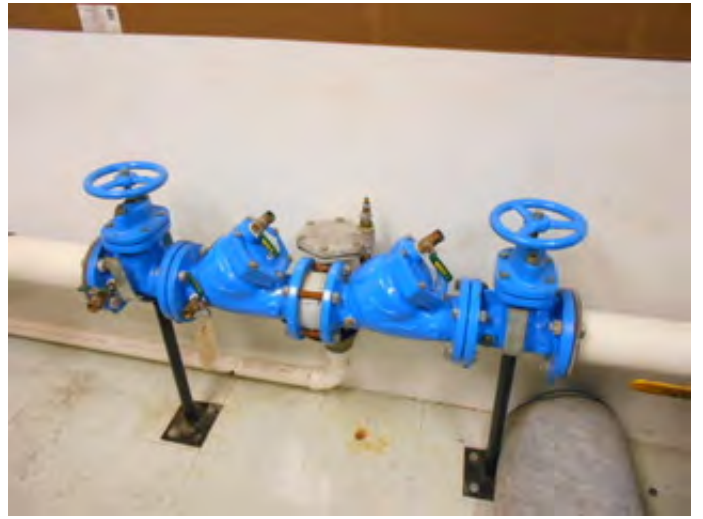
Reduced Pressure Backflow Preventer

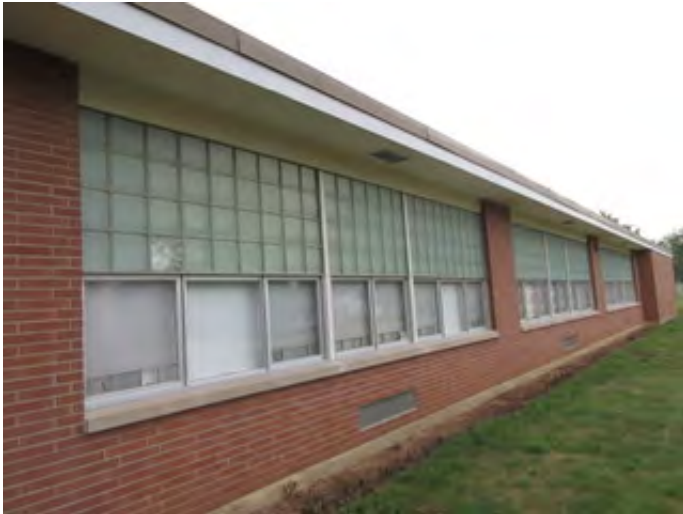
**Description:** The overall facility is equipped with aluminum frame windows with single glazed type window system, which was installed in 1964 and 1968, and is in fair to poor condition. Windows in the Library were recently replaced and are in good condition. The window system features operable windows throughout the building, and operable windows are not equipped with opening limiters, but do contain insect screens in fair condition. Window system seals are in fair condition, with minimal air and water infiltration being experienced. Window system hardware is in fair condition. The window system features no blinds. This facility is not equipped with any curtain wall systems. There are glass block windows in the overall facility, in fair to poor condition. The exterior doors in the overall facility are equipped with aluminum sidelights and transoms with tempered insulated glazing, in good condition. Exterior door vision panels are tempered insulated glazing. The school does not contain any skylights. The school does not contain any clerestories. Interior glass is OSDM-compliant. Window security grilles are not provided for ground floor windows. There is not a Greenhouse associated with this school.

**Rating:** 3 Needs Replacement

Typical Windows of the Original Construction

**Recommendations:** Replace the existing non-insulated window system and glass block in the overall facility, except for the Library windows, with a new insulated window system to comply with Ohio School Design Manual requirements.

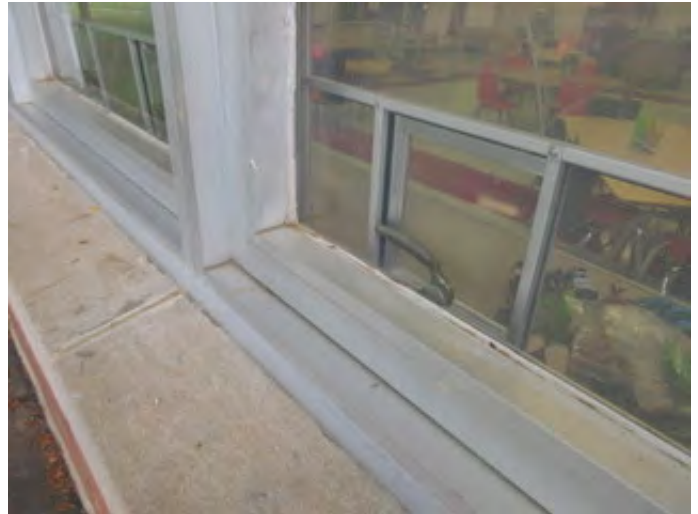
Typical Aluminum Window

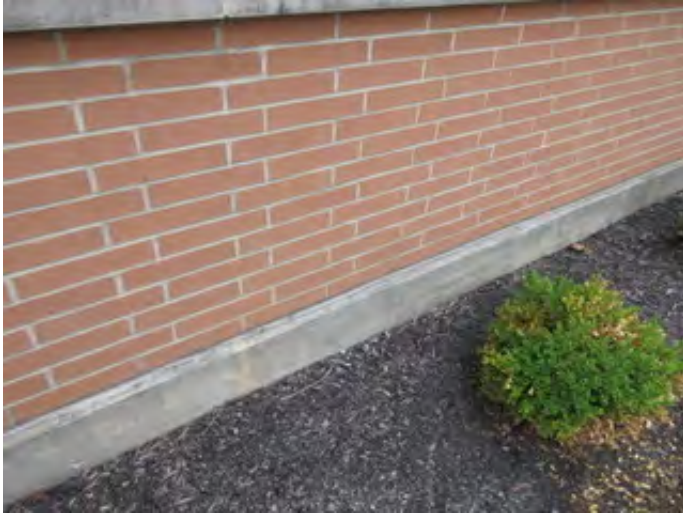
**Description:** The overall facility is equipped with concrete foundation walls on concrete footings, which displayed minor locations of significant differential settlement, cracking, or leaking, and are in fair condition. Areas of minor cracking and spalling were observed through the overall facility. The District reports that there has been no past leaking. No grading or site drainage deficiencies were noted around the perimeter of the structure that are contributing or could contribute to foundation wall structural deterioration.

Typical Foundation of the Original Construction

**Recommendations:** Repair areas of cracking and spalling through the overall facility.

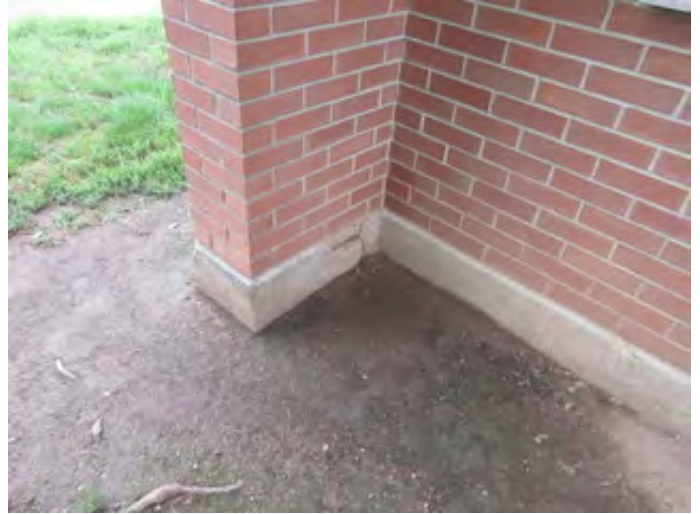
**Rating:** 2 Needs Repair

Minor Foundation Repair

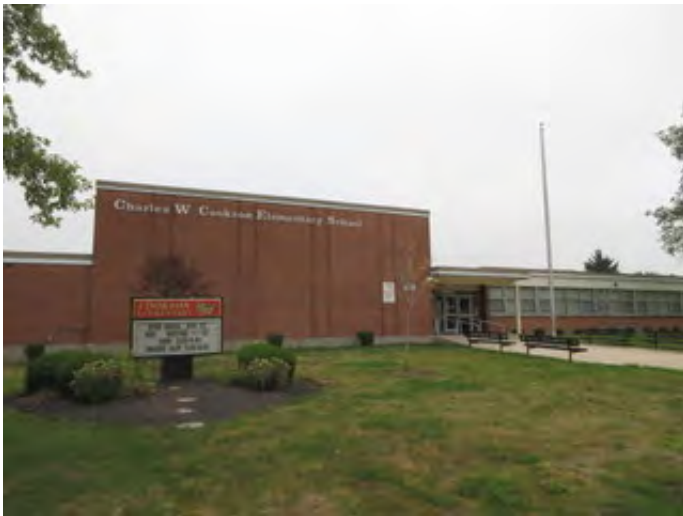
**Description:** The overall facility has a brick veneer on load bearing masonry wall system, which displayed locations of minor deterioration, and is in good to fair condition. The exterior masonry appears to have appropriately spaced and adequately caulked control joints in fair condition. Control joints are provided at some lintel locations, at doors and windows, building corners, and wall offsets and are in fair condition. The school does not have sufficient expansion joints, and they are in fair condition. There is one corner in the Original Construction on the front elevation that is cracked due to lack of expansion joints. Exterior walls in the overall facility inadequately insulated. Brick veneer masonry walls are not cavity walls. Weep holes and vents are not provided or required, with the exception of weeps being provided in the masonry below the new Library windows, and those are in good condition. Weep holes are not rope type weeps. Vents are not provided. The exterior masonry has not been cleaned and sealed in recent years, and shows evidence of mortar deterioration in minor locations throughout the building. Architectural exterior accent materials consist of EIFS and vertical vinyl siding, which are in good to fair condition. Exterior building fenestration in the Original Construction represents 19.71% of the exterior surfaces. Exterior building fenestration in the 1968 Classroom Addition represents 26.68% of the exterior surfaces. The classrooms in the overall facility have unit ventilators which will be removed. Masonry infill will be required. Interior Corridor and demising walls are concrete masonry units and glazed block partition walls, project full height from floor to bottom of deck, and are in good condition. Interior masonry appears to have adequately spaced and caulked control joints in good condition. Interior soffits are of plaster type construction, and in good condition. The window sills are stone, and are in good to fair condition. The exterior lintels are steel, and are in fair condition. Chimneys are in good condition. Canopies over entrances are steel tube frame and plaster type construction, and are in good condition. Exterior soffits are of plaster type construction, and in good condition. The school is not equipped with a loading dock.

Exterior Masonry

**Recommendations:** Provide tuckpointing in all areas of mortar deterioration as required through the overall facility. Provide masonry cleaning and sealing as required through the overall facility. Recaulk existing control joints. Sawcut and caulk one new expansion joint in existing masonry in the Original Construction. Prep and paint exposed steel lintels through the overall facility. Exterior wall insulation deficiencies are addressed in Item J. Infill masonry openings from removed unit ventilators.

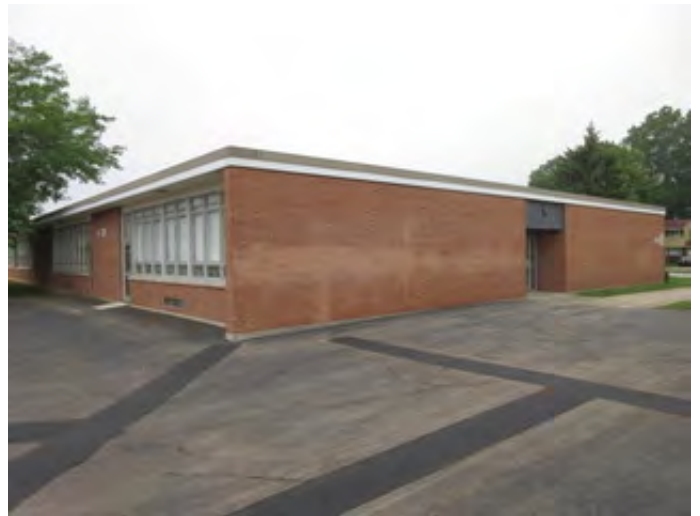
**Rating:** 2 Needs Repair

Exterior Masonry Cleaning Needed

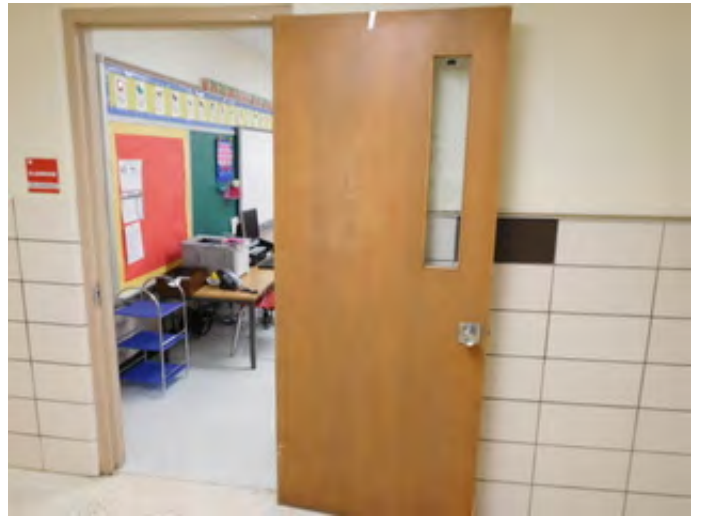
**Description:** The overall facility features conventionally partitioned Classrooms with VCT type flooring, acoustical tile type ceilings, as well as painted block and glazed block type wall finishes, and they are in fair condition. The overall facility has Corridors with terrazzo type flooring, acoustical tile type ceilings, as well as painted block and glazed block type wall finishes, and they are in fair condition. The overall facility has Restrooms with terrazzo type flooring, acoustical tile type ceilings, as well as painted block and glazed block type wall finishes, and they are in fair condition. Toilet partitions are metal or plastic, and are in good to fair condition. Classroom casework in the overall facility is wood type construction with plastic laminate tops, is inadequately provided, and in fair condition. The typical Classroom contains 5 lineal feet of casework, and Classroom casework provided ranges from 5 to 8 feet. Classrooms are provided adequate chalkboards, markerboards, and tackboards which are in fair condition. The Classroom storage cubbies and coat hooks, located in the Classrooms, are adequately provided, and in fair condition. The Art program is not equipped with a kiln. The facility is equipped with wood non-louvered interior doors that are flush mounted with proper ADA clearances, and in fair condition. Interior doors are not equipped with proper ADA hardware, except for three doors in the 1968 Addition. The Gymnasium space has rubber type flooring, exposed type ceilings, as well as brick, painted block, and glazed block type wall finishes, and they are in fair condition. Gymnasium stands are not provided. Six Gymnasium basketball backboards are a fixed type, and are in good to fair condition. The Media Center, located in the 1964 Original Construction, has marmoleum type flooring, acoustical tile type ceilings, as well as painted block and glazed block type wall finishes, and they are in fair condition. Student Dining shares the Gymnasium space. OSDM-required fixed equipment for Stage is adequately provided, and in fair condition. Existing Gymnasium, Media Center, and Music spaces are inadequately provided with appropriate sound attenuation acoustical surface treatments. The existing Kitchen is a Warming Kitchen only, is slightly oversized based on current enrollment, and the existing Kitchen equipment, installed over 20 years ago, is in fair condition. The Kitchen hood is in fair condition, and is not equipped with the required UL 300 compliant wet chemical fire suppression system. The required 6" overhang on all three exposed sides of the cooking equipment is provided by the hood. Kitchen hood exhaust ductwork is of proper construction, material, insulation, and installed as required by the OSDM and OBCMC. Reach-in coolers and freezers are located within the Kitchen spaces, and are in fair condition.

Typical Classroom Door

**Recommendations:** Provide complete replacement of finishes and casework due to condition and installation of systems outlined in Items A, C, D, E, I, K, L, M, N, T, U, and W. Provide for the replacement of interior doors due to age and condition. Provide for the replacement of walk-in cooler and freezer due to age and condition. Provide for the replacement of the Warming Kitchen Hood to meet OSDM standards. Provide for complete replacement of Warming Kitchen Equipment due to age and condition. Provide for an Art program kiln, with funding for exhaust system provided in Item C. Provide for the replacement of toilet accessories. Provide for the repair of terrazzo flooring due to condition. Provide for Gymnasium bleachers. Provide for appropriate sound attenuation acoustical surface treatments in the Gymnasium, Media Center, and Music Room. Provide for Stage Equipment. Provide for additional wall insulation. Remove Corridor transfer grilles, fill voids, and coordinate with adjacent finishes.

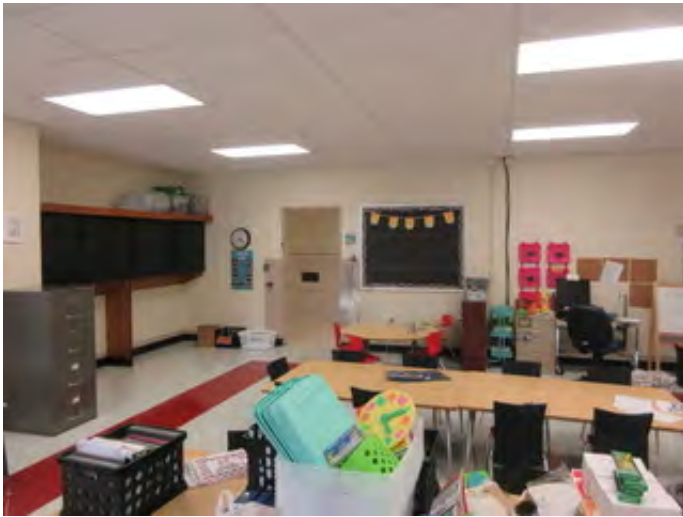
**Description:** The typical Classrooms in the overall facility are equipped with T-8 1x4 suspended direct fluorescent fixture type lighting, with dual level switching. Classroom fixtures are in fair condition, providing an average illumination of 47 FC, thus complying with the 40 FC recommended by the OSDM. The typical Corridors in the overall facility are equipped with T-8 2x4 lay-in direct fluorescent fixture type lighting, with single level switching. Corridor fixtures are in fair condition, providing an average illumination of 14 FC, which is less than the 15 FC recommended by the OSDM. The Multi-Purpose Room (Gymnasium/Student Dining) spaces are equipped with T-8 2x4 surface mount fluorescent fixture type lighting, in fair condition, providing an average illumination of 37 FC, which is less than the 40 FC recommended by the OSDM. The Media Center is equipped with T-8 2x4 suspended direct fluorescent fixture type lighting, in fair condition, providing an average illumination of 58 FC, thus complying with the 30 FC recommended by the OSDM. The Kitchen spaces are equipped with T-8 1x4 lay-in direct fluorescent fixture type lighting, with single level switching. Kitchen fixtures are in fair condition, providing an average illumination of 43 FC, which is less than the 50 FC recommended by the OSDM. The Service Areas in the overall facility are equipped with T-8 1x4 suspended and surface mount fluorescent fixture type lighting, in fair condition, providing inadequate illumination based on OSDM requirements. The typical Administrative spaces in the overall facility are equipped with T-8 2x4 lay-in direct fluorescent fixture type lighting, in fair condition, providing inadequate illumination based on OSDM requirements. The overall lighting systems of the facility are not fully compliant with Ohio School Design Manual requirements due to age and condition, inadequate lighting levels, and lack of multi-level switching.

**Rating:** 3 Needs Replacement

Classroom Fluorescent Light Fixtures

**Recommendations:** Provide complete replacement of lighting system due to age, condition, lighting levels, lack of multilevel switching, and installation of systems outlined in Items A, C, J, and U.

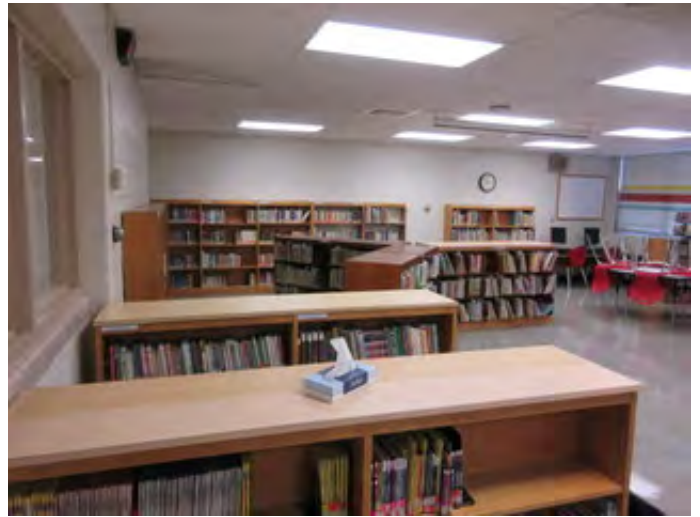
Media Center Fluorescent Light Fixtures

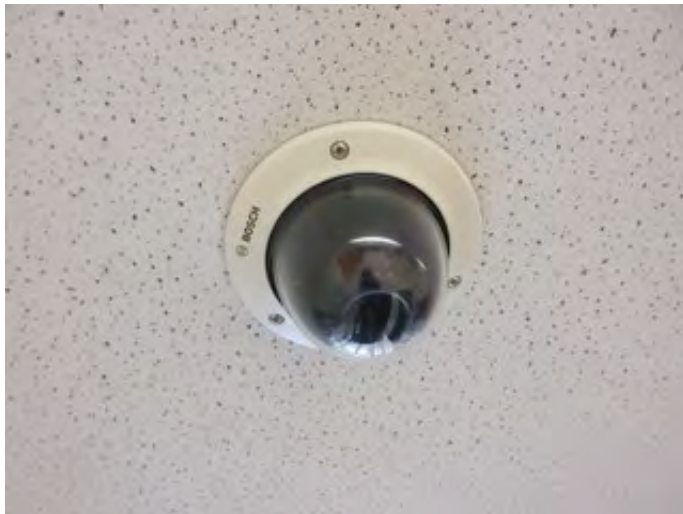
**Description:** The overall facility contains a Sonitrol motion detector, CCTV, door contact type security system in fair condition. Motion detectors are inadequately provided in main entries, central gathering areas, offices, main Corridors, and spaces where 6 or more computers are located. Exterior doors are inadequately equipped with door contacts. An automatic visitor control system is provided. Compliant color CCTV cameras are inadequately provided at main entry areas, parking lots, central gathering areas, and main Corridors. CCTV is monitored in Administrative Area with the use of a LCD monitor. A compliant computer controlled access control system integrating alarms and video signals, with appropriate UPS backup, is not provided. The system is equipped with card / biometric readers. The security system is not adequately provided throughout, and the system is not fully compliant with Ohio School Design Manual guidelines. There is no site fencing provided for security or separation from vehicular traffic. The exterior site lighting system is equipped with recessed incandescent and surface mounted LED and HID high pressure sodium entry lights in fair condition. Pedestrian walkways are illuminated with surface mounted LED and HID high pressure sodium fixtures in fair condition. Parking and bus pick-up / drop off areas are not illuminated. The exterior site lighting system provides inadequate illumination due to insufficient fixture capacity and sparse placement of fixtures.

**Rating:** 3 Needs Replacement

Security System CCTV Camera

**Recommendations:** Provide complete replacement of security system to meet Ohio School Design Manual guidelines. Provide complete replacement of exterior site lighting system to meet Ohio School Design Manual guidelines. Provide OSDM-compliant playground fencing, with funding included in complete replacement of security system.

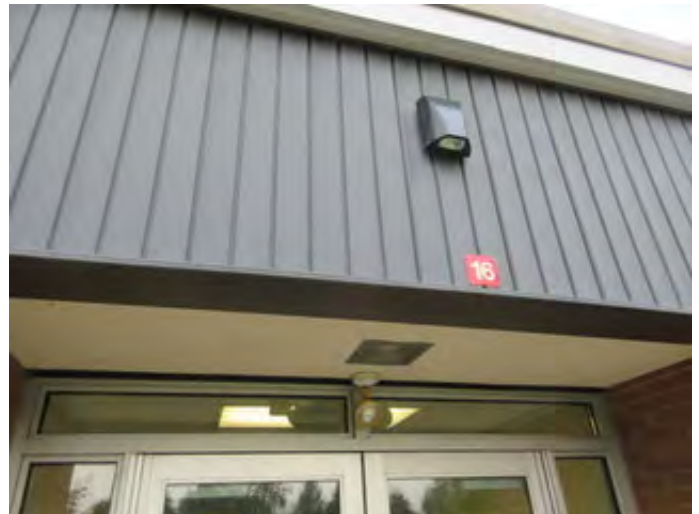
Entry Light Fixtures

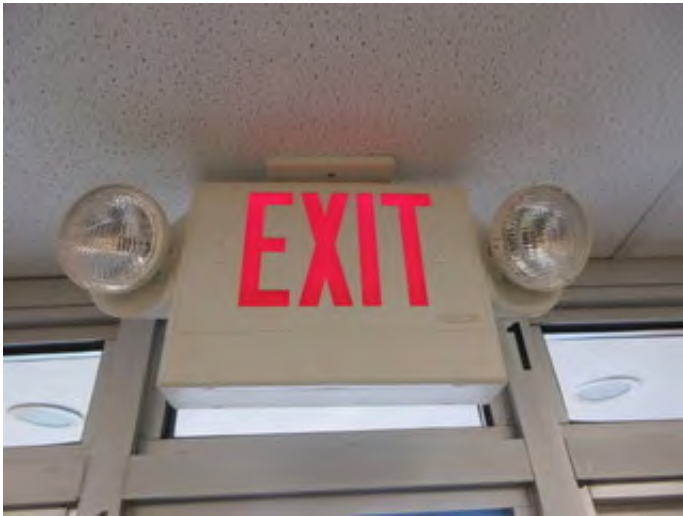
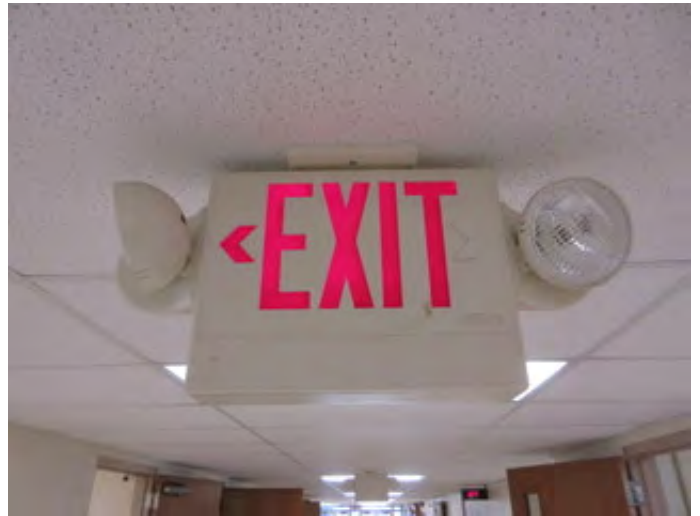
**Description:** The overall facility is inadequately equipped with an emergency egress lighting system consisting of non-compliant non-illuminated and plastic construction exit signs, as well as OSDM compliant red lettered and LED illuminated exit signs, and the system is in fair condition. The facility is inadequately equipped with emergency egress floodlighting (which consists mainly of emergency egress lighting attached to exit signs), but is also equipped with some recessed fluorescent lighting used as emergency egress lighting, and the system is in fair condition. The system is not provided with appropriate battery backup or emergency generator on separate circuits. The system is not adequately provided throughout, and does not meet Ohio School Design Manual and Ohio Building Code requirements.

**Rating:** 3 Needs Replacement

Exit Sign with Emergency Egress Lighting

**Recommendations:** Provide complete replacement of emergency / egress lighting system to meet Ohio School Design Manual and Ohio Building Code guidelines.

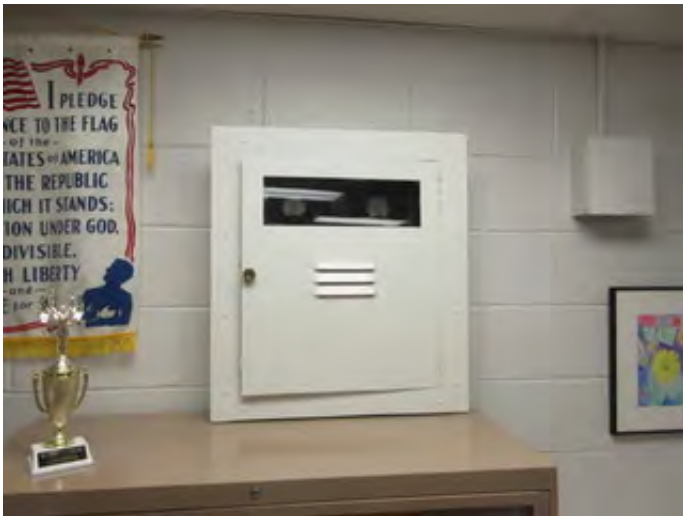
Fire Alarm System Control Panel

**Recommendations:** Provide complete replacement of fire alarm systems to meet OBC, NFPA, and Ohio School Design Manual guidelines.

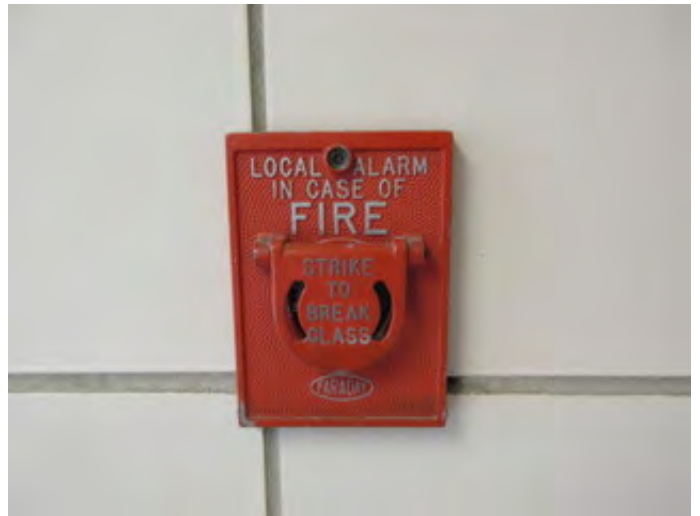
Fire Alarm System Manual Pull Station

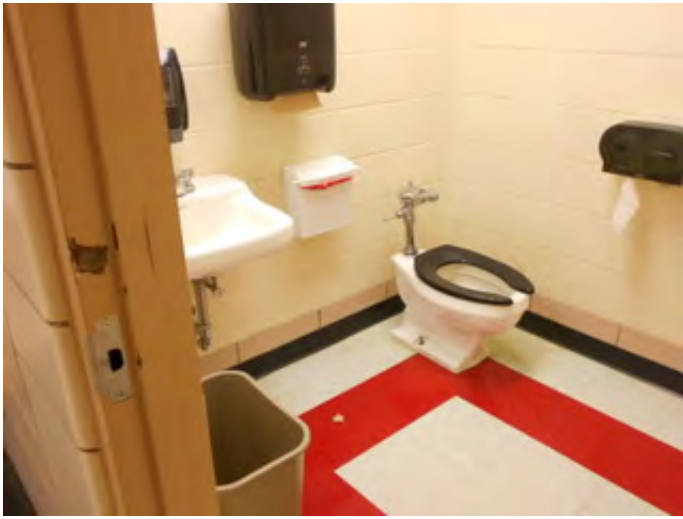
Non Compliant Unisex Restroom

<b>Other:</b> Reconfigure Toilet Room for ADA Compliance	\$10,000.00	per restroom		3 Required		\$30,000.00	Enlarge and reconfigure existing Toilet Room to meet ADA requirements. Includes fixtures, walls, door and hardware, supply lines and full set of accessories including grab bars.
<b>Sum:</b>			\$78,240.00	\$78,240.00	\$0.00

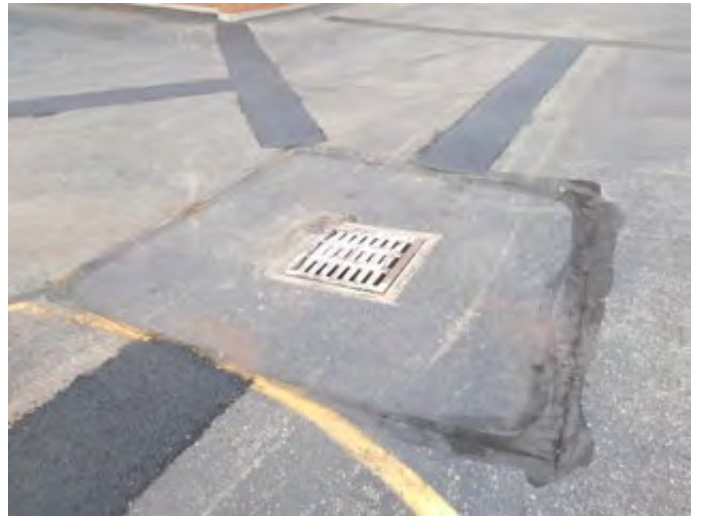
Play Area Asphalt and Catch Basin

Provide Exterior Parking Lot Catch Basin:	\$2,500.00	each		4 Required	1 Required	\$12,500.00	
Provide Concrete Dumpster Pad:	\$2,400.00	each		1 Required		\$2,400.00	(for two dumpsters)
Base Sitework Allowance for Unforeseen Circumstances	\$50,000.00	allowance		Required		\$50,000.00	Include this and one of the next two. (Applies for whole building, so only <b>one</b> addition should have this item)
Sitework Allowance for Unforeseen Circumstances for buildings between 0 SF and 100,000 SF	\$1.50	sq.ft. (of entire building addition)		Required	Required	\$68,742.00	Include this one <b>or</b> the next. (Each addition should have this item)
<b>Other:</b> Basketball Backboard Replacement	\$1,000.00	each		5 Required	1 Required	\$6,000.00	Provide for replacement of basketball backboards due to age and condition.
<b>Other:</b> Exterior Furnishing Replacement	\$500.00	each		2 Required		\$1,000.00	Provide for replacement of two exterior furnishings due to condition.

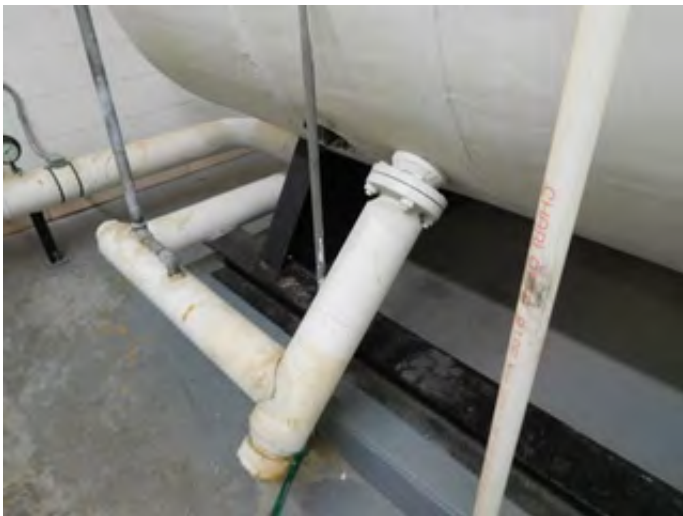
Pipe Insulation

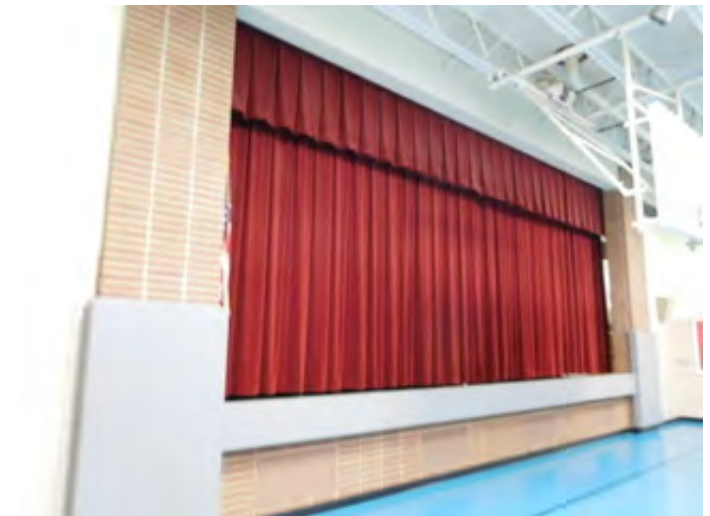
Stage Curtain
