**Building Information - Troy City (44925) - Forest Elementary**

Program Type	Classroom Facilities Assistance Program (CFAP) - Regular
Setting	Small City
Assessment Name	Forest Elementary School (11924) FINAL
Assessment Date (on-site; non-EEA)	2016-08-06
Kitchen Type	Warming Kitchen
Cost Set:	2016
Building Name	Forest Elementary
Building IRN	11924
Building Address	413 East Canal Street
Building City	Troy
Building Zipcode	45373
Building Phone	(937) 332.6746
Acreage	1.96
Current Grades:	K-5
Teaching Stations	22
Number of Floors	2
Student Capacity	360
Current Enrollment	262
Enrollment Date	2016-08-06
Enrollment Date is the date in which the current enrollment was taken.	
Number of Classrooms	18
Historical Register	<b>NO</b>
Building's Principal	Mr. Paul Hohlbein
Building Type	Elementary

**Building Construction Information - Troy City (44925) - Forest Elementary (11924)**

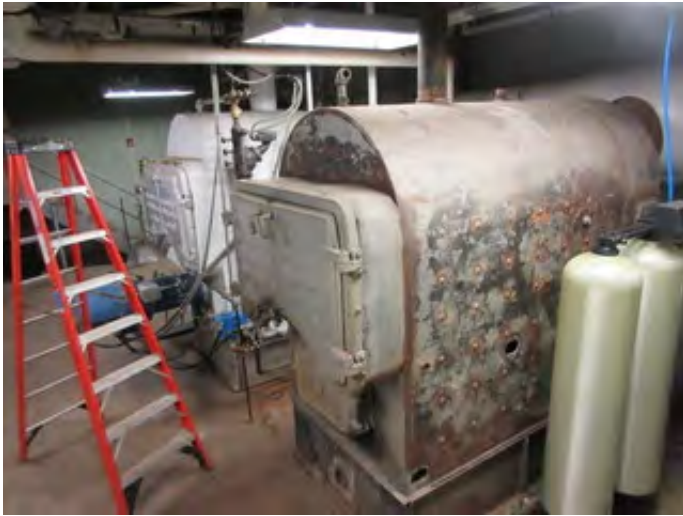
**Description:** The existing system for the 1949 Original Construction is a natural gas fired steam boiler type system, installed in 1949, and is in fair condition. The systems in the 1973 and 2006 Additions are an extension of that found in the 1949 Original Construction. 2-pipe vs. 4-pipe designations are not applicable in this facility, as no central air conditioning is provided. The facility is equipped with (2) steam boilers, only one of which is operational. The single steam boiler was manufactured by Fitzgibbon Boilers, was installed in 1949, and is in fair condition. Steam is distributed to terminal units consisting of fin tubes, unit ventilators, cabinet heaters, unit heaters, and air handlers. The terminal equipment is original to each addition and is in fair condition. The system does not appear to comply with the 15 CFM per person fresh air requirements of the Ohio Building Code mechanical code and Ohio School Design Manual. The pneumatic and electric type system temperature controls are original to each addition and are in fair to poor condition. The system does not feature individual temperature controls in all spaces required by the OSDM. The overall system does not feature any central energy recovery systems. The facility is not equipped with louvered interior doors to facilitate Corridor utilization as return air plenums. The existing systems in the overall facility are not ducted, and floor to structural deck heights will accommodate the installation of properly sized ductwork for a future Ohio School Design Manual approved system. The overall heating system is evaluated as being unsafe and in inefficient working order, and long term life expectancy of the existing system is not anticipated. The structure is not equipped with central air conditioning. The site does not contain underground fuel tanks.

**Rating:** 3 Needs Replacement

Natural Gas Fired Steam Boilers

**Recommendations:** Provide new overall heating, ventilating, and air conditioning system to achieve compliance with Ohio Building Code and Ohio School Design Manual standards. Convert to ducted system to facilitate efficient exchange of conditioned air.

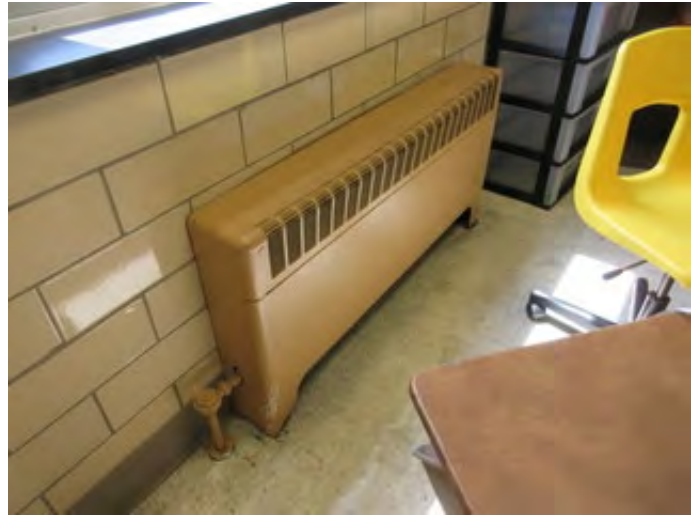
Fin Tube Heater

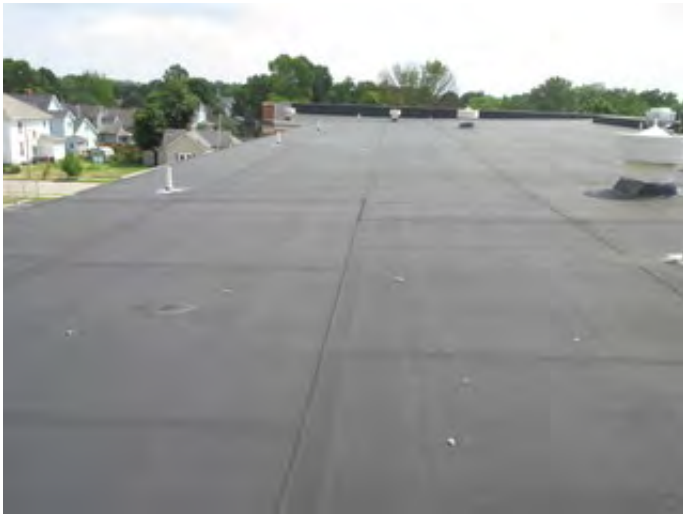
**Description:** The roof over the Original Construction and the 1973 Office Addition is an EPDM system that was installed approximately in 2005, and is in fair condition. There is also a small section of slate roof in fair condition over the Original Construction. The roof over the 2006 Kindergarten Addition is a TPO system that was installed in 2006, and is in good condition. There are no District reports of current leaking. No signs of past leaking were observed during the physical assessment. Access to the roof was gained by access hatch in good condition and access ladder that is in poor condition. The ladder is unsafe as the ceiling plane passes through the ladder. Fall safety protection cages are not required, and are not provided. Access to the 1973 Office Addition is through a window. An access door could be provided in this location. There is no access to the 2006 Kindergarten Addition. There were observations of standing water on the roof. Metal cap flashings and stone copings are in good condition. Roof storm drainage is addressed through a system of gutters and downspouts and roof drains, which are properly located, and in good condition. The roof of the 1973 Office Addition is not equipped with overflow roof drains though they will be required in areas of roof replacement. Overflow drains are not required in the rest of the school. Several roof penetrations have some flashings that are loose. There are not any covered walkways attached to this structure.

**Rating:** 3 Needs Replacement

Typical EPDM Roofing of the Original Construction

**Recommendations:** The roof over the Original Construction and the 1973 Office Addition, with the exception of the slate roof area, requires replacement to meet Ohio School Design Manual guidelines due to age of system and projected lifecycle. Due to existing conditions one section of downspout requires repair or replacement. Provide one overflow drain for the 1973 Office Addition. Provide one access hatch and ladder for the 2006 Kindergarten Addition. Replace one access ladder in the Original Construction. Install tapered insulation to correct ponding at the Original Construction. Install insulation in areas where the roof is being replaced throughout the overall facility. See Section S for new access door.

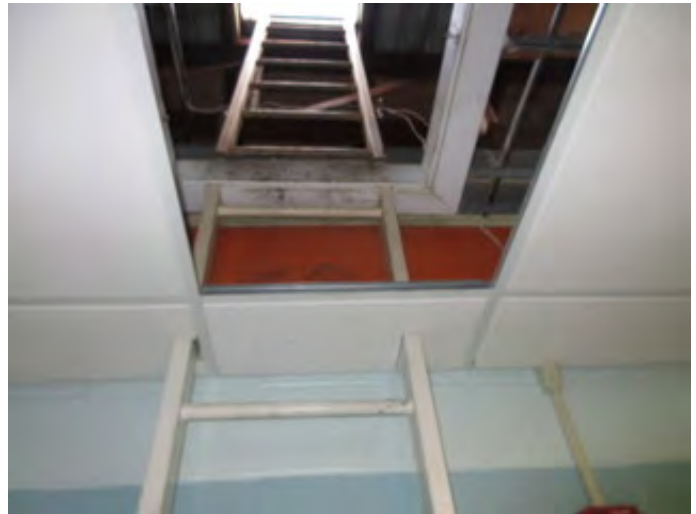
Unsafe Roof Access Ladder of the Original Construction

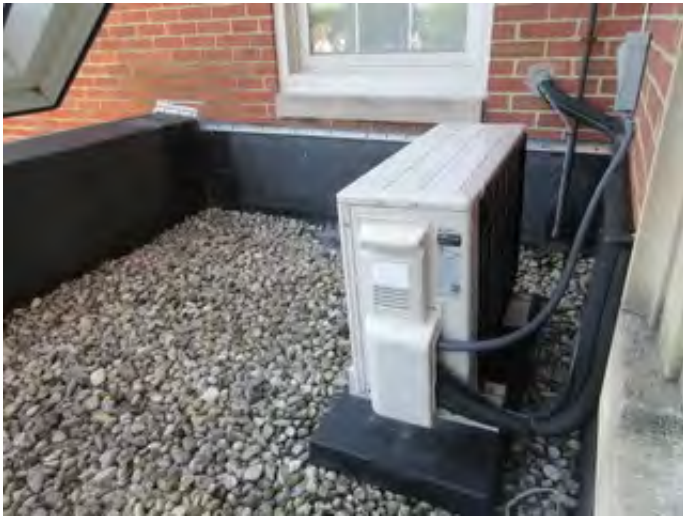
**Description:** The overall facility is not equipped with a central air conditioning system. Window units are not present in the overall facility. Isolated room systems consisting of thru-wall PTAC units are located in the Administrative Offices and Health Clinic. Isolated room systems consisting of ducted and ductless split AC units (with condensing units pad-mounted on the exterior and on the roof of the overall facility) are located in the 1973 Addition, Computer Lab, and various other locations throughout the overall facility. The ventilation system in the overall facility consists of unit ventilators, original to each addition and in fair condition, providing fresh air to Classrooms and Media Center and air handlers, original to each addition and in fair condition, providing fresh air to other miscellaneous spaces such as the Gymnasium and Student Dining areas. Relief air venting is provided by unit ventilators, transfer grilles to corridors, central relief fans, thru-wall PTAC units, and air handlers. The ventilation system does not appear to meet the Ohio Building Code 15 CFM per occupant fresh air requirement. The overall system is not compliant with Ohio Building Code and Ohio School Design Manual requirements. Dust collection systems are not required in this facility. The Art program is equipped with a kiln and the kiln ventilation system is inadequate. General building exhaust systems for Restrooms, Storage Rooms, Art Rooms, and Custodial Closets do not appear to be inadequately placed, and in fair condition.

**Rating:** 2 Needs Repair

Ductless Split AC Condensing Unit

**Recommendations:** Provide an air conditioning system to meet with Ohio Building Code and Ohio School Design Manual requirements. Replace general building exhaust systems located in Restrooms, Storage Rooms, Art Rooms, and Custodial Closets. Pricing included in Item A. Provide the Art program with a kiln ventilation system to meet Ohio Building Code and Ohio School Design Manual requirements.

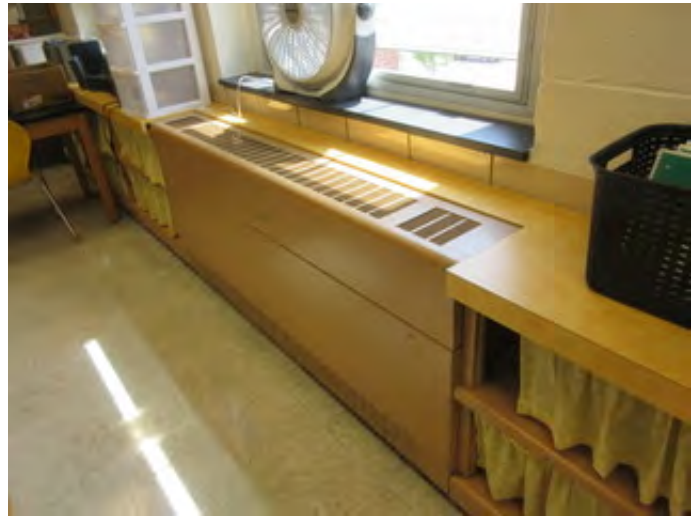
Unit Ventilator

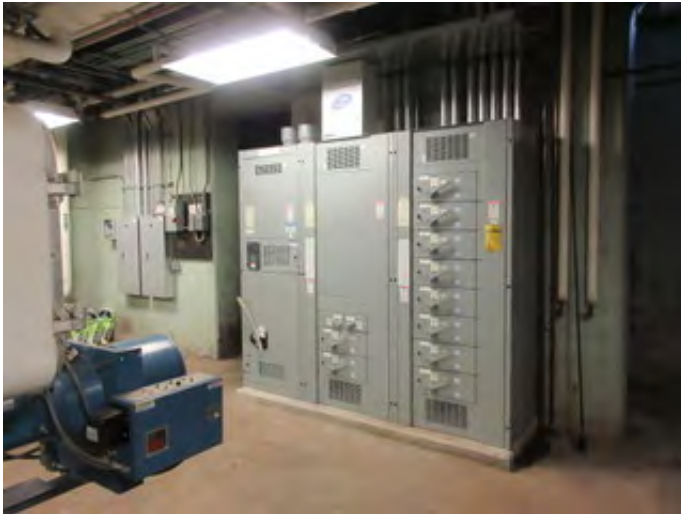
**Description:** The electrical system provided to the 1949 Original Construction is a 208Y/120V volts, 1,600 amp, 3 phase and 4 wire system installed in 1949 with upgrades in 2006, and is in fair condition. The systems in the 1973 and 2006 Additions are an extension of that found in the 1949 Original Construction. Power is provided to the school by a single utility owned, pad-mounted transformer located outside the Mechanical Room, and appears to be in fair condition. The Eaton panel systems, original to each addition with upgrades in 2006, are in fair condition, and for the most part cannot be expanded to add additional capacity. The Classrooms are not equipped with adequate electrical outlets. The typical Classroom contains (5) general purpose outlets, (0) dedicated outlets for each Classroom computer, and (1) dedicated outlet for each Classroom television. Some Classrooms are equipped with as many as (6) general purpose outlets, while others are equipped with as few as (4) general purpose outlets. There are not any spaces that have no electrical outlets. The Corridors appear to be equipped with adequate electrical outlets for servicing. Adequate GFI protected exterior outlets are not provided around the perimeter of the building. The facility is not equipped with an emergency generator. Adequate lightning protection safeguards do not appear to be provided. Stage lighting power system including control panel, breakers, and dimmers is inadequately provided, in fair condition and does not meet OSDM requirements. The overall electrical system does not fully meet Ohio School Design Manual requirements in supporting the current needs of the school, and will be inadequate to meet the facility's future needs.

**Rating:** 3 Needs Replacement

Main Electrical Distribution Panel

**Recommendations:** The entire electrical system requires replacement to meet Ohio School Design Manual guidelines for overall capacity and due to lack of OSDM-required features and to accommodate the addition of an air conditioning system. Provide an emergency generator, with funding included in the electrical system replacement. Provide adequate lightning protection safeguards in the overall facility, including associated grounding system, with funding included in the electrical system replacement. Provide control panel, dimmers, and breakers to support the Stage lighting system, with funding included in the electrical system replacement.

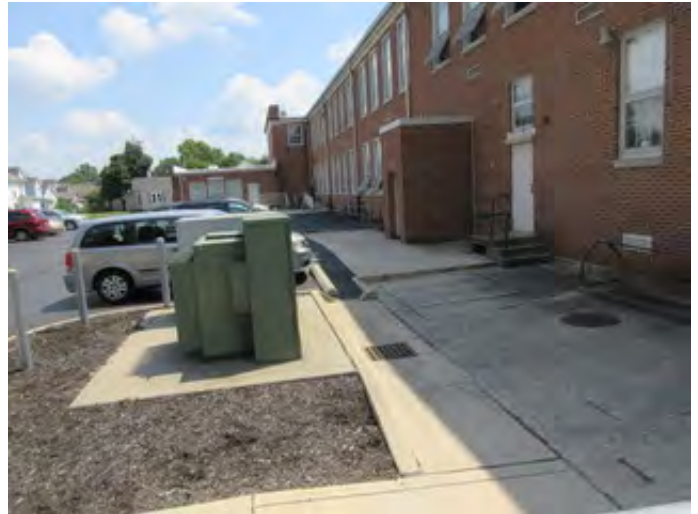
Pad Mounted Transformer

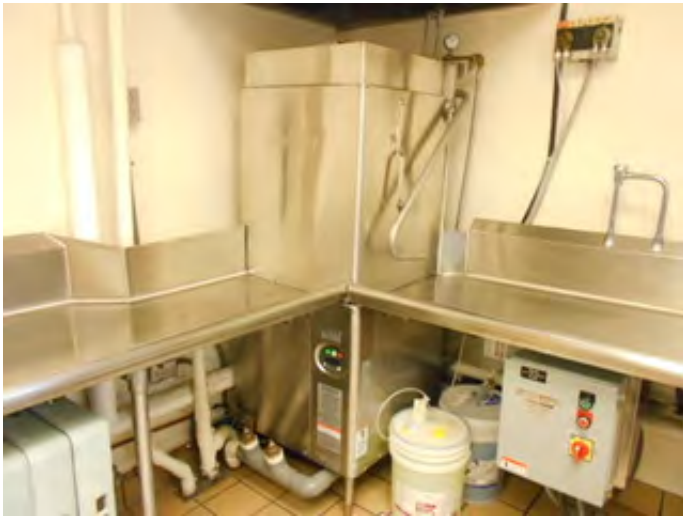
3 Needs Replacement

Commercial Dish Washer

In the overall facility, due to age and condition, replace the remaining galvanized steel domestic water piping and the remaining cast iron waste piping in the 1949 Original Construction and the 1973 Addition. Due to age and condition and to facilitate the school's compliance with OBC and OSFC fixture requirements, in the 1949 Original Construction, replace 21 toilets, 2 lavatories (include ADA compliant faucets) and 2 electric water coolers. Provide 4 additional wall mounted lavatories with ADA compliant faucets, 1 per Boy's and Girl's Restroom. Provide 2 additional electric water coolers in the 1949 Original Construction. Replace 1 lavatory faucet with an ADA compliant faucet, in the Boy's Restroom in the 1949 Original Construction. Due to age, condition, LEED, OBC and OSFC, replace 44 faucets and valves throughout the overall facility. Provide 3 new and replace 4 in Classroom sinks with deck mounted drinking fountain in the 1949 Original Construction. All fixtures, whether new or replaced, to be mounted at ADA compliant heights. Provide a solids interceptor in the Art Room. Provide 4 additional exterior wall hydrants. See Item O for replacement of fixtures related to ADA requirements, as well as the reconfiguration of 2 Staff Restrooms, 1 Restroom in the Health Clinic and 1 Kindergarten Restroom.

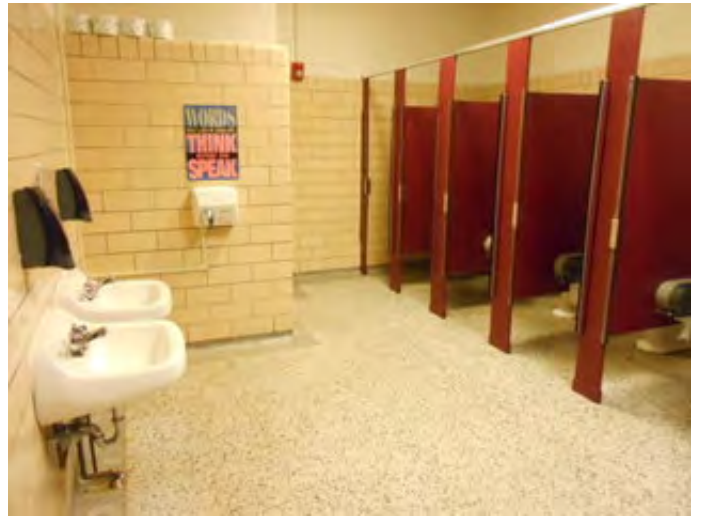
Large Group Restroom-Girls

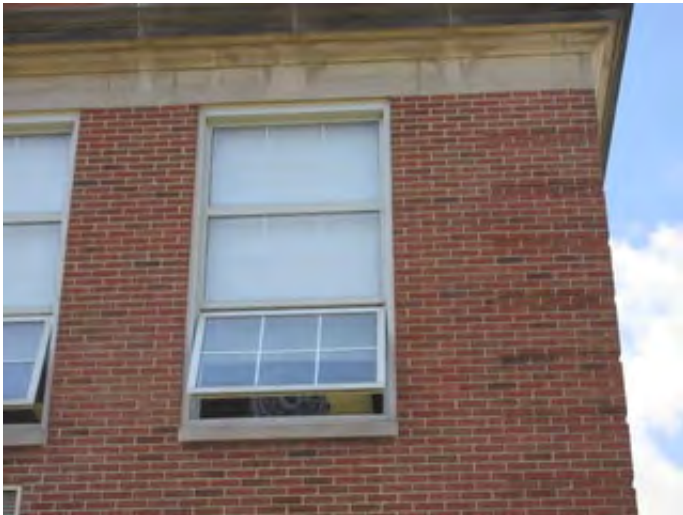
**Description:** The Original Construction and 1973 Office Addition is equipped with thermally broken aluminum frame windows with insulated glazing type window system, which was installed at an unknown date, and is in fair to poor condition. The circular and arch-top windows of the Original Construction are wood frame windows with single glazed type window system, which was installed in 1949, and is in fair to poor condition. The window system features operable windows throughout the building, and operable windows are not equipped with opening limiters, but do contain insect screens in fair to poor condition. Window system seals are in fair to poor condition, with minimal air and water infiltration being experienced. Window system hardware is in fair to poor condition. The window system features no blinds. This facility is not equipped with any curtain wall systems. This facility does not feature any glass block windows. The 2006 Kindergarten Addition is equipped with thermally broken aluminum frame windows with insulated glazing type window system, which was installed in 2006, and is in fair condition. The window system features operable windows throughout the building, and operable windows are equipped with opening limiters in fair condition and insect screens in fair to poor condition. Window system seals are in fair condition, with no air and water infiltration being experienced. Window system hardware is in fair to poor condition. The window system features integral blinds, which are in fair condition. This facility is not equipped with any curtain wall systems. This facility does not feature any glass block windows. The exterior doors in the overall facility are equipped with thermally broken aluminum frame sidelights and transoms with tempered insulated glazing, in good condition. Exterior door vision panels are tempered insulated glazing. The school does not contain any skylights. The school does not contain any clerestories. Interior glass is OSDM-compliant. Window security grilles are not provided for ground floor windows. There is not a Greenhouse associated with this school.

**Rating:** 3 Needs Replacement

Typical Aluminum Windows of the Original Construction

**Recommendations:** Provide a new insulated window system with integral blinds to meet with Ohio School Design Manual requirements.

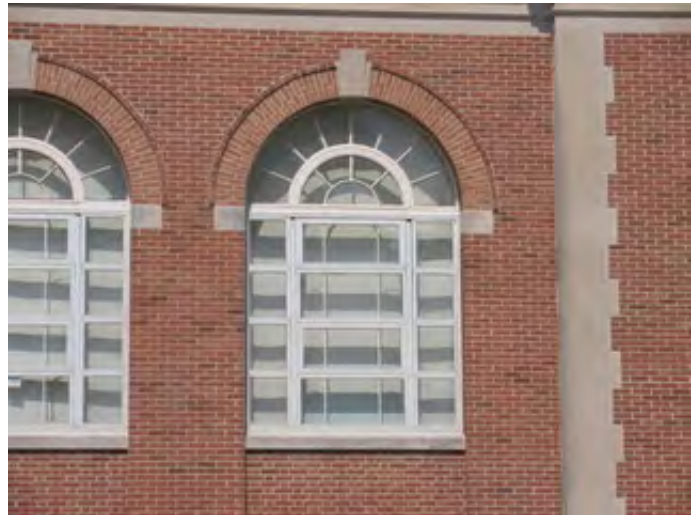
Typical Wood Arch Top Windows

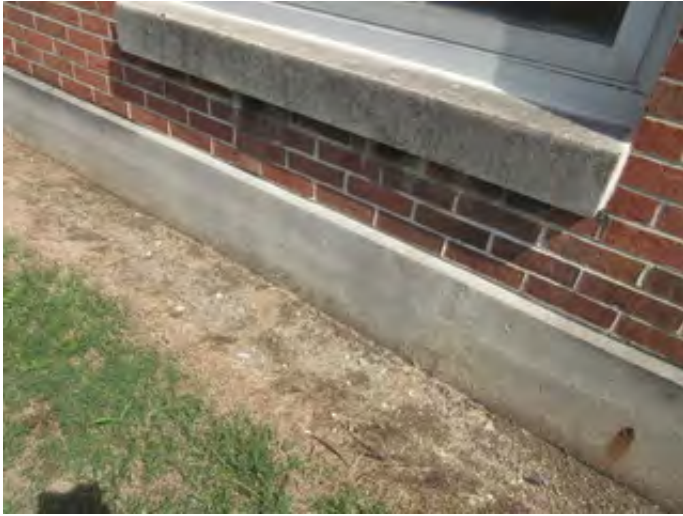
**Description:** The Original Construction and the 1973 Office Addition is equipped with concrete foundation walls on concrete footings, which displayed no locations of significant differential settlement, cracking, or leaking, and are in good condition. The 2006 Kindergarten Addition is equipped with concrete masonry unit foundation walls on concrete footings, which displayed no locations of significant differential settlement, cracking, or leaking, and are in good condition. No significant issues related to foundation cracking or spalling were encountered. The District reports that there has been no past leaking. No grading or site drainage deficiencies were noted around the perimeter of the structure that are contributing or could contribute to foundation / wall structural deterioration.

Typical Concrete Foundation

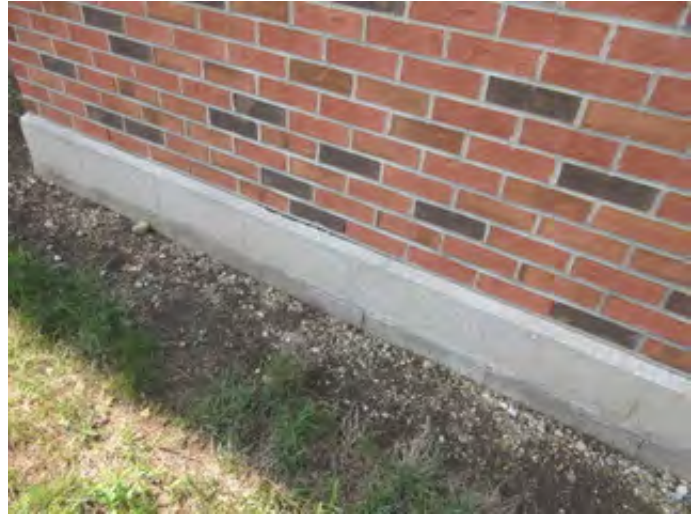
Typical Concrete Masonry Foundation of the 2006 Kindergarten Addition

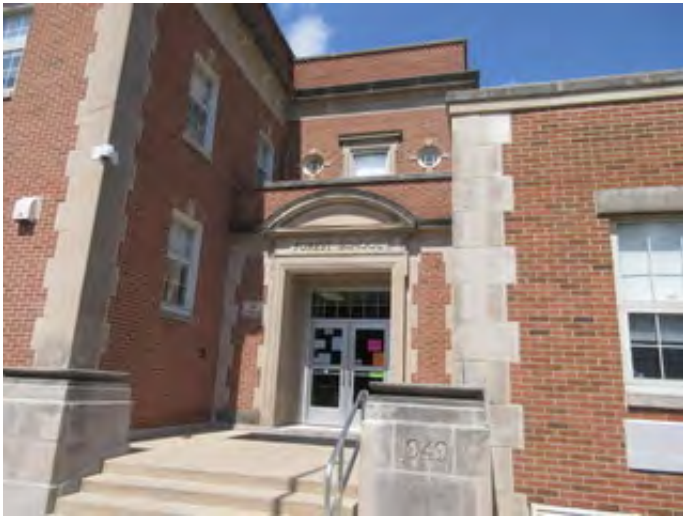
**Description:** The Original Construction and 1973 Office Addition has a brick veneer on load bearing masonry wall system, which displayed locations minor locations of deterioration, and is in good to fair condition. These portions of the school do not contain control or expansion joints and none are needed, as there is no indication of exterior masonry cracking or separation. The 2006 Kindergarten Addition has a brick veneer on load bearing masonry wall system, which displayed locations no locations of deterioration, and is in good condition. The exterior masonry appears to have appropriately spaced and adequately caulked control joints in good condition. Control joints are provided at lintel locations, at doors and windows, building corners, and wall offsets and are in good condition. The school does have sufficient expansion joints, and they are in good condition. Exterior walls in the Original Construction and 1973 Office Addition are inadequately insulated. Brick veneer masonry walls are not cavity walls. Exterior walls in the 2006 Kindergarten Addition are adequately insulated. Brick veneer masonry walls are cavity walls. Weep holes and vents are not provided or required in the Original Construction and 1973 Office Addition. In the 2006 Kindergarten Addition, weep holes are provided in sufficient quantity at lintels, below sills, and the base of masonry cavity walls, and are in good condition. Weep holes are not rope type weeps. Vents are provided in sufficient quantity. The exterior masonry of the Original Construction has not been cleaned and sealed in recent years, and has locations of mold. Architectural exterior accent materials consist of stone, which is in fair condition. Exterior building fenestration in the Original Construction represents 17.76% of the exterior surfaces. The exterior masonry of the 1973 Office Addition has not been cleaned and sealed in recent years, and has locations of mold. Architectural exterior accent materials consist of stone, which is in fair condition. Exterior building fenestration in the 1973 Office Addition represents 7.72% of the exterior surfaces. The exterior masonry of the 2006 Kindergarten Addition has not yet needed to be cleaned and sealed, showing no evidence of mortar deterioration Architectural exterior accent materials consist of stone, which is in good condition. Exterior building fenestration in the 2006 Kindergarten Addition represents 8.44% of the exterior surfaces. Most classrooms in the Original Construction have unit ventilators which will be removed. Masonry infill will be required. Interior Corridor and demising walls are concrete masonry units and glazed block, project full height from floor to bottom of deck, and are in good condition. Interior masonry appears to have adequately spaced and caulked control joints in good condition. Interior soffits are of plaster type construction, and in good condition. The window sills are stone, and are in good condition. The exterior lintels are steel, and are in fair condition. Chimneys are in poor condition, requiring tuckpointing. Canopies over entrances are stone, concrete, and wood type construction, and are in good to fair condition. Exterior soffits are of wood type construction, and in fair condition. The school is not equipped with a loading dock.

Typical Masonry and Stone Accents of the Original Construction

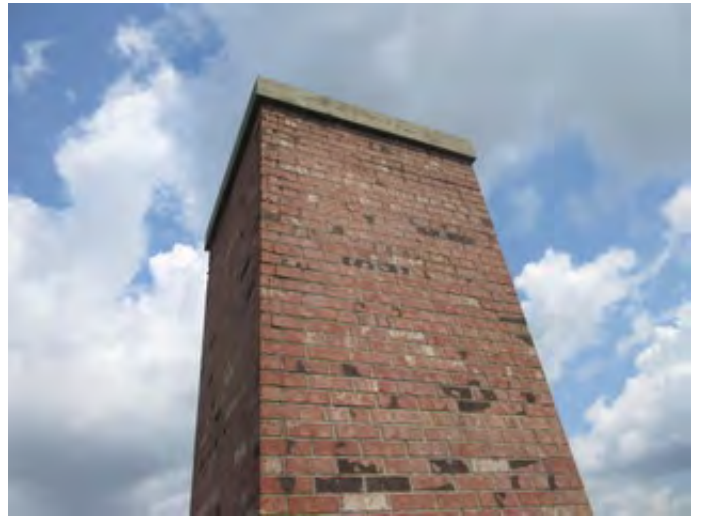
Chimney Tuckpointing Required

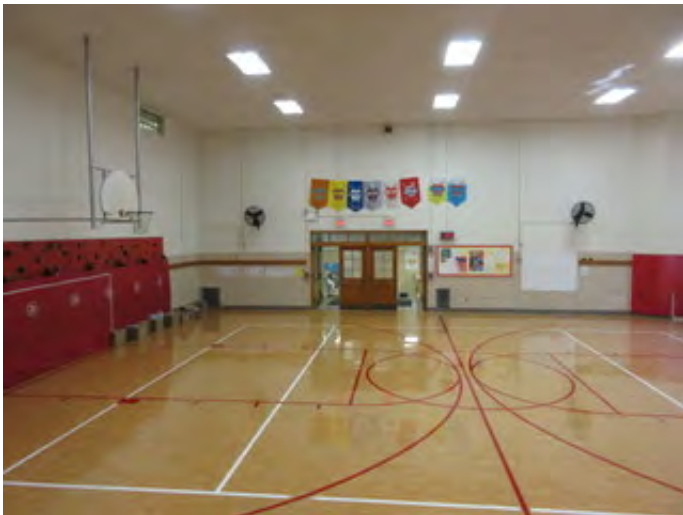
Gymnasium Fluorescent Light Fixtures

**Recommendations:** Provide complete replacement of lighting system due to age, condition, lighting levels, lack of multilevel switching, utilization of incandescent fixtures, and installation of systems outlined in Items A, C, J, and U.

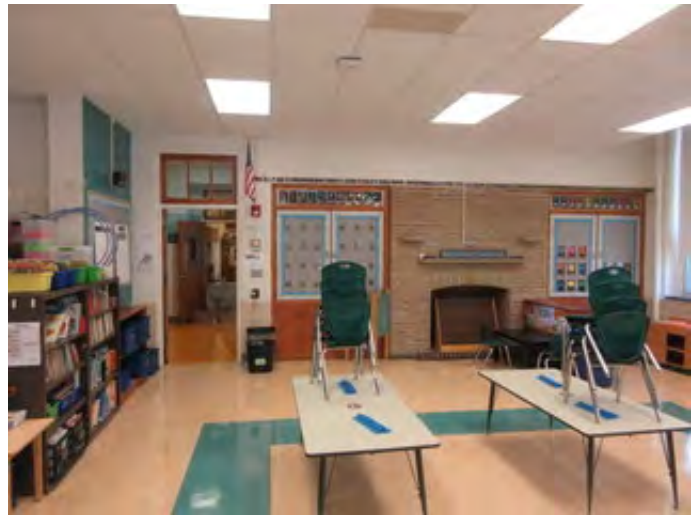
Classroom Fluorescent Light Fixtures

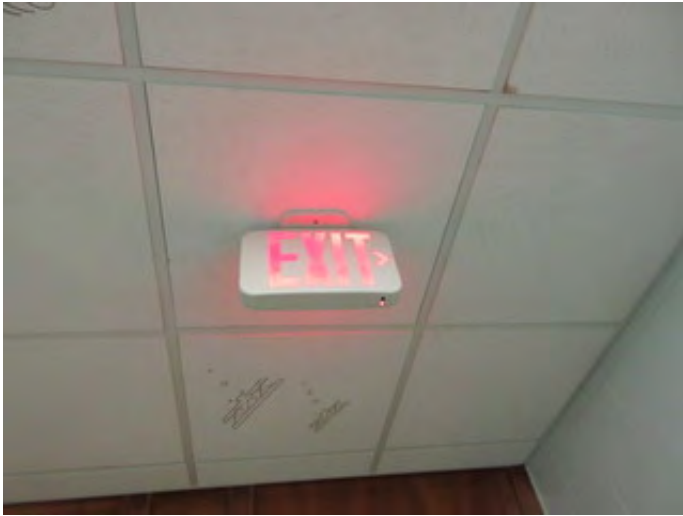
Exit Sign

**Recommendations:** Provide complete replacement of emergency / egress lighting system to meet Ohio School Design Manual and Ohio Building Code guidelines.

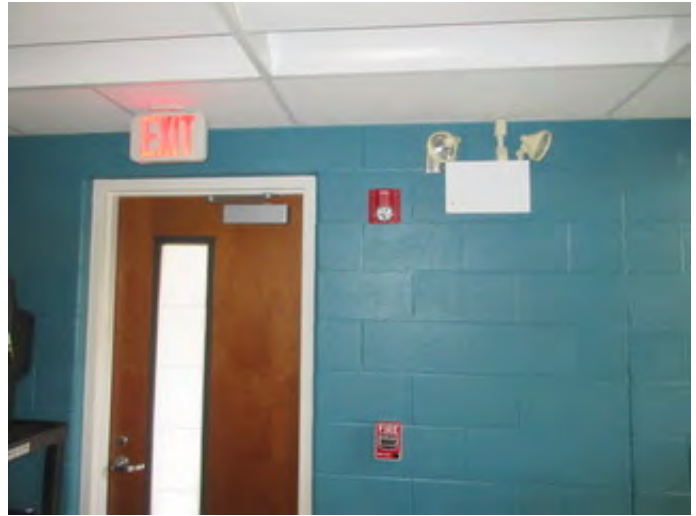
Exit Sign and Emergency Egress Lighting Fixture

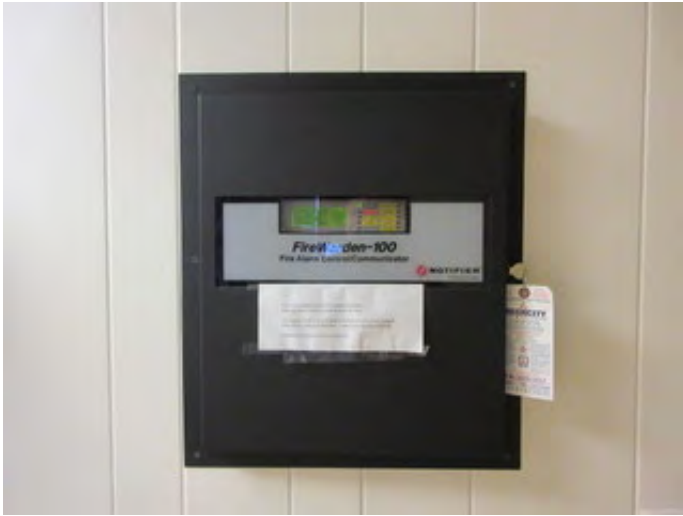
Fire Alarm Control Panel

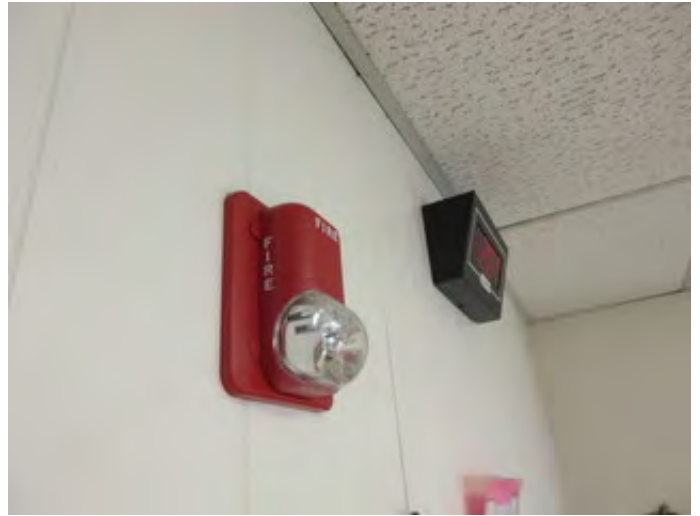
Fire Alarm Audible Horn and Visual Strobe Indicating Device

**Recommendations:** Provide complete replacement of fire alarm systems to meet OBC, NFPA, and Ohio School Design Manual guidelines.

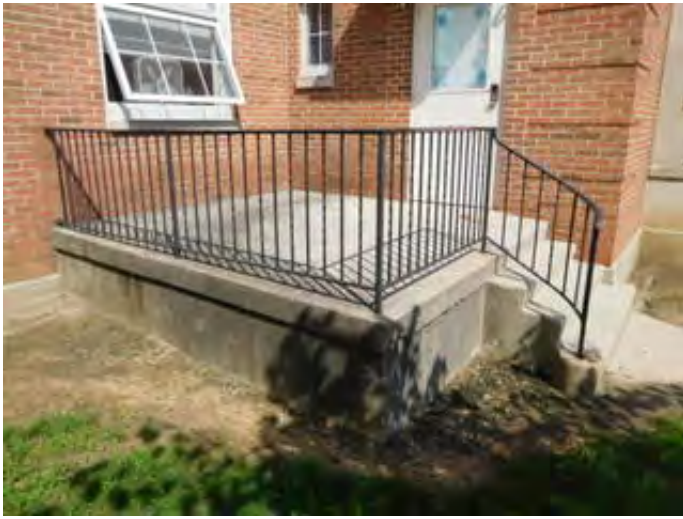
Concrete Steps and Handrail/Guardrail

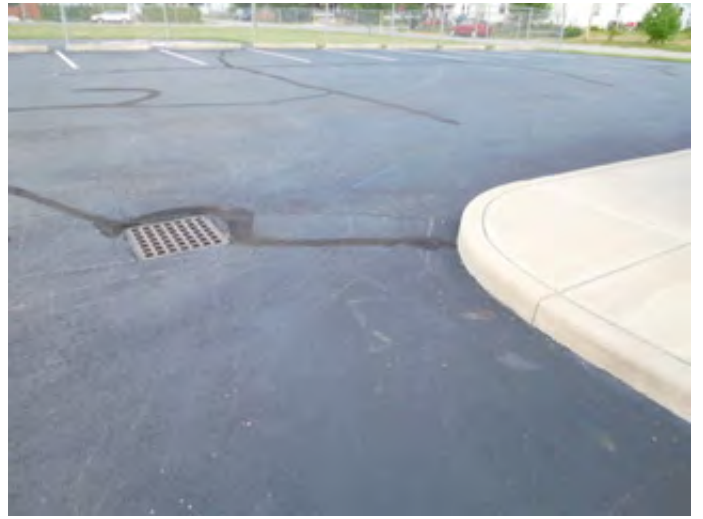
Asphalt Parking Lot and Catch Basin

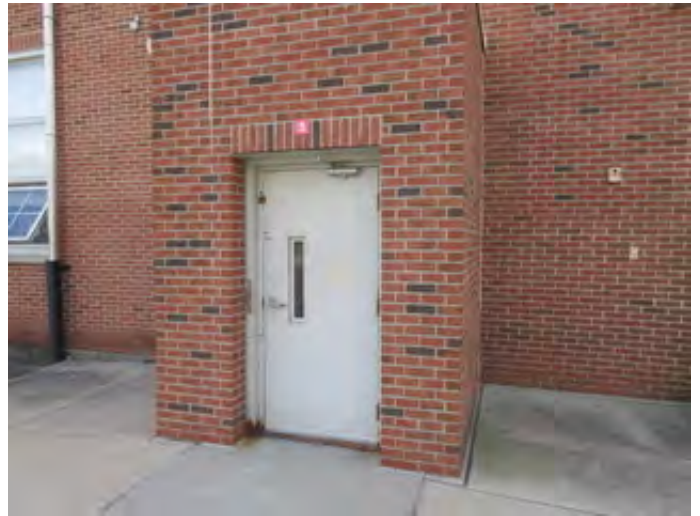
Typical Hollow Metal Exterior Door

**Recommendations:** Replace all exterior hollow metal doors due to poor condition. Provide one roof access door.

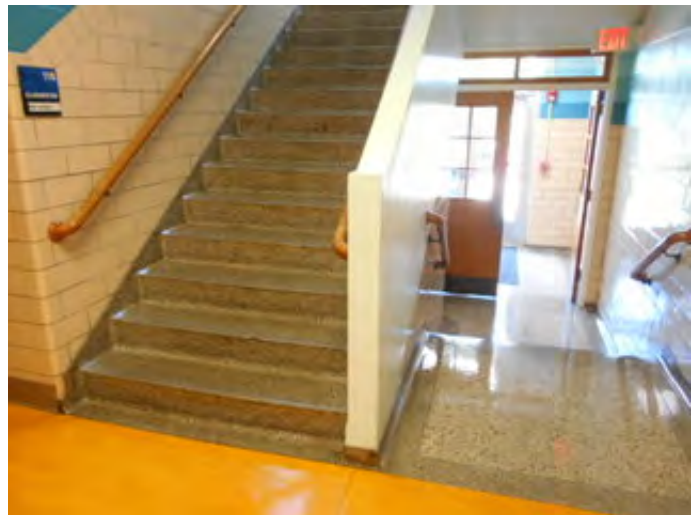
Non-Compliant Stair Tower

**Recommendations:** Provide new automated fire suppression system to meet Ohio School Design Manual guidelines. Provide increased water service of a capacity sufficient to support the fire suppression system, funding included in fire suppression funding. Provide new emergency generator, with funding provided via complete replacement of electrical system in Item D. Provide new handrails at all interior stairways in the overall facility. Provide fire-rated enclosure around 3 existing interior stair towers. Provide 3 additional fire extinguishers.
