Building Information - Troy City (44925) - Heywood Elementary

Program Type	Classroom Facilities Assistance Program (CFAP) - Regular
Setting	Small City
Assessment Name	Heywood Elementary School (15990) FINAL
Assessment Date (on-site; non-EEA)	2016-08-06
Kitchen Type	Warming Kitchen
Cost Set:	2016
Building Name	Heywood Elementary
Building IRN	15990
Building Address	290 South Ridge Avenue
Building City	Troy
Building Zipcode	45373
Building Phone	(937) 332.6750
Acreage	4.37
Current Grades:	K-5
Teaching Stations	25
Number of Floors	2
Student Capacity	500
Current Enrollment	314
Enrollment Date	2016-08-06
Enrollment Date is the date in which the current enrollment was taken.	
Number of Classrooms	21
Historical Register	NO
Building's Principal	Mr. Maurice Sadler
Building Type	Elementary

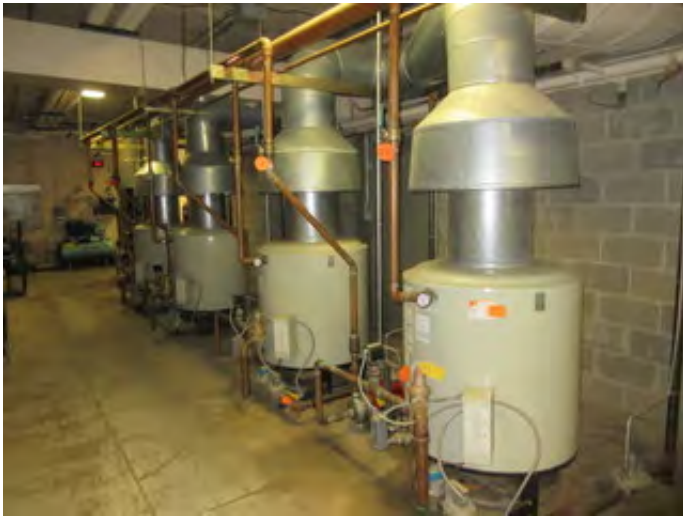
Description: The existing system for the 1930 Original Construction is a natural gas fired boiler type system (converted from a Columbus Heat and Vent and furnace type system), installed in 1930 with upgrades in 1973 and 1999, and is in fair condition. The system in the 1973 Addition is an extension of that found in the 1930 Original Construction. 2-pipe vs. 4-pipe designations are not applicable in this facility, as no central air conditioning is provided. The (4) heated water boilers, manufactured by Weben-Jarco, Inc., were installed in 1999 and are in fair condition. Heating water is distributed via circulating pumps to heating coils in a central air handling unit, with heated air supplied throughout the overall facility. The terminal equipment was installed in 1999 and is in fair condition. The system does not appear to comply with the 15 CFM per person fresh air requirements of the Ohio Building Code mechanical code and Ohio School Design Manual. The pneumatic type system temperature controls are original to each addition and are in fair condition. The system does not feature individual temperature controls in all spaces required by the OSDM. The overall system does not feature any central energy recovery systems. The facility is equipped with widespread louvered interior doors to facilitate Corridor utilization as return air plenums. The existing system is ducted, but the ductwork cannot be integrated into a possible future system due to arrangement, air volume, and routing of existing ductwork. The overall heating system is evaluated as being in safe but inefficient working order, and long term life expectancy of the existing system is not anticipated. The structure is not equipped with central air conditioning. The site does not contain underground fuel tanks.

Rating: 3 Needs Replacement

Natural Gas Fired Heated Water Boilers

Recommendations: Provide new overall heating, ventilating, and air conditioning system to achieve compliance with Ohio Building Code and Ohio School Design Manual standards. Replace existing ductwork to facilitate efficient exchange of conditioned air.

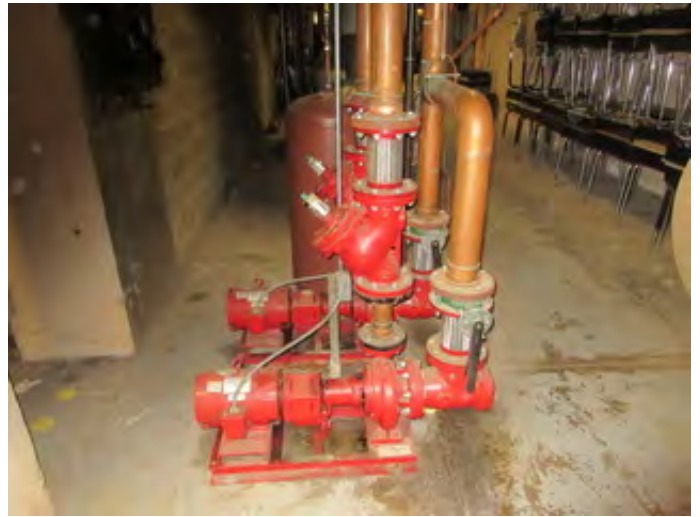
Circulating Pumps

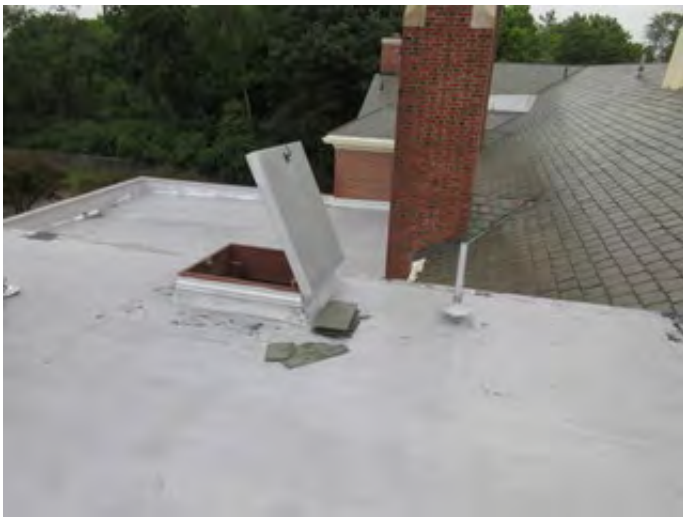
Roof Hatch

Recommendations: The roof over the Tremco portions of the Original Construction and the 1973 Kitchen Addition requires replacement to meet Ohio School Design Manual guidelines due to condition and age of system and projected lifecycle. The roof over the slate roof portions of the Original Construction requires yearly inspection and maintenance. The flashing and coping for the Tremco portions of the roof require replacement due to condition and projected lifecycle. Due to existing conditions gutters and downspouts require replacement. Replace wood decking in areas of past leaking in the Original Construction. Replace one wooden ladder. Provide three ladders and one access hatch for inaccessible low roof areas in the Original Construction.

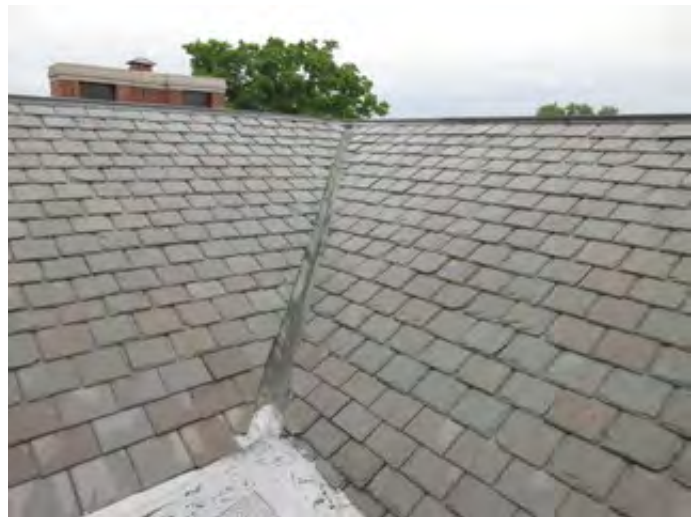
Description: The roof over portions of the Original Construction is a slate shingle system that is believed to be installed in 1930, and is in fair condition. There are a few shingles that have been broken, or have come loose and need to be replaced. The roof over the other portions of the Original Construction and 1973 Kitchen Addition is a modified bitumen system by Tremco that was installed in 2006, is under a 15-year warranty, and is in fair condition. There are District reports of current leaking. Blisters form in the roofing system and burst. Burst blisters adjacent to seams cause leaks. Signs of past leaking were observed during the physical assessment. Access to portions of the roof was gained by access hatch that is in fair condition and access ladder that is in poor condition. Some low roof areas were not accessible. Fall safety protection cages are not required, and are not provided. There were no observations of standing water on the roof. Metal cap flashings and copings are in fair condition. Roof storm drainage is addressed through a system of gutters and downspouts and through-wall scuppers, which are properly located, and in poor condition. The roof is not equipped with overflow roof drains though they are not required. No problems requiring attention were encountered with any roof penetrations. There are not any covered walkways attached to this structure.

Rating: 3 Needs Replacement

Slate Roof

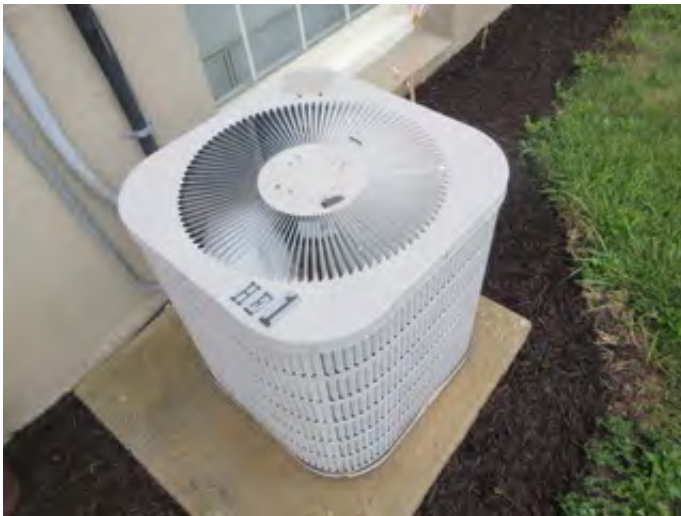
Condensing Unit

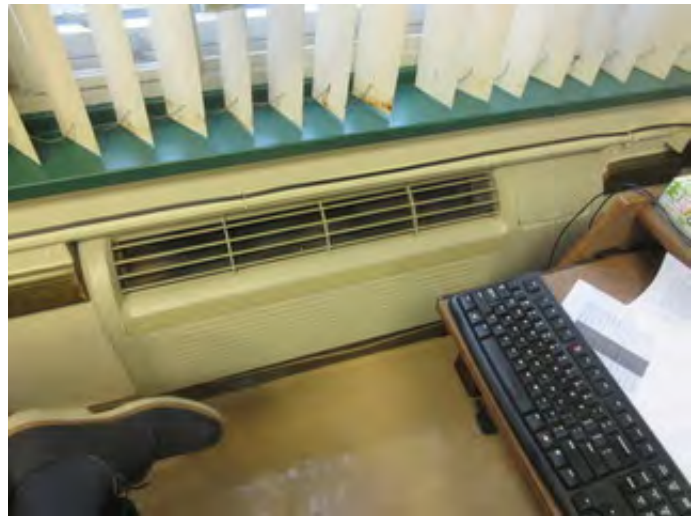
Description: The overall facility is not equipped with a central air conditioning system. Window units are located in the Teacher's Lounge and Lab Room locations. Isolated room systems consisting of thru-wall heat pump/fan coil HVAC units are located in the Administrative Offices, Computer Lab, and Media Center. The ventilation system in the overall facility consists of an air handling unit, installed in 1999 and in fair condition, providing fresh air to Classrooms and other miscellaneous spaces such as the Multi-Purpose Room (Gymnasium and Student Dining). Relief air venting is provided by louvered interior doors, transfer grilles to corridors, and an air handler. The ventilation system does not appear to meet the Ohio Building Code 15 CFM per occupant fresh air requirement. The overall system is not compliant with Ohio Building Code and Ohio School Design Manual requirements. Dust collection systems are not required in this facility. The Art program is equipped with a kiln and the kiln ventilation system is inadequate. General building exhaust systems for Restrooms, Storage Rooms, Art Rooms, and Custodial Closets do not appear to be adequately placed, and in fair condition.

Rating: 2 Needs Repair

Thru-Wall HVAC Unit

Recommendations: Provide an air conditioning system to meet with Ohio Building Code and Ohio School Design Manual requirements. Replace general building exhaust systems located in Restrooms, Storage Rooms, Art Rooms, and Custodial Closets. Pricing included in Item A. Provide the Art program with a kiln ventilation system to meet Ohio Building Code and Ohio School Design Manual requirements.

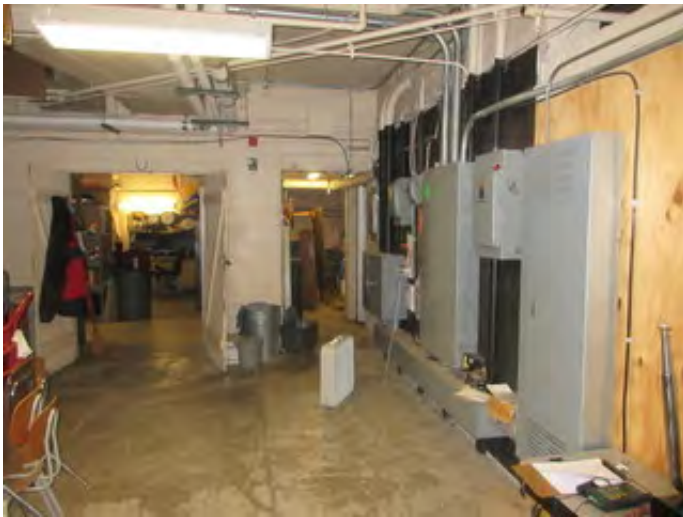
Description: The electrical system provided to the 1930 Original Construction is a 250 volts, 900 amp, 3 phase and 3 wire system installed in 1930 with upgrades in 1973, and is in fair condition. The system in the 1973 Addition is an extension of that found in the 1930 Original Construction. Power is provided to the school by multiple utility owned, pole-mounted transformer located outside the Mechanical Room, and is presumed to be in fair condition. The Square D panel systems, original to each addition, are in fair condition, and for the most part cannot be expanded to add additional capacity. The Classrooms are not equipped with adequate electrical outlets. The typical Classroom contains (4) general purpose outlets, (0) dedicated outlets for each Classroom computer, and (1) dedicated outlet for each Classroom television. Some Classrooms are equipped with as many as (5) general purpose outlets, while others are equipped with as few as (3) general purpose outlets. There are not any spaces that have no electrical outlets. The Corridors appear to be equipped with adequate electrical outlets for servicing. Adequate GFI protected exterior outlets are not provided around the perimeter of the building. The facility is not equipped with an emergency generator. Adequate lightning protection safeguards are not provided. Stage lighting power system including control panel, breakers, and dimmers is inadequately provided, in fair condition and does not meet OSDM requirements. The overall electrical system does not fully meet Ohio School Design Manual requirements in supporting the current needs of the school, and will be inadequate to meet the facility's future needs.

Rating: 3 Needs Replacement

Main Electrical Distribution Panel

Recommendations: The entire electrical system requires replacement to meet Ohio School Design Manual guidelines for overall capacity and due to age, condition, lack of OSDM-required features, and to accommodate the addition of an air conditioning system. Provide an emergency generator, with funding included in the electrical system replacement. Provide adequate lightning protection safeguards in the overall facility, including associated grounding system, with funding included in the electrical system replacement. Provide control panel, dimmers, and breakers to support the Stage lighting system, with funding included in the electrical system replacement.

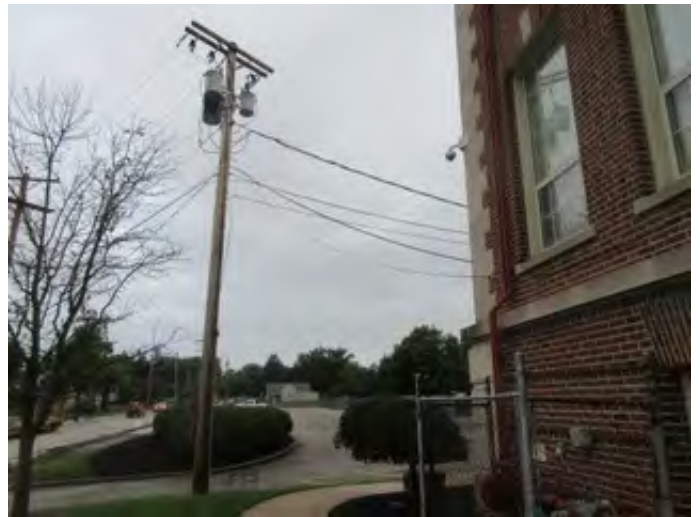
Pole Mounted Transformers

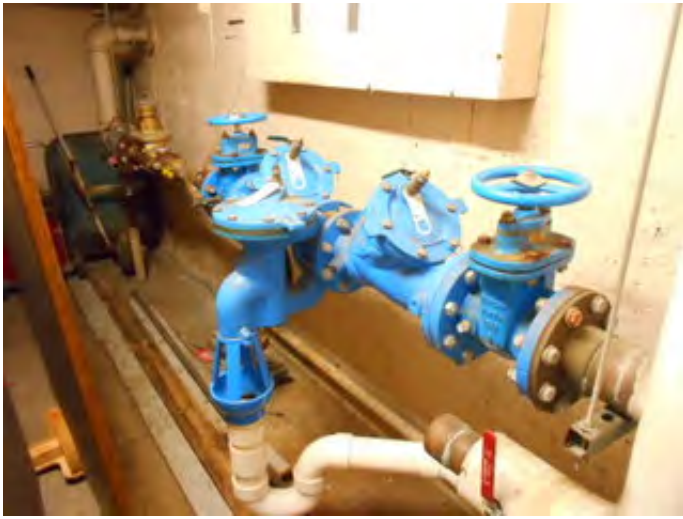
Reduced Pressure Backflow Preventer

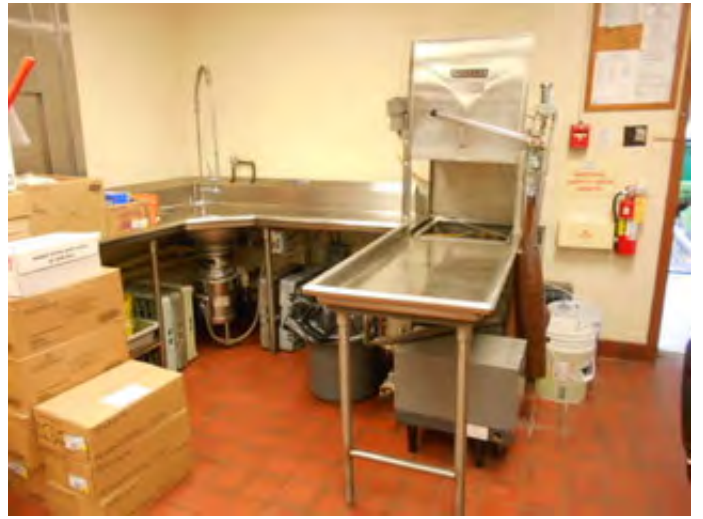
Commercial Dishwasher with Heat Booster

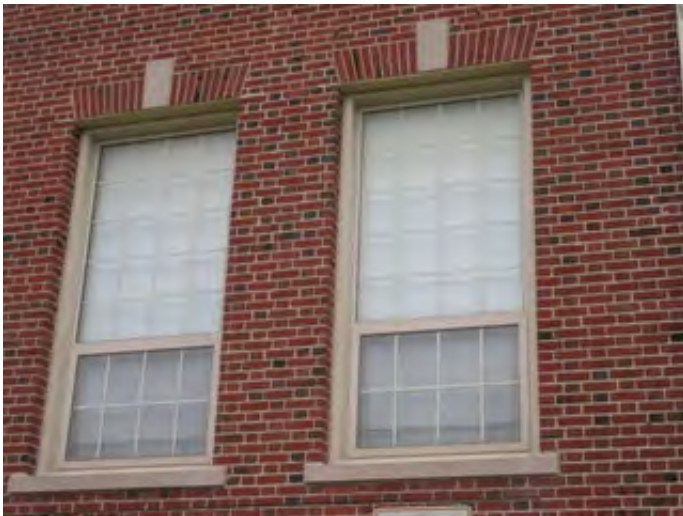
Description: The overall facility is equipped with aluminum frame windows with insulated glazing type window system, which was installed sometime between 1985 and 1995, and is in good condition. The window system features operable windows throughout the building, and operable windows are not equipped with opening limiters, but do have insect screens in fair condition. Window system seals are in good to fair condition, with minimal air and water infiltration being experienced. Window system hardware is in fair condition. The window system features no blinds. This facility is not equipped with any curtain wall systems. This facility does not feature any glass block windows. The exterior doors in the overall facility are equipped with thermally broken aluminum frame transoms with tempered insulated glazing, in good condition. Exterior door vision panels are tempered insulated glazing. The school does not contain any skylights. The school does not contain any clerestories. Interior glass is OSDM-compliant. Window security grilles are not provided for ground floor windows. There is not a Greenhouse associated with this school.

Rating: 2 Needs Repair

Typical Aluminum Windows of the Original Construction

Recommendations: Caulk perimeter of window panels to remain throughout the overall facility.

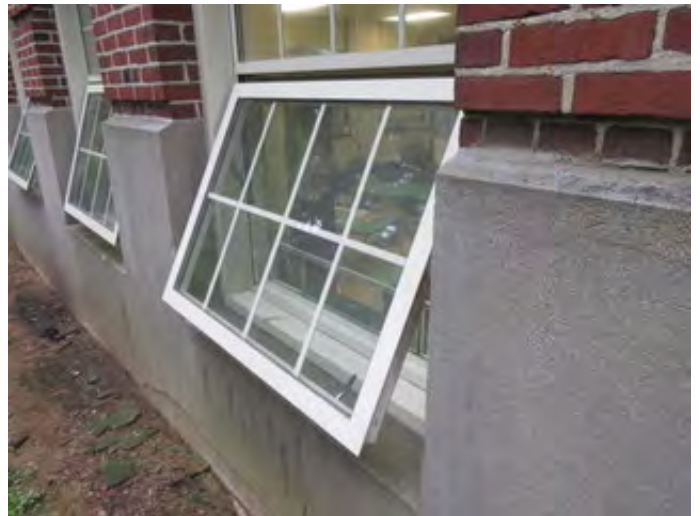
Typical Awning Windows

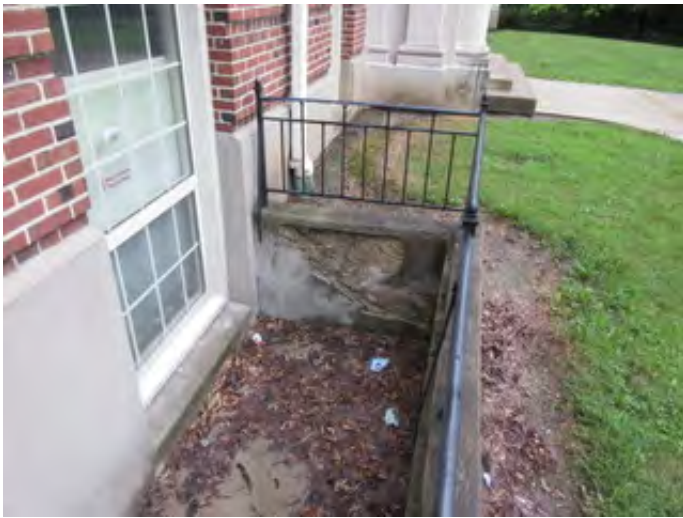
Description: The overall facility is equipped with concrete foundation walls on concrete footings, which displayed minimal locations of significant differential settlement, cracking, or leaking, and are in fair condition. Areas of minor cracking and spalling were observed through the overall facility. The District reports that there has been minor past leaking throughout the basement. No grading or site drainage deficiencies were noted around the perimeter of the structure that are contributing or could contribute to foundation / wall structural deterioration.

Rating: 2 Needs Repair

Replace Concrete Window Wells

Recommendations: Repair areas of cracking and spalling through the overall facility. Replace the concrete walls of the window wells and exterior basement steps as required through the overall facility.

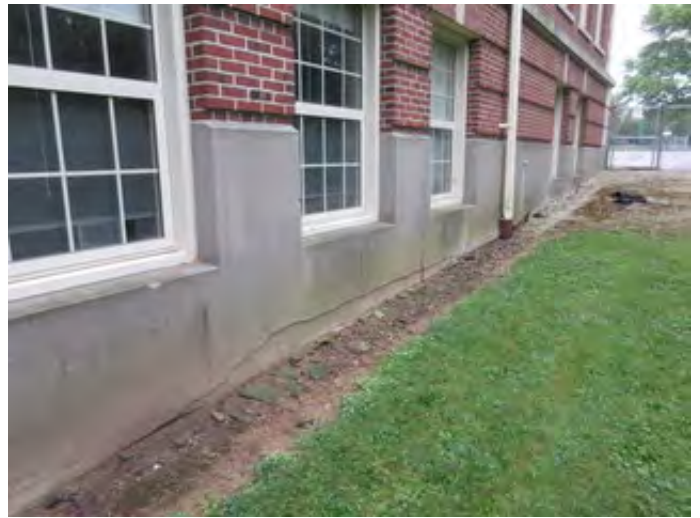
Minor Foundation Repair

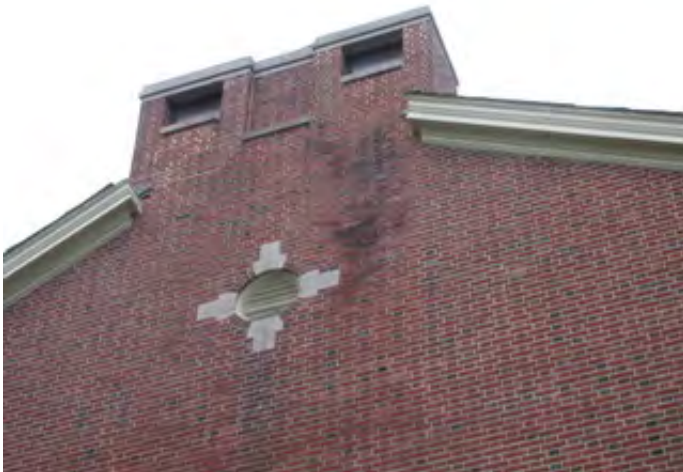
Description: The overall facility has a brick veneer on load bearing masonry wall system, which displayed locations of deterioration, and is in fair condition. The Original Construction does not contain control or expansion joints and none are needed, as there is no indication of exterior masonry cracking or separation. The exterior masonry of the 1973 Kitchen Addition appears to have appropriately spaced and adequately caulked control joints in fair condition. Control joints are provided at lintel locations, at doors and windows, building corners, and wall offsets and are in fair condition. The school does not contain expansion joints and none are needed, as there is no indication of exterior masonry cracking or separation. Exterior walls in the overall facility are inadequately insulated. Brick veneer masonry walls are not cavity walls. Weep holes and vents are not provided or required. The exterior masonry has not been cleaned and sealed in recent years, and shows evidence of mortar deterioration in minor locations. Architectural exterior accent materials consist of stone, which is in fair condition. Exterior building fenestration in the Original Construction represents 13.93% of the exterior surfaces. Exterior building fenestration in the 1973 Kitchen Addition represents 3.20% of the exterior surfaces. Interior Corridor and demising walls are glazed brick and plaster partition walls, project full height from floor to bottom of deck, and are in good condition. Interior masonry appears to have adequately spaced and caulked control joints in good condition. Interior soffits are of plaster type construction, and in good condition. The window sills are stone and are in fair condition. The exterior lintels are steel, and are in good condition, with the exception of one which is rusted. Chimneys are in fair condition. Canopies over entrances are of stone, plaster, and wood type construction, and are in good condition. The school is provided with a covered concrete and masonry conventional loading dock to facilitate the receipt of product, supplies, and foodstuffs, 167 square feet in size and featuring conventional man doors. The dock itself is in good condition, and is equipped with bumper pads in poor condition.

Rating: 2 Needs Repair

Typical Areas of Tuckpointing

Recommendations: Provide tuckpointing in all areas of mortar deterioration as required through the overall facility. Repair stone accents as required in the Original Construction. Provide masonry cleaning and sealing as required through the overall facility. Recaulk existing control joints in the 1973 Kitchen Addition. Replace one masonry lintel as required in the Original Construction. Exterior wall insulation deficiencies are addressed in Item J. Replace the loading dock bumper pads. Replace the ornamental railing at window wells.

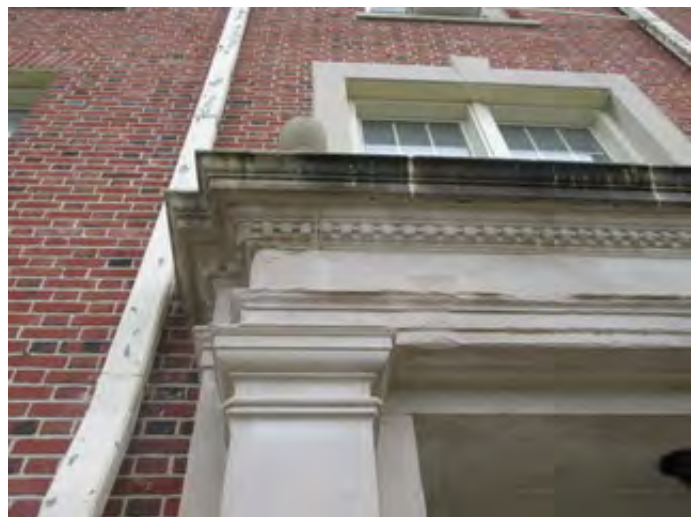
Typical Stone Repairs

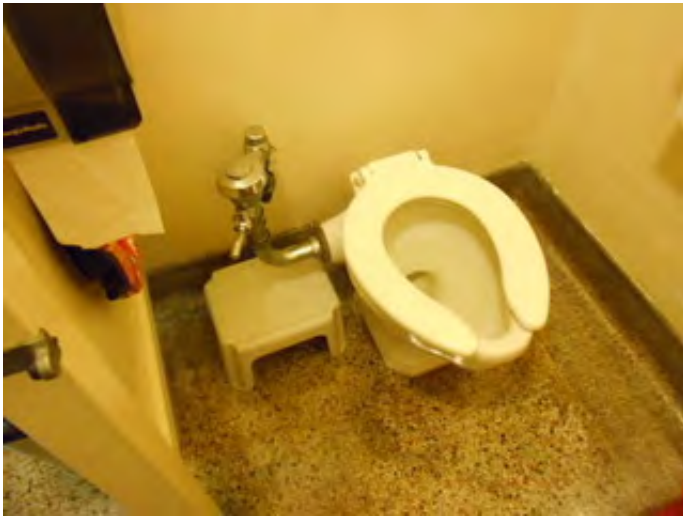
Rating: 3 Needs Replacement

Non-Compliant Restroom

Recommendations: To facilitate the school's meeting of ADA requirements, throughout the overall facility: Provide ADA-compliant signage. Provide an accessible elevator. Provide 2 power assisted doors. Provide stairway chair lift at northeast stair tower near playground. Provide stairway chair lift at Gym/Cafeteria for access and 1 lift for Stage access. Provide exterior access ramp at rear northwest corner entrance. Remount 1 urinal in the Boy's first floor Restroom. Reconfigure a total of 4 toilet compartments; 1 per Boys and Girl's Restrooms, to provide a fully ADA compliant toilet compartment. Includes 4 toilets, 4 full sets of accessories, grab bars and partitions. Reconfigure and enlarge 4 existing Staff Restrooms, to include 4 toilets, 4 lavatories and 4 full sets of accessories including grab bars. Provide a new Restroom for the Kitchen, to include 1 toilet, 1 lavatory and 1 full set of accessories including grab bars. All fixtures, whether new or replaced, to be mounted at correct ADA compliant heights. Provide 41 ADA compliant pipe wrap throughout the overall facility. Provide non-slip strips on 4 non-compliant stairways. Rework a total of 4 doors to meet ADA clearance requirements. Funding for replacement of door hardware in the overall facility not included in Item O, is provided for in Item J with the complete replacement of doors. Funding provided in Item E for electric water coolers, classroom sink with drinking fountains and fixtures not included in Item O. Funding for replacement of handrails is provided for in Item U. Funding for replacement of toilets and lavatories to be mounted at ADA compliant heights is provided for in Item E.

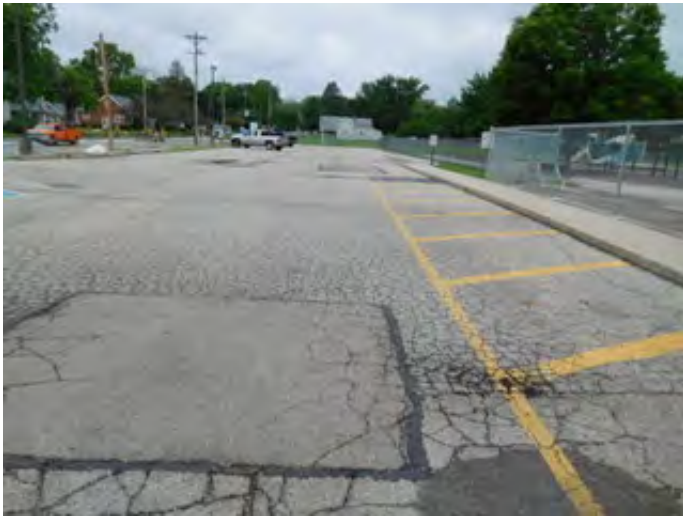
Asphalt Parking Lot Condition

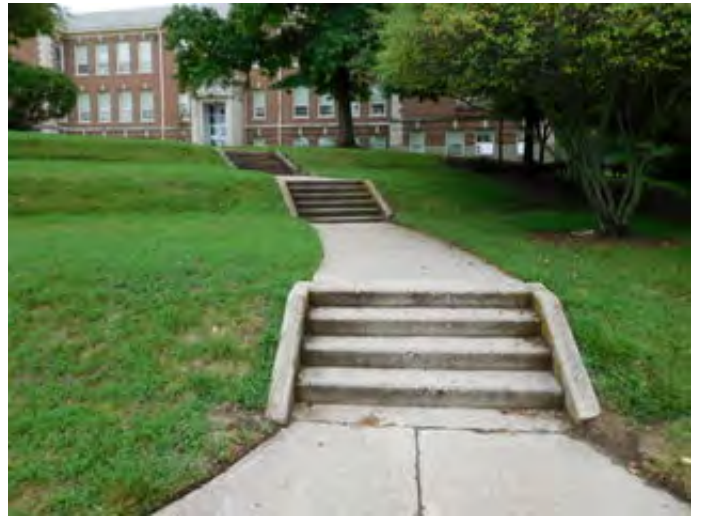
Exterior Concrete Steps and Sidewalk

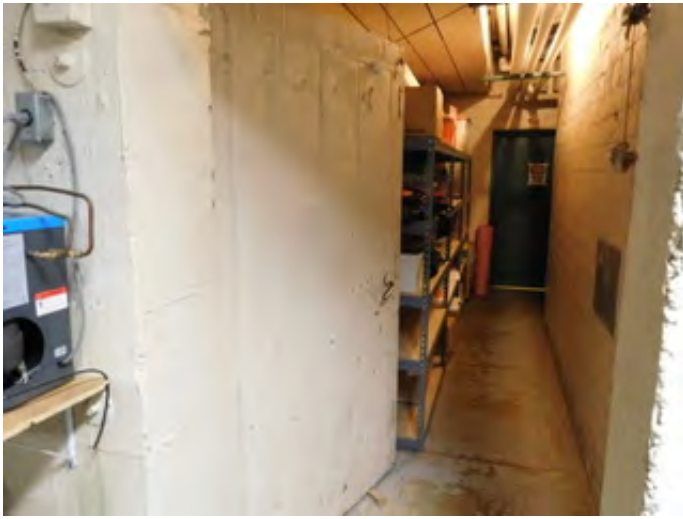
Fire Door

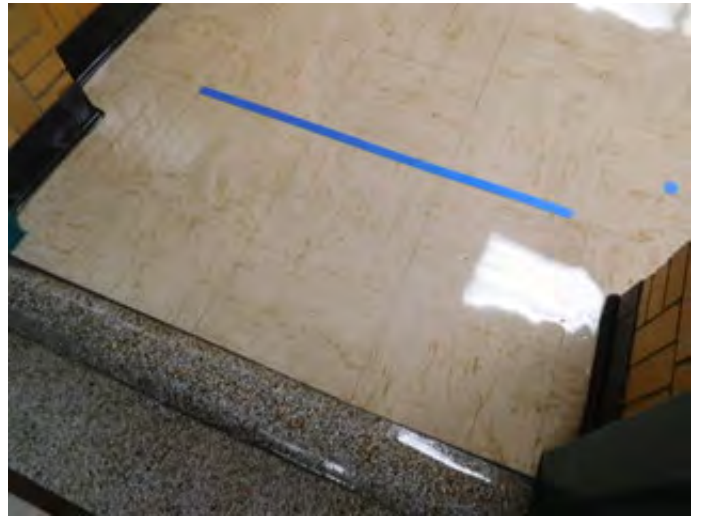
VAT Flooring

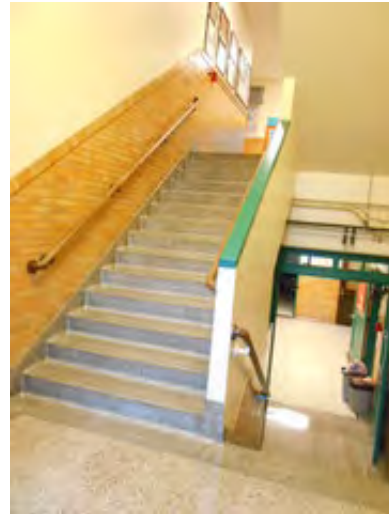
Non-Compliant Stair Tower

Recommendations: Provide new automated fire suppression system to meet Ohio School Design Manual guidelines. Provide increased water service of a capacity sufficient to support the fire suppression system, funding included in fire suppression funding. Provide new emergency generator, with funding provided via complete replacement of electrical system in Item D. Provide new guard and handrails at all interior stairways in the overall facility. Provide fire-rated enclosure around 2 existing stair towers in the overall facility. Provide 4 additional fire extinguishers. Funding for replacement of Kitchen hood is provided for in Item J.
