Building Information - Troy City (44925) - Hook Elementary

| Assessment Name | Hook Elementary School (16725) FINAL |
| Assessment Date (on-site; non-EEA) | 2016-08-06 |
| Building Name | Hook Elementary |

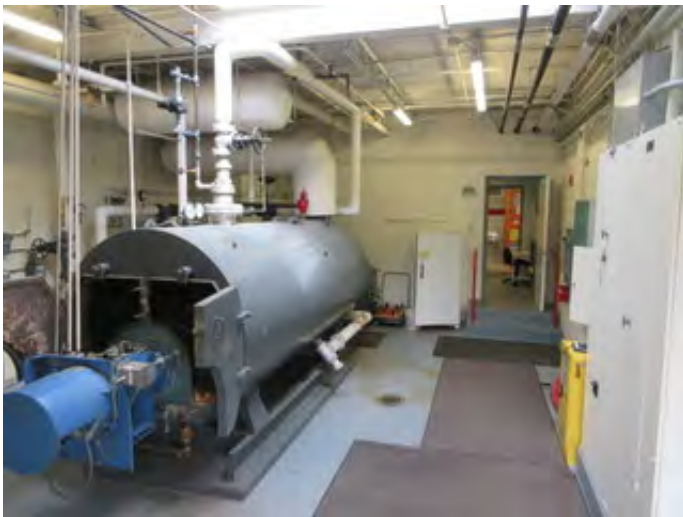
Description: The existing system for the overall facility is a natural gas fired heated water boiler type system, installed in 1966, and is in fair condition. 2-pipe vs. 4-pipe designations are not applicable in this facility, as no central air conditioning is provided. The single Whirl Power Space Conditioner boiler, manufactured by Iron Fireman, was installed in 1966 and is in fair condition. Heating water is distributed to terminal units consisting of unit ventilators, cabinet heaters, unit heaters, fin tubes, and air handlers. The terminal equipment was installed in 1966 with incremental upgrades and is in fair to poor condition. The system does not appear to comply with the 15 CFM per person fresh air requirements of the Ohio Building Code mechanical code and Ohio School Design Manual. The pneumatic type system temperature controls were installed in 1966 with incremental upgrades and are in fair to poor condition. The system does not feature individual temperature controls in all spaces required by the OSDM. The overall system does not feature any central energy recovery systems. The facility is equipped with widespread louvered interior doors to facilitate Corridor utilization as return air plenums. The existing system is not ducted, and floor to structural deck heights will not accommodate the installation of properly sized ductwork for a future Ohio School Design Manual approved system. The overall heating system is evaluated as not being in safe and efficient working order, and long term life expectancy of the existing system is not anticipated. The structure is not equipped with central air conditioning. The site does not contain underground fuel tanks.

Rating: 3 Needs Replacement

Natural Gas Fired Heated Water Boiler

Recommendations: Provide new overall heating, ventilating, and air conditioning system to achieve compliance with Ohio Building Code and Ohio School Design Manual standards. Convert to ducted system to facilitate efficient exchange of conditioned air. Provide architectural soffits to accommodate the installation of ductwork.

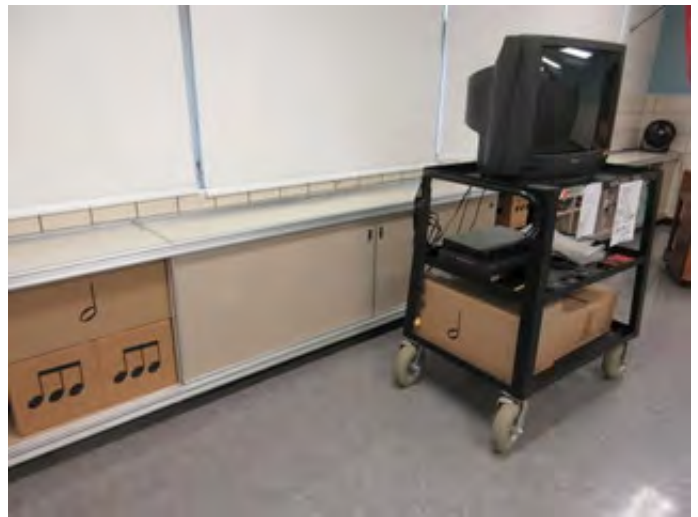
Unit Ventilator

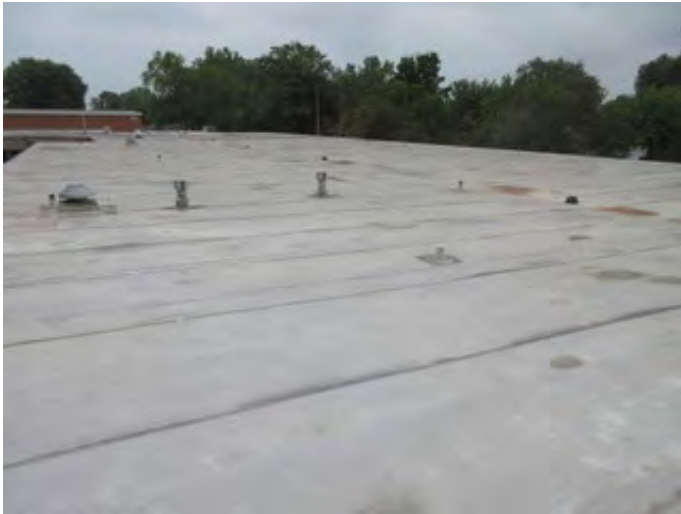
Description: The roof over the majority of the overall facility is a PVC system by Duro-Last that was installed in phases between 2010 and 2012, is under a 15-year warranty, and is in good condition. The roof over the Stage and Multi-Purpose Room is a metal roof installed over a built-up roof that was installed at an unknown date, and is in good condition. There are no District reports of current leaking. Signs of past leaking were observed during the physical assessment. Access to the roof was gained by access hatch and access ladder that are in fair condition. Fall safety protection cages are not required, and are not provided. There were observations of standing water on the roof. Metal cap flashings and copings are in fair to poor condition. Roof storm drainage is addressed through a system of gutters and downspouts, which are properly located, and in fair to poor condition and roof drains, which are properly located, and in good condition. The roof is not equipped with overflow roof drains though they are not required due to no parapets. No problems requiring attention were encountered with any roof penetrations. There are not any covered walkways attached to this structure.

Typical PVC Roofing

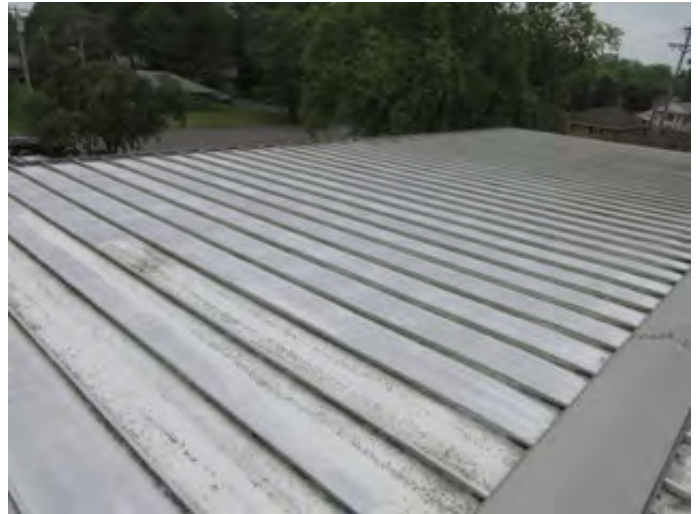
Rating: 2 Needs Repair

Standing Seam Metal Roofing Over the Stage and Multi-Purpose Room

Recommendations: The coping at the roof over the Stage and Multi-Purpose Room of the overall facility require replacement due to condition. Due to existing conditions gutters and downspouts require replacement. Paint one exterior roof access ladder.

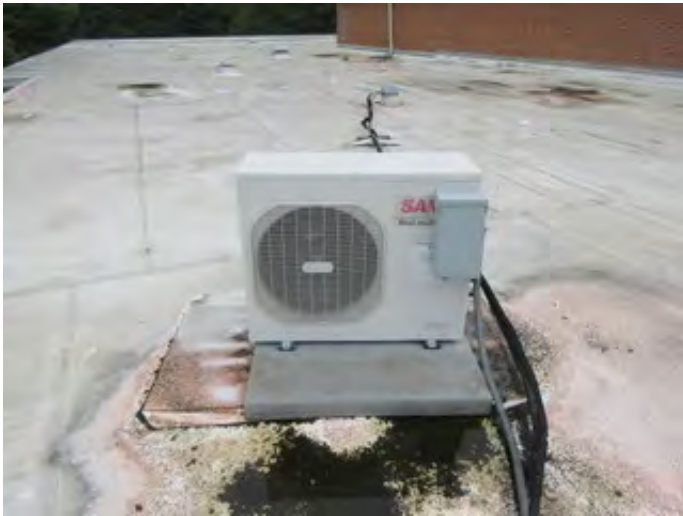
Description: The overall facility is not equipped with a central air conditioning system. A single window unit is located in the Teacher's Lounge. An isolated room system consisting of a ductless split AC system (with the condensing unit located on the roof) is located in the Media Center. An isolated room system consisting of a 5-ton Trane ducted packaged roof top unit with DX cooling is located in the Administrative Offices. An isolated room system consisting of a Carrier ducted packaged roof top unit with DX cooling is located in the Administrative Offices and Computer Lab. The ventilation system in the overall facility consists of unit ventilators, installed in 1966 and in fair condition, providing fresh air to Classrooms and the Media Center, and air handlers, installed in 1966 and in fair condition, providing fresh air to other miscellaneous spaces such as the Multi-Purpose Room (Gymnasium/Student Dining). Relief air venting is provided by louvered interior doors, ceiling plenums, unit ventilators, central relief fans, and air handlers. The ventilation system does not appear to meet the Ohio Building Code 15 CFM per occupant fresh air requirement. The overall system is not compliant with Ohio Building Code and Ohio School Design Manual requirements. Dust collection systems are not required in this facility. The Art program is not equipped with a kiln. General building exhaust systems for Restrooms, Storage Rooms, Art Rooms, and Custodial Closets do not appear to be inadequately placed, and in fair condition.

Rating: 2 Needs Repair

AC Split Condenser

Recommendations: Provide an air conditioning system to meet with Ohio Building Code and Ohio School Design Manual requirements. Replace general building exhaust systems located in Restrooms, Storage Rooms, Art Rooms, and Custodial Closets. Pricing included in Item A. Provide the Art program with a kiln ventilation system to meet Ohio Building Code and Ohio School Design Manual requirements.

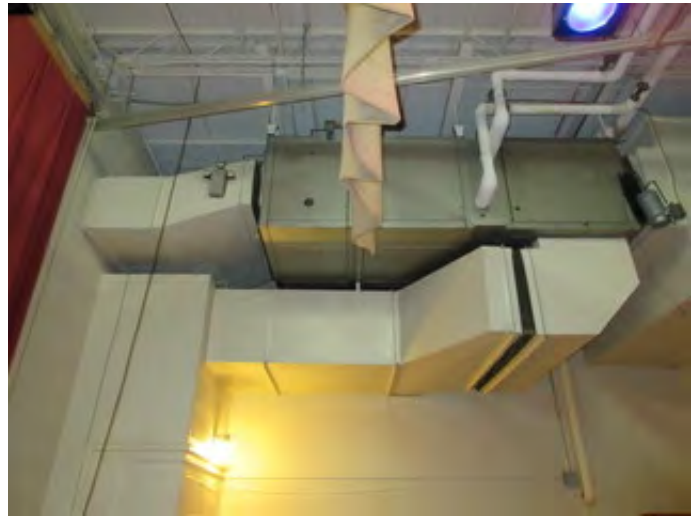
Air Handling Unit

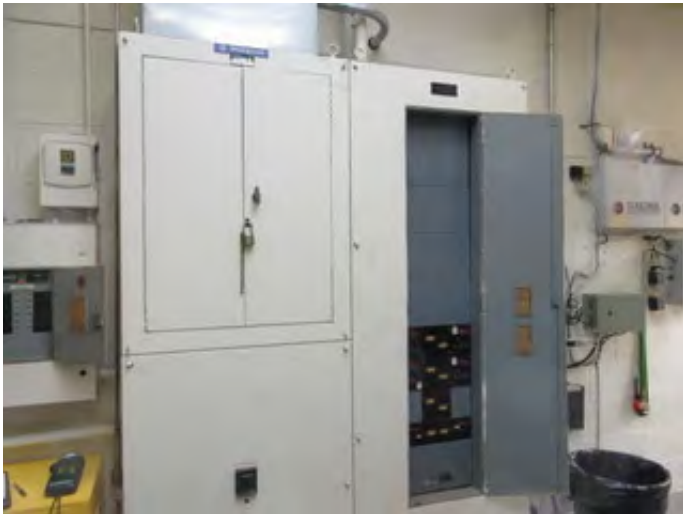
Description: The electrical system provided to the overall facility is a 120/208 volts, 800 amp, 3 phase and 4 wire system installed in 1966, and is in fair condition. Power is provided to the school by a single utility owned, pad-mounted transformer located outside the Mechanical Room in a utility company Electrical Room, and is presumed to be in fair condition. The Westinghouse panel systems, installed in 1966, are in fair condition, and for the most part cannot be expanded to add additional capacity. The Classrooms are not equipped with adequate electrical outlets. The typical Classroom contains (5) general purpose outlets, (0) dedicated outlets for each Classroom computer, and (1) dedicated outlet for each Classroom television. Some Classrooms are equipped with as many as (6) general purpose outlets, while others are equipped with as few as (4) general purpose outlets. There are not any spaces that have no electrical outlets. The Corridors appear to be equipped with adequate electrical outlets for servicing. Adequate GFI protected exterior outlets are not provided around the perimeter of the building. The facility is not equipped with an emergency generator. Adequate lightning protection safeguards are not provided. Stage lighting power system including control panel, breakers, and dimmers is inadequately provided, in fair condition and does not meet OSDM requirements. The overall electrical system does not fully meet Ohio School Design Manual requirements in supporting the current needs of the school, and will be inadequate to meet the facility's future needs.

Rating: 3 Needs Replacement

Main Electrical Distribution Panel

Recommendations: The entire electrical system requires replacement to meet Ohio School Design Manual guidelines for overall capacity and due to age, condition, lack of OSDM-required features, and to accommodate the addition of an air conditioning system. Provide an emergency generator, with funding included in the electrical system replacement. Provide adequate lightning protection safeguards in the overall facility, including associated grounding system, with funding included in the electrical system replacement. Provide control panel, dimmers, and breakers to support the Stage lighting system, with funding included in the electrical system replacement.

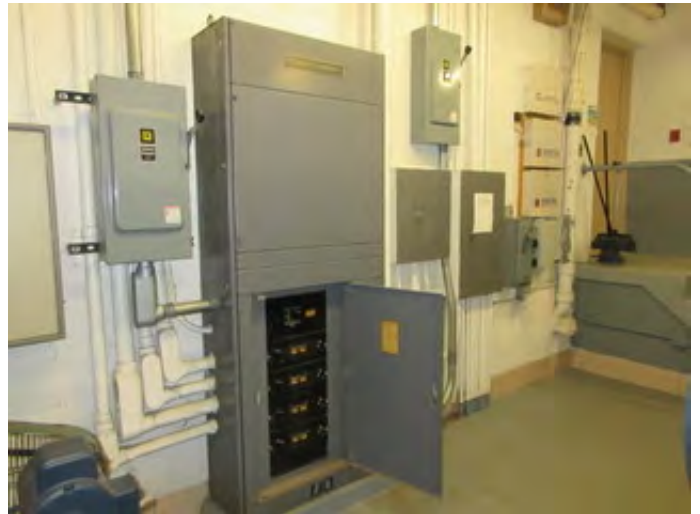
Electrical Sub-Panel

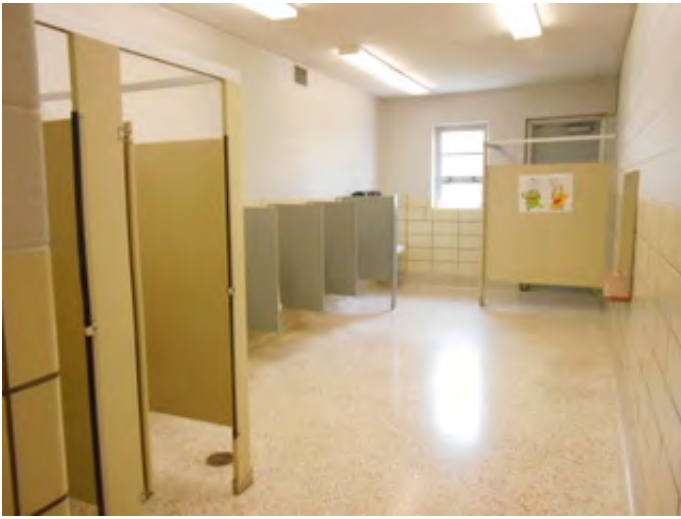
Rating: 3 Needs Replacement

Large Group Restroom-Boy's

Recommendations: In the overall facility, replace the remaining galvanized steel domestic water piping. Replace the remaining cast iron waste piping in the overall facility. Due to age and condition and to facilitate the school's compliance with OBC and OSFC fixture requirements, in the overall facility, replace 12 toilets, 4 lavatories (include ADA compliant faucets) and 1 electric water cooler. Due to age, condition, LEED, OBC and OSFC, replace 66 faucets and valves throughout the overall facility. Replace 9 in Classroom sinks with deck mounted drinking fountain, due to age. Provide 1 additional in Classroom sink with deck mounted drinking fountain (include ADA compliant faucets). All fixtures, whether new or replaced, to be mounted at ADA compliant heights. Provide 2 solids interceptors for the Art Room. Provide for complete replacement of Kitchen fixtures with funding provided for in Item J. See Item O for replacement of fixtures related to ADA requirements, as well as the reconfiguration of 3 Staff Restrooms including the Kitchen and Health Clinic and 2 Kindergarten Restrooms.

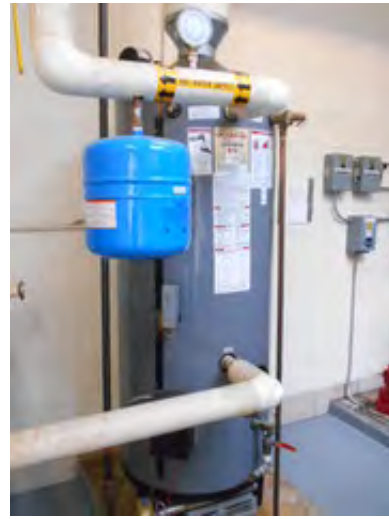
91 Gallon Gas Water Heater

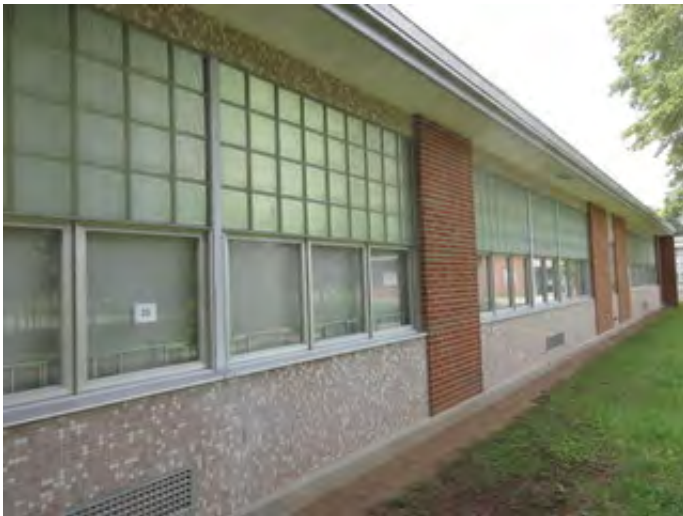
Description: The overall facility is equipped with aluminum frame windows with single glazed type window system, which was installed in 1966, and is in poor condition. The window system features operable windows throughout the building, and operable windows are not equipped with opening limiters, but do contain insect screens in fair condition. Window system seals are in fair to poor condition, with minimal air and water infiltration being experienced. Window system hardware is in fair to poor condition. The window system features no blinds. This facility is not equipped with any curtain wall systems. There are glass block windows in the overall facility, in fair to poor condition. The exterior doors in the overall facility are equipped with aluminum sidelights with tempered insulated glazing, in good condition. Exterior door vision panels are tempered insulated glazing. The school does contain one aluminum single glazed with wire mesh skylight in good condition. The school does not contain any clerestories. Interior glass is OSDM-compliant. Window security grilles are not provided for ground floor windows. There is not a Greenhouse associated with this school.

Rating: 3 Needs Replacement

Typical Windows of the Original Construction

Recommendations: Replace the existing non-insulated window system and glass block in the overall facility with a new insulated window system to comply with Ohio School Design Manual requirements.

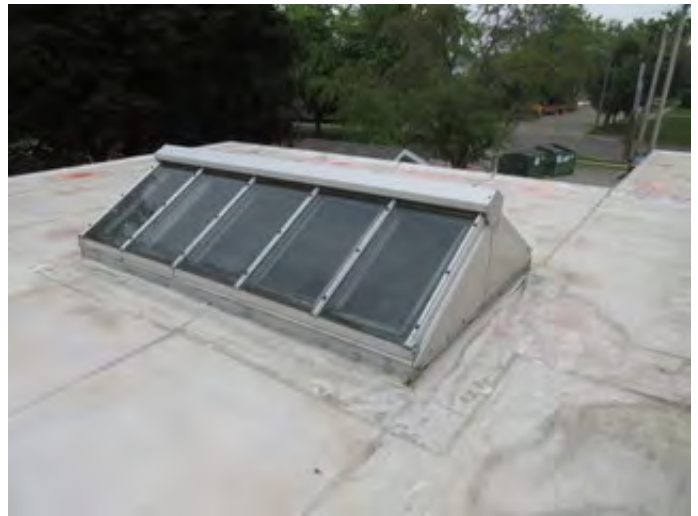
Aluminum Framed Skylight

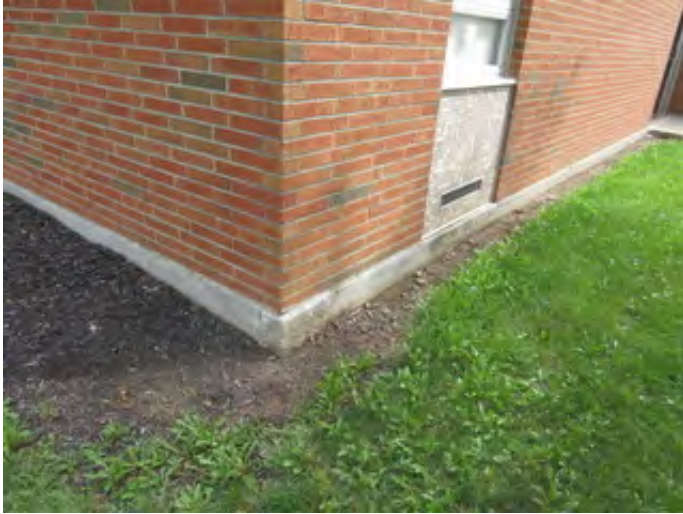
Description: The overall facility is equipped with concrete foundation walls on concrete footings, which displayed no locations of significant differential settlement, cracking, or leaking, and are in fair condition. Areas of minor cracking and spalling were observed through the overall facility. The District reports that there has been no past leaking. No grading or site drainage deficiencies were noted around the perimeter of the structure that are contributing or could contribute to foundation / wall structural deterioration.

Typical Concrete Foundation

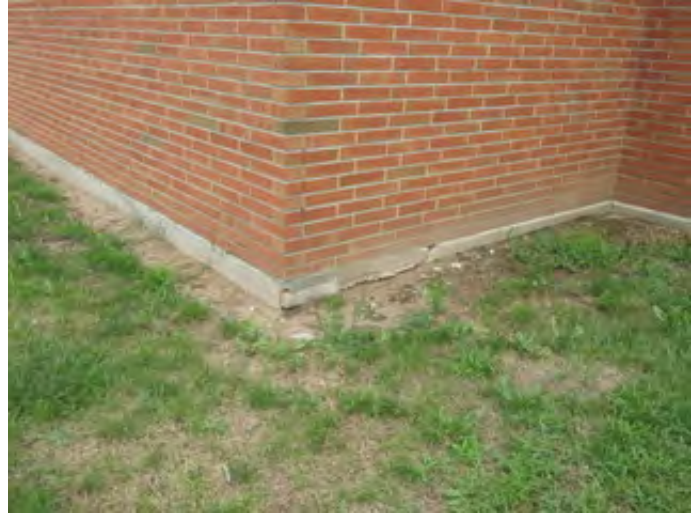
Rating: 2 Needs Repair

Minor Foundation Repair

Recommendations: Repair areas of cracking and spalling through the overall facility.

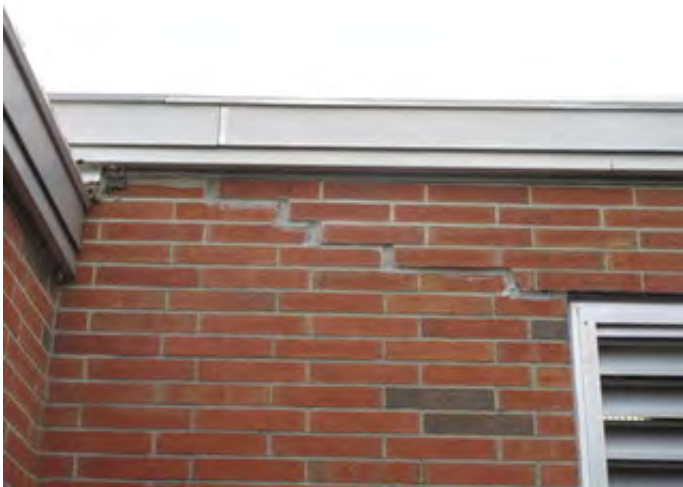
Description: The overall facility has a brick veneer on load bearing masonry wall system, which displayed minor locations of deterioration, and is in good condition. Control joints are not provided and are not needed. The school does have sufficient expansion joints at the joint between the Original Construction and the 1974 Kitchen Addition, and they are in fair condition. Exterior walls in the Original Construction are inadequately insulated. Brick veneer masonry walls are not cavity walls. Exterior walls in the 1974 Addition are inadequately insulated. Brick veneer masonry walls are cavity walls. Weep holes and vents are not provided or required. The exterior masonry has been cleaned and sealed in recent years, showing little evidence of mortar deterioration. Architectural exterior accent materials consist of stone, which is in fair condition. Exterior building fenestration in the Original Construction represents 15.76% of the exterior surfaces. Exterior building fenestration in the 1974 Kitchen Addition represents 3.05% of the exterior surfaces. Many classrooms in the Original Construction have unit ventilators which will be removed. Masonry infill will be required. Interior Corridor and demising walls are concrete masonry units and glazed block partition walls, project full height from floor to bottom of deck, and are in good condition. Interior masonry appears to have adequately spaced and caulked control joints in good condition. Interior soffits are of plaster type construction, and in good condition. The window sills are stone, and are in good condition. The exterior lintels are steel, and are in good condition. There are no chimneys. Canopies over entrances are of concrete, plaster, and wood type construction, and are in good to fair condition. Exterior soffits are of wood type construction, and in fair condition. The school is provided with a covered concrete and masonry conventional loading dock to facilitate the receipt of product, supplies, and foodstuffs, 73 square feet in size and featuring conventional man doors. The dock itself is in good condition, and is equipped with bumper pads in poor condition.

Rating: 2 Needs Repair

Replace Masonry

Recommendations: Provide tuckpointing in all areas of mortar deterioration as required through the overall facility. Provide masonry cleaning and sealing as required through the overall facility. Recaulk existing control joints. Sawcut and caulk new appropriately spaced expansion joints in existing masonry in two locations. Replace masonry in one location above a door of the overall facility. Exterior wall insulation deficiencies are addressed in Item J. Infill masonry openings from removed unit ventilators. Repair/replace mosaic ceramic tile as required throughout the overall facility.

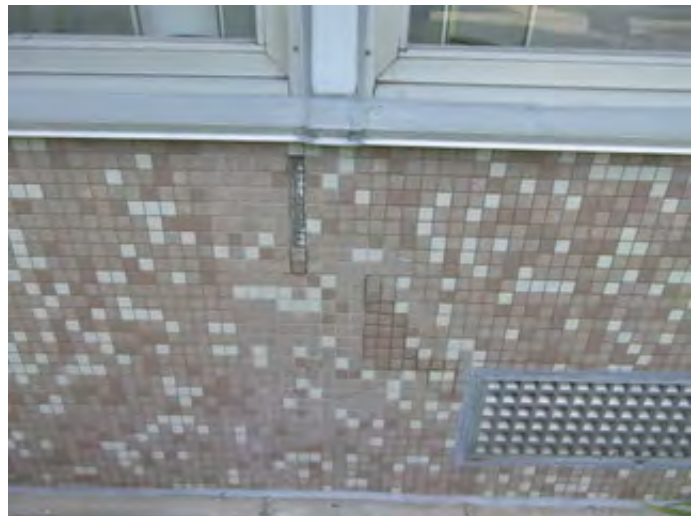
Mosaic Ceramic Tile Repairs

| Item | Cost | Unit | Whole Building | Original Construction (1966) | Sum | Comments |
|---|---|---|---|---|---|--|
| Other: Mosaic Tile | \$45.00 | sq.ft. (Qty) | | 240 Required | \$10,800.00 | Repair/replace exterior mosaic ceramic tile. |

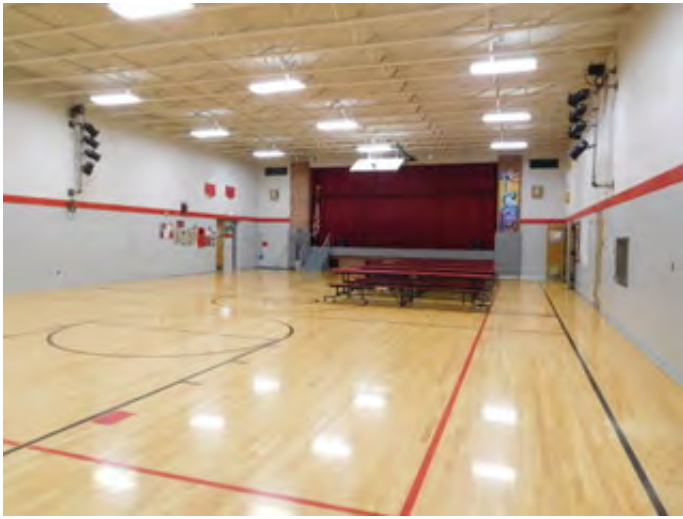
Description: The overall facility features conventionally partitioned Classrooms with marmoleum or VCT type flooring, acoustical tile type ceilings, as well as painted block and glazed block type wall finishes, and they are in fair condition. The overall facility has Corridors with terrazzo type flooring, acoustical tile type ceilings, as well as painted block and glazed block type wall finishes, and they are in fair condition. The overall facility has Restrooms with terrazzo type flooring, acoustical tile type ceilings, as well as painted block and glazed block type wall finishes, and they are in fair condition. Toilet partitions are metal or plastic, and are in good to fair condition. Classroom casework in the overall facility is wood type construction with plastic laminate tops, is inadequately provided, and in fair condition. The typical Classroom contains 5 lineal feet of casework, and Classroom casework provided ranges from 5 to 8 feet. Classrooms are provided adequate chalkboards, markerboards, and tackboards which are in fair condition. The lockers, Classroom storage cubbies, and coat hooks, located in the Classrooms, are adequately provided, and in fair condition. The Art program is not equipped with a kiln. The facility is equipped with wood louvered interior doors that are flush mounted without proper ADA hardware, and in fair condition. The Gymnasium space has wood type flooring, exposed type ceilings, as well as painted block, glazed block, and brick type wall finishes, and they are in fair condition. Wood Gymnasium flooring has been somewhat well maintained, will accommodate one future sanding and refinishing, and is rated at an advanced stage of its product lifecycle. Gymnasium stands are not provided. One Gymnasium basketball backboard is an electrically operated type, and is in fair condition. One Gymnasium basketball backboard is a fixed type, and is in fair condition. The circular shaped Media Center, has marmoleum type flooring, acoustical tile type ceilings, as well as painted block and glazed block type wall finishes, and they are in fair condition. Student Dining shares the Gymnasium space. OSDM-required fixed equipment for Stage is adequately provided, and in fair condition. Existing Gymnasium, Media Center, and Music spaces are inadequately provided with appropriate sound attenuation acoustical surface treatments. The existing Kitchen is a Warming Kitchen only, is slightly oversized based on current enrollment, and the existing Kitchen equipment, installed over 20 years ago, is in fair condition. The Kitchen hood is in fair condition, and is not equipped with the required UL 300 compliant wet chemical fire suppression system. The required 6" overhang on all three exposed sides of the cooking equipment is provided by the hood. Kitchen hood exhaust ductwork is of proper construction, material, insulation, and installed as required by the OSDM and OBCMC. Reach-in coolers and freezers are located within the Kitchen spaces, and are in fair condition.

Rating: 2 Needs Repair

Gymnasium Finishes

Recommendations: Provide complete replacement of finishes and casework due to condition and installation of systems outlined in Items A, C, D, E, I, K, L, M, N, T, U, and W. Provide for the replacement of interior doors due to age and condition, except 3 doors being replaced in Item O due to inadequate clearances. Provide for the replacement of the Warming Kitchen Hood to meet OSDM standards. Provide for the replacement of walk-in cooler and freezer due to age and condition. Provide for complete replacement of Warming Kitchen Equipment due to age and condition. Provide for an Art program kiln, with funding for exhaust system provided in Item C. Provide for the replacement of toilet accessories. Provide for the repair of terrazzo flooring due to condition. Provide for Gymnasium bleachers. Provide for appropriate sound attenuation acoustical surface treatments in the Gymnasium, Media Center, and Music Room. Provide for a Stage Equipment allowance. Provide for additional wall insulation. Remove Corridor transfer grilles, fill voids, and coordinate with adjacent finishes. Provide for the replacement of basketball backboards due to age and condition. Provide additional funding for the replacement of the Gymnasium flooring due to age and condition.

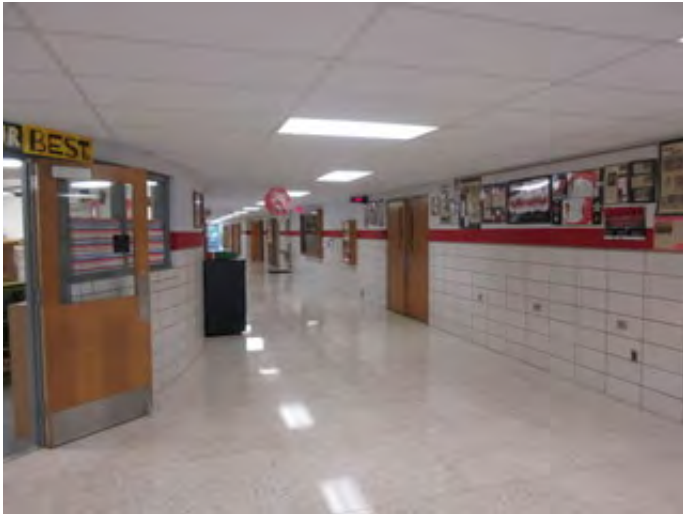
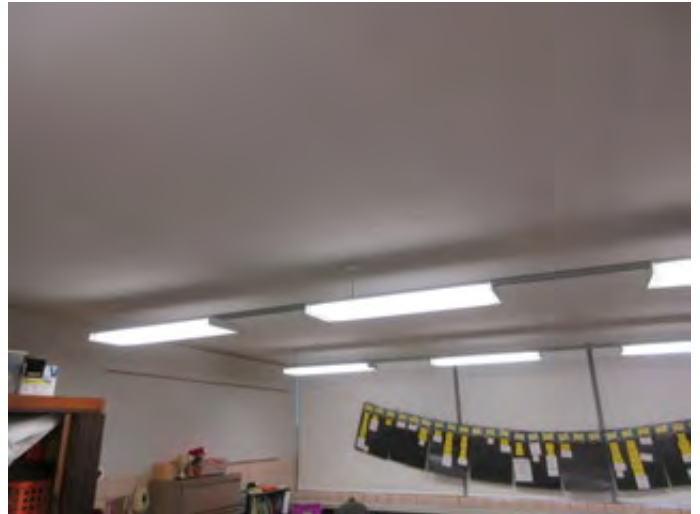
Description: The typical Classrooms in the overall facility are equipped with T-8 1x4 suspended direct fluorescent fixture type lighting, with dual level switching. Classroom fixtures are in fair condition, providing an average illumination of 51 FC, thus complying with the 40 FC recommended by the OSDM. The typical Corridors in the overall facility are equipped with T-8 2x4 lay-in direct fluorescent fixture type lighting, with single level switching. Corridor fixtures are in fair condition, providing an average illumination of 13 FC, which is less than the 15 FC recommended by the OSDM. The Multi-Purpose Room (Gymnasium/Student Dining) spaces are equipped with T-8 2x4 surface mount fluorescent fixture type lighting, in fair condition, providing an average illumination of 37 FC, which is less than the 40 FC recommended by the OSDM. The Media Center is equipped with T-8 2x4 suspended direct fluorescent fixture type lighting, in fair condition, providing an average illumination of 88 FC, thus complying with the 30 FC recommended by the OSDM. The Kitchen spaces are equipped with T-8 1x4 lay-in direct fluorescent fixture type lighting, with single level switching. Kitchen fixtures are in fair condition, providing an average illumination of 47 FC, which is less than the 50 FC recommended by the OSDM. The Service Areas in the overall facility are equipped with T-8 1x4 suspended and surface mount fluorescent fixture type lighting, in fair condition, providing inadequate illumination based on OSDM requirements. The typical Administrative spaces in the overall facility are equipped with T-8 2x4 lay-in direct fluorescent fixture type lighting, in fair condition, providing inadequate illumination based on OSDM requirements. The overall lighting systems of the facility are not fully compliant with Ohio School Design Manual requirements due to age and condition, inadequate lighting levels, and lack of multi-level switching.

Rating: 3 Needs Replacement

Corridor Fluorescent Light Fixtures

Classroom Fluorescent Light Fixtures

Recommendations: Provide complete replacement of lighting system due to age, condition, lighting levels, lack of multilevel switching, and installation of systems outlined in Items A, C, J, and U.

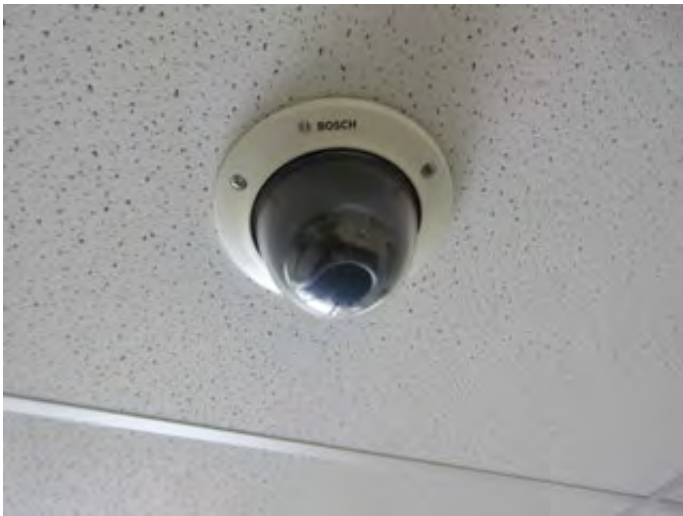
Description: The overall facility contains a Sonitrol motion detector, CCTV, door contact type security system in fair condition. Motion detectors are inadequately provided in main entries, central gathering areas, offices, main Corridors, and spaces where 6 or more computers are located. Exterior doors are inadequately equipped with door contacts. An automatic visitor control system is provided. Compliant color CCTV cameras are inadequately provided at main entry areas, parking lots, central gathering areas, and main Corridors. CCTV is monitored in Administrative Area with the use of a LCD monitor. A compliant computer controlled access control system integrating alarms and video signals, with appropriate UPS backup, is not provided. The system is equipped with card / biometric readers. The security system is not adequately provided throughout, and the system is not fully compliant with Ohio School Design Manual guidelines. There are no playground fencing issues requiring attention. The exterior site lighting system is equipped with recessed incandescent and surface mounted LED and HID high pressure sodium entry lights in fair condition. Pedestrian walkways are illuminated with surface mounted LED and HID high pressure sodium fixtures in fair condition. Parking and bus pick-up / drop off areas are not illuminated. The exterior site lighting system provides inadequate illumination due to insufficient fixture capacity and sparse placement of fixtures.

Rating: 3 Needs Replacement

Security System CCTV Camera

Recommendations: Provide complete replacement of security system to meet Ohio School Design Manual guidelines. Provide complete replacement of exterior site lighting system to meet Ohio School Design Manual guidelines.

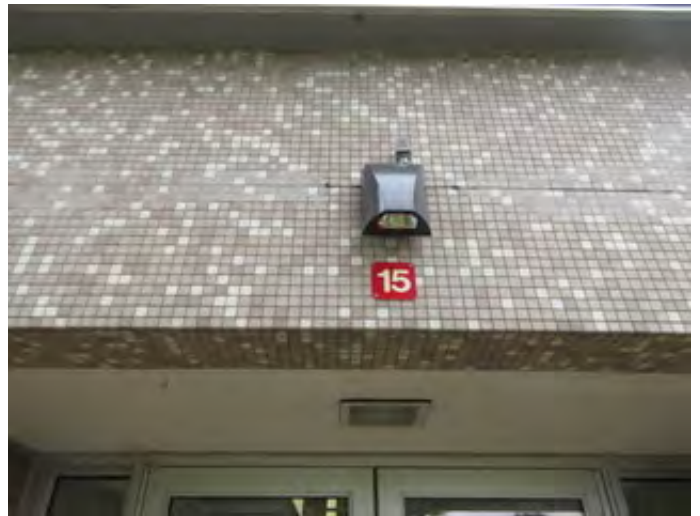
Entry Light Fixture

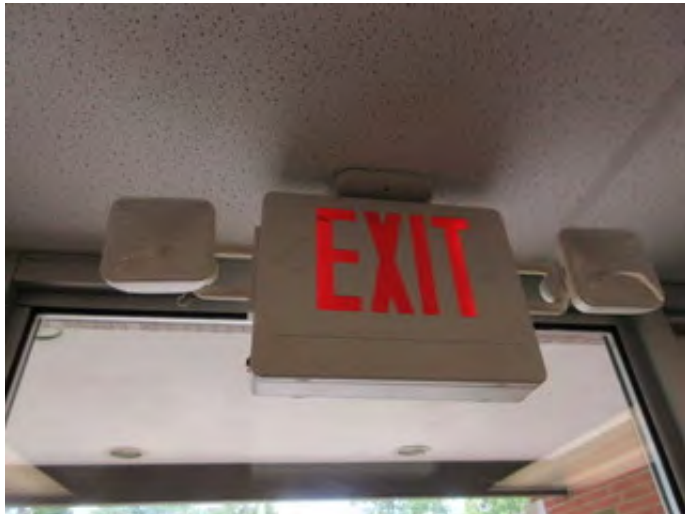
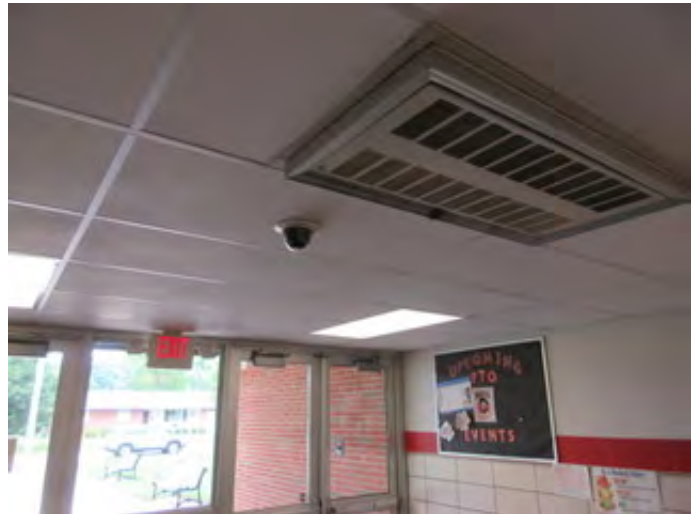
Description: The overall facility is inadequately equipped with an emergency egress lighting system consisting of non-compliant non-illuminated and plastic construction exit signs, as well as OSDM compliant red lettered and LED illuminated exit signs, and the system is in fair condition. The facility is inadequately equipped with emergency egress floodlighting (which consists mainly of emergency egress lighting attached to exit signs), but is also equipped with some recessed fluorescent lighting used as emergency egress lighting, and the system is in fair condition. The system is not provided with appropriate battery backup or emergency generator on separate circuits. The system is not adequately provided throughout, and does not meet Ohio School Design Manual and Ohio Building Code requirements.

Rating: 3 Needs Replacement

Exit Sign with Emergency Egress Lighting

Recommendations: Provide complete replacement of emergency / egress lighting system to meet Ohio School Design Manual and Ohio Building Code guidelines.

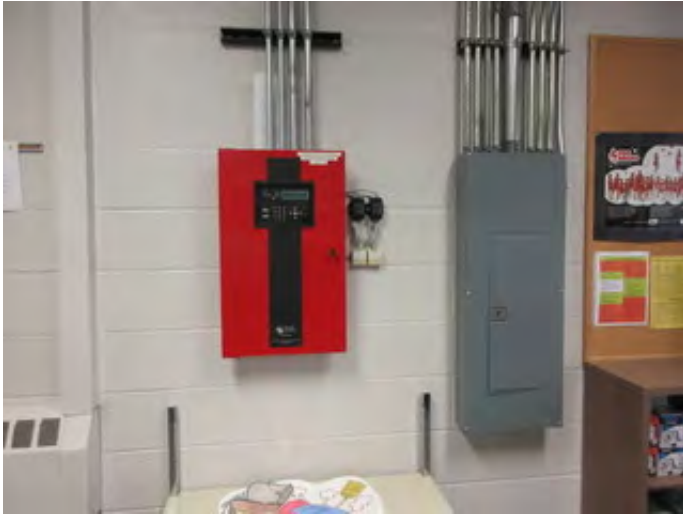
Description: The overall facility is equipped with a Honeywell Silent Knight SK-5208 addressable type fire alarm system, installed in 1966 with incremental upgrades, and in fair condition, consisting of manual pull stations and horn and strobe indicating devices. The system is automatic and is monitored by a third party. The system appears to be equipped with sufficient audible horns and strobe indicating devices. The system does not appear to be equipped with sufficient smoke detectors. The system is not equipped with any heat sensors, flow switches, and tamper switches. The systems thus will not support future fire suppression systems. The systems are not adequately provided throughout, and does not have additional zone capabilities. The systems are not fully compliant with Ohio Building Code, NFPA, and Ohio School Design Manual requirements.

Rating: 3 Needs Replacement

Fire Alarm System Control Panel

Recommendations: Provide complete replacement of fire alarm systems to meet OBC, NFPA, and Ohio School Design Manual guidelines.

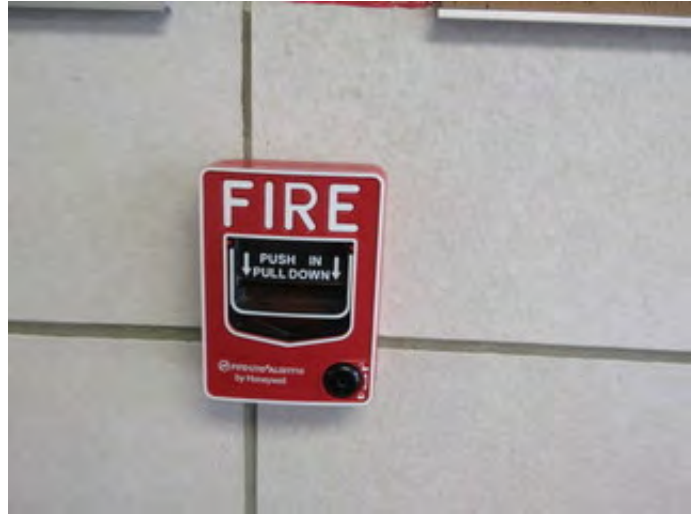
Fire Alarm System Manual Pull Station

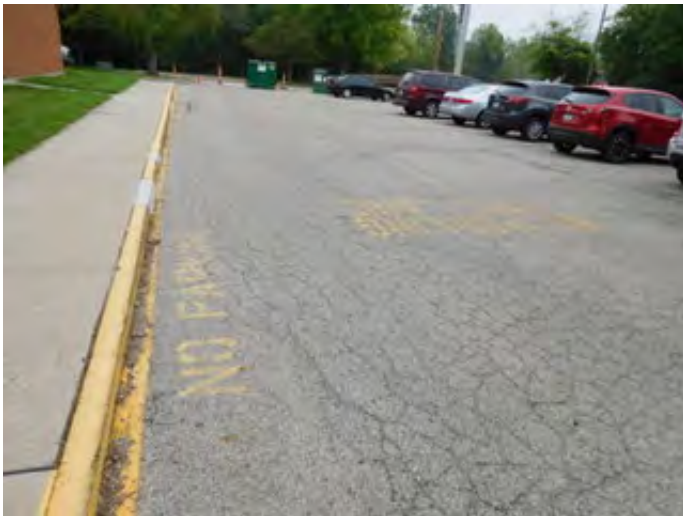
Rating: 2 Needs Repair

Parking Lot

Recommendations: Provide for replacement of heavy duty asphalt due to age and condition. Provide for replacement of light duty asphalt due to age and condition. Provide for an adequate bus drop-off area. Provide for replacement of concrete curbs due to age and condition. Provide for replacement of concrete sidewalks due to age and condition. Provide for soil stabilization at edges of pavement. Provide for replacement of catch basins due to signs of ponding on site. Funding for adequate provisions for disabled parking spaces is provided in parking lot asphalt replacement. Provide allowances for unforeseen site circumstances.

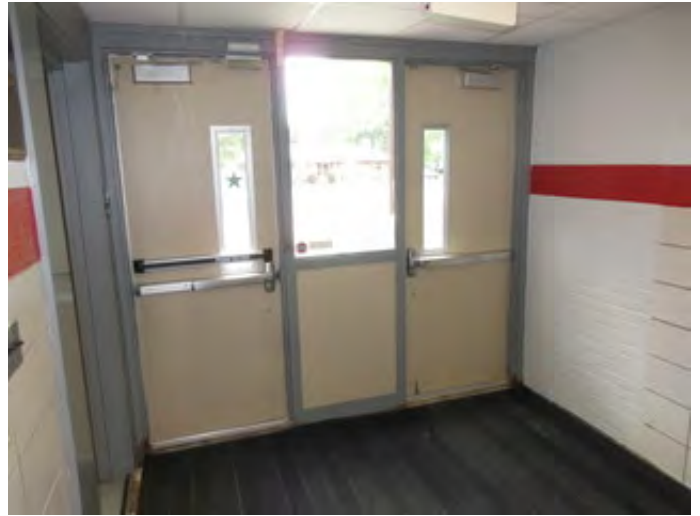
Rating: 2 Needs Repair

Hollow Metal Framed Exterior Door

Recommendations: Replace the hollow metal framed exterior doors, due to poor condition.
