Building Information - Troy City (44925) - Kyle Elementary

Program Type	Classroom Facilities Assistance Program (CFAP) - Regular
Setting	Small City
Assessment Name	Kyle Elementary School (19372) FINAL
Assessment Date (on-site; non-EEA)	2016-08-06
Kitchen Type	Warming Kitchen
Cost Set:	2016
Building Name	Kyle Elementary
Building IRN	19372
Building Address	501 South Plum Street
Building City	Troy
Building Zipcode	45373
Building Phone	(937) 332.6770
Acreage	2.04
Current Grades:	K-5
Teaching Stations	22
Number of Floors	2
Student Capacity	360
Current Enrollment	245
Enrollment Date	2016-08-06
Enrollment Date is the date in which the current enrollment was taken.	
Number of Classrooms	18
Historical Register	NO
Building's Principal	Mr. Matthew Dillon
Building Type	Elementary

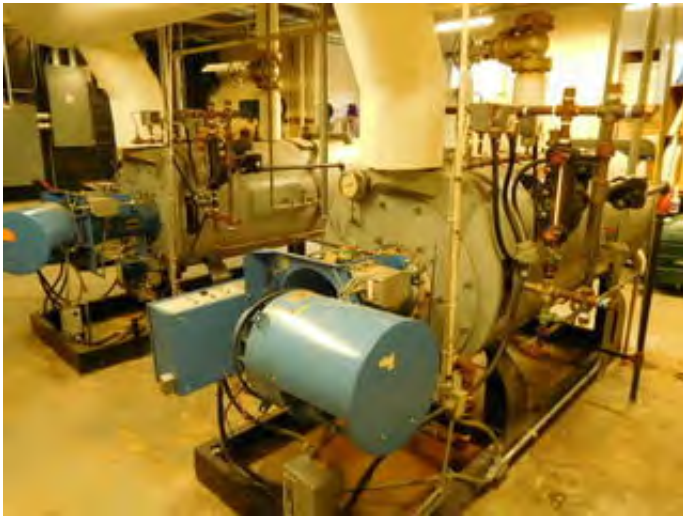
Description: The existing system for the 1950 Original Construction is a natural gas fired steam boiler type system, installed in 1950, and is in fair condition. The systems in the 1974 Addition is an extension of that found in the 1950 Original Construction. 2-pipe vs. 4-pipe designations are not applicable in this facility, as no central air conditioning is provided. The (2) steam boilers were manufactured by Cyclotherm, were installed in 1950, and are in fair condition. Steam is distributed to terminal units consisting of fin tubes, unit ventilators, cabinet heaters, unit heaters, and air handlers. The terminal equipment is original to each addition and is in fair condition. The system does not appear to comply with the 15 CFM per person fresh air requirements of the Ohio Building Code mechanical code and Ohio School Design Manual. The pneumatic type system temperature controls are original to each addition and are in fair to poor condition. The system does not feature individual temperature controls in all spaces required by the OSDM. The overall system does not feature any central energy recovery systems. The facility is not equipped with louvered interior doors to facilitate Corridor utilization as return air plenums. The existing systems in the overall facility are not ducted, and floor to structural deck heights will accommodate the installation of properly sized ductwork for a future Ohio School Design Manual approved system. The overall heating system is evaluated as being unsafe and in inefficient working order, and long term life expectancy of the existing system is not anticipated. The structure is not equipped with central air conditioning. The site does not contain underground fuel tanks.

Rating: 3 Needs Replacement

Natural Gas Fired Heated Water Boilers

Recommendations: Provide new overall heating, ventilating, and air conditioning system to achieve compliance with Ohio Building Code and Ohio School Design Manual standards. Convert to ducted system to facilitate efficient exchange of conditioned air.

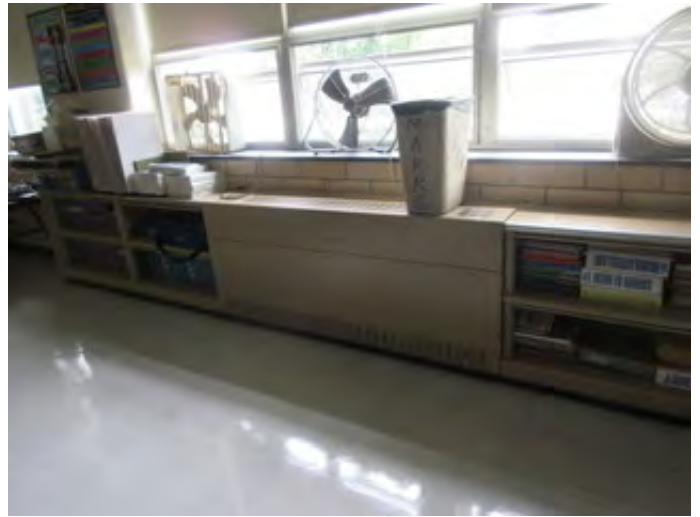
Unit Ventilator

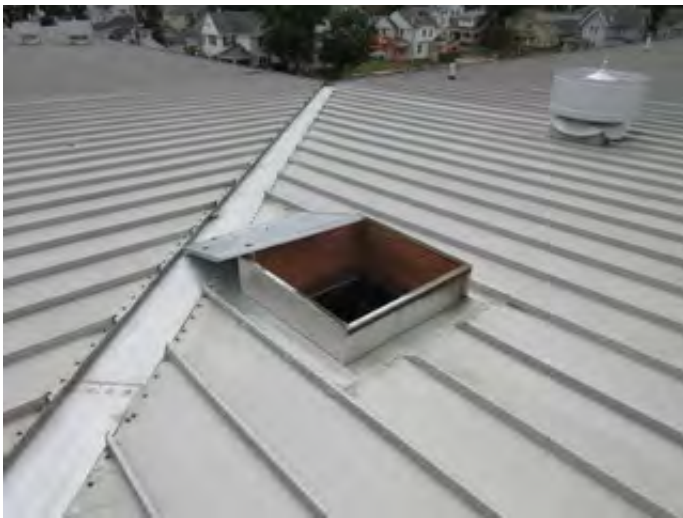
Description: The roof over the overall facility is a standing seam metal roofing system that was installed over a built-up roofing system at an unknown date, and is in good condition. There are no District reports of current leaking. No signs of past leaking were observed during the physical assessment. Access to the roof was gained by access hatch and access ladder that are in poor condition. Fall safety protection cages are not required, and are not provided. There were no observations of standing water on the roof. Metal cap flashings and copings are in good condition. Roof storm drainage is addressed through a system of gutters and downspouts, which are properly located, and in poor condition. The roof is not equipped with overflow roof drains though they are not required. No problems requiring attention were encountered with any roof penetrations. There are not any covered walkways attached to this structure.

Rating: 2 Needs Repair

Access Hatch & Standing Seam Metal Roof

Recommendations: Due to existing conditions gutters and downspouts require replacement. Replace the existing access ladder and hatch.

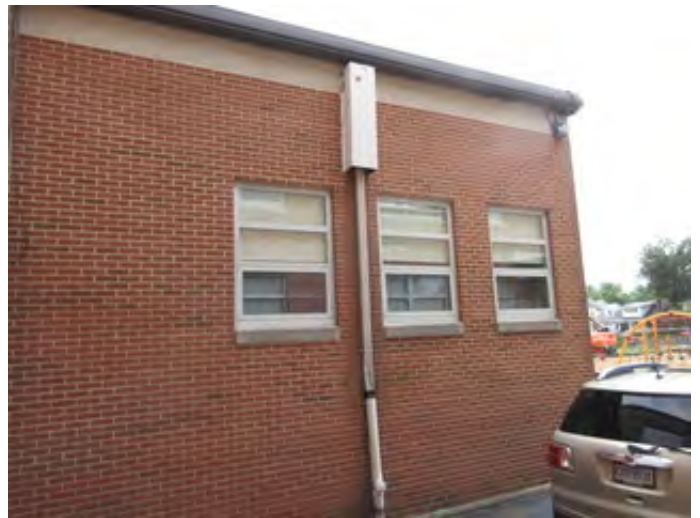
Downspout of 1974 Kitchen Addition

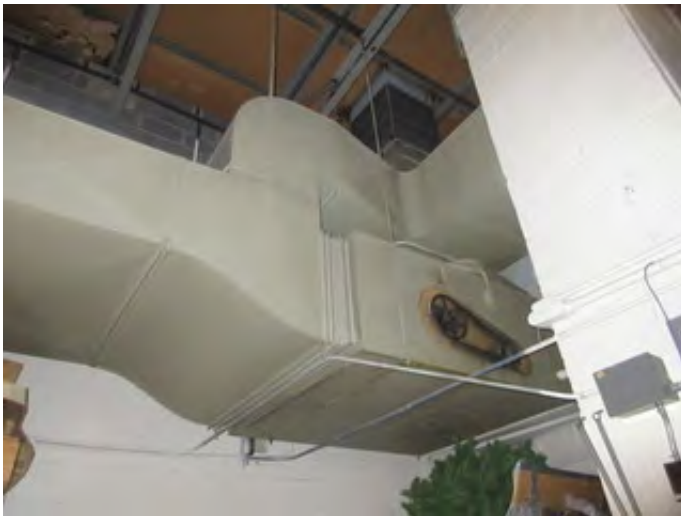
Description: The overall facility is not equipped with a central air conditioning system. Window units are not present in the overall facility. Isolated room systems consisting of ducted and ductless split AC units (with condensing units pad-mounted on the exterior of the facility) are located in the Administrative Offices and Computer Lab. The ventilation system in the overall facility consists of unit ventilators, original to each addition and in fair condition, providing fresh air to Classrooms and Media Center and air handlers, original to each addition and in fair condition, providing fresh air to other miscellaneous spaces such as the Multi-Purpose Room (Gymnasium and Student Dining). Relief air venting is provided by unit ventilators, transfer grilles to corridors, central relief fans, and air handlers. The ventilation system does not appear to meet the Ohio Building Code 15 CFM per occupant fresh air requirement. The overall system is not compliant with Ohio Building Code and Ohio School Design Manual requirements. Dust collection systems are not required in this facility. The Art program is not equipped with a kiln. General building exhaust systems for Restrooms, Storage Rooms, Art Rooms, and Custodial Closets do not appear to be inadequately placed, and in fair condition.

Rating: 2 Needs Repair

Air Handling Unit

Recommendations: Provide an air conditioning system to meet with Ohio Building Code and Ohio School Design Manual requirements. Replace general building exhaust systems located in Restrooms, Storage Rooms, Art Rooms, and Custodial Closets. Pricing included in Item A. Provide the Art program with a kiln ventilation system to meet Ohio Building Code and Ohio School Design Manual requirements.

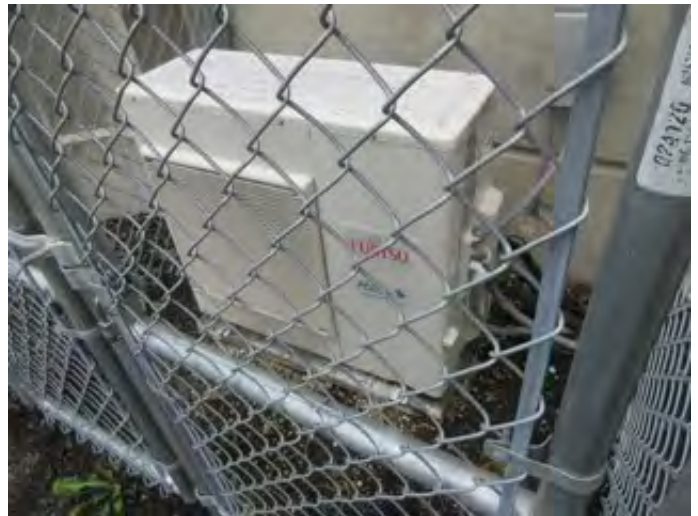
Ductless Split AC Condensing Unit

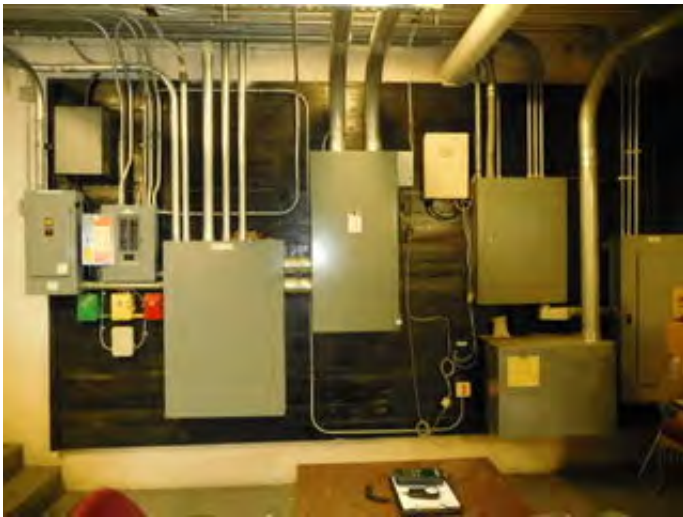
Description: The electrical system provided to the 1950 Original Construction is a 120/240 volts, 800 amp, 3 phase and 4 wire system installed in 1950 with upgrades in 1974, and is in fair condition. The system in the 1974 Addition is an extension of that found in the 1950 Original Construction. Power is provided to the school by multiple utility owned, pole-mounted transformers located outside the Kitchen, and are in fair condition. The Square D panel systems, original to each addition, are in fair condition, and for the most part cannot be expanded to add additional capacity. The Classrooms are not equipped with adequate electrical outlets. The typical Classroom contains (4) general purpose outlets, (0) dedicated outlets for each Classroom computer, and (1) dedicated outlet for each Classroom television. Some Classrooms are equipped with as many as (5) general purpose outlets, while others are equipped with as few as (3) general purpose outlets. There are not any spaces that have no electrical outlets. The Corridors appear to be equipped with adequate electrical outlets for servicing. Adequate GFI protected exterior outlets are not provided around the perimeter of the building. The facility is not equipped with an emergency generator. Adequate lightning protection safeguards are not provided. Stage lighting power system including control panel, breakers, and dimmers is inadequately provided, in fair condition and does not meet OSDM requirements. The overall electrical system does not fully meet Ohio School Design Manual requirements in supporting the current needs of the school, and will be inadequate to meet the facility's future needs.

Rating: 3 Needs Replacement

Main Electrical Distribution Panels

Recommendations: The entire electrical system requires replacement to meet Ohio School Design Manual guidelines for overall capacity and due to age, condition, lack of OSDM-required features, and to accommodate the addition of an air conditioning system. Provide an emergency generator, with funding included in the electrical system replacement. Provide adequate lightning protection safeguards in the overall facility, including associated grounding system, with funding included in the electrical system replacement. Provide control panel, dimmers, and breakers to support the Stage lighting system, with funding included in the electrical system replacement.

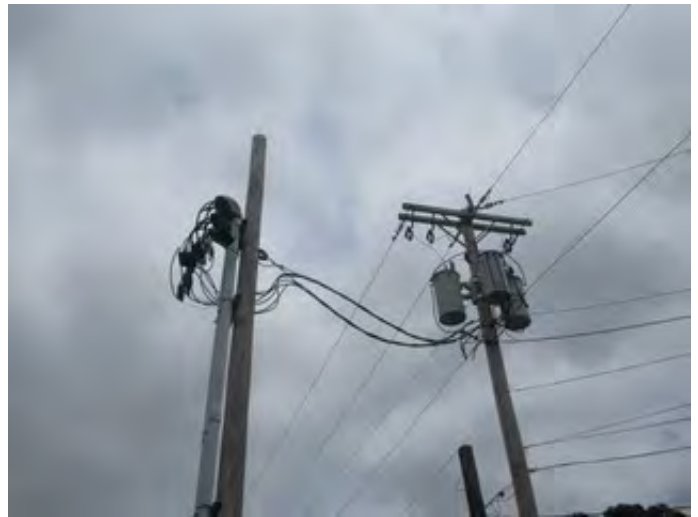
Pole Mounted Transformers

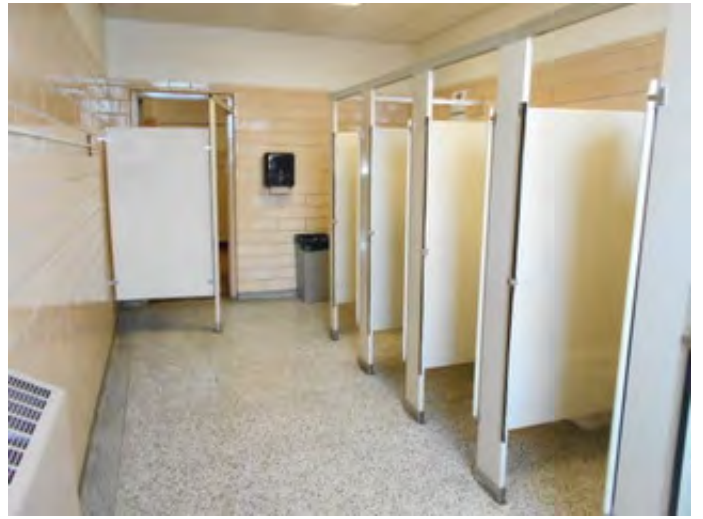
Large Group Restroom-Girls

In the overall facility, replace the remaining galvanized steel domestic water piping and the remaining cast iron waste piping due to age and condition. Due to age and condition and to facilitate the school's compliance with OBC and OSFC fixture requirements, in the overall facility, replace 16 toilets, 12 lavatories (include ADA compliant faucets) and 2 electric water coolers. Provide 1 additional electric water cooler. Provide 5 additional wall mounted lavatories, with ADA compliant faucets; 1 per Girl's and Boy's Restrooms and 1 in the Kitchen. Due to age, condition, LEED, OBC and OSFC, replace 60 faucets and valves throughout the overall facility. Provide 17 in Classroom sinks with deck mounted drinking fountain. All fixtures, whether new or replaced, to be mounted at ADA compliant heights. Provide 1 additional exterior wall hydrant. Provide 2 solids interceptors for the Art Room. See Item O for replacement of fixtures related to ADA requirements, as well as reconfiguration of toilet stalls in Boys and Girls Restrooms and the reconfiguration of 2 Staff Restrooms. Funding for fixtures and equipment replacement in Kitchen is provided for in Item J.

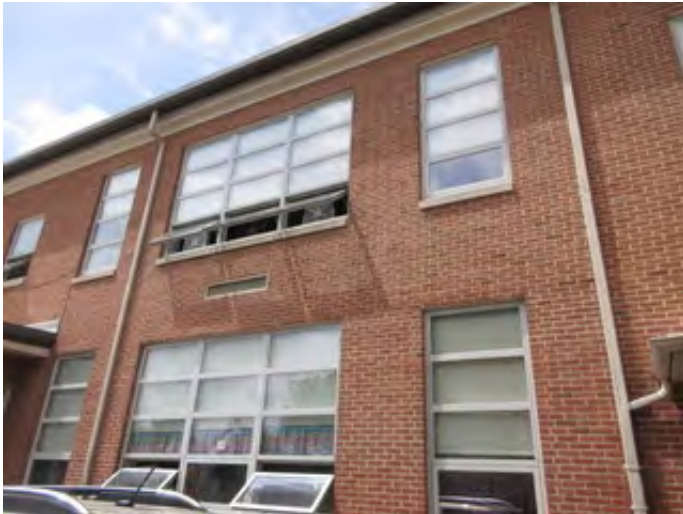
Description: The overall facility is equipped with thermally broken aluminum frame windows with insulated glazing type window system, which was installed at an unknown date, and is in good condition. The window system features operable windows throughout the building, and operable windows are not equipped with opening limiters, but do contain insect screens in fair to poor condition. Window system seals are in good condition, with no air and water infiltration being experienced. Window system hardware is in good condition. The window system features no blinds. This facility is not equipped with any curtain wall systems. There are glass block windows in the Original Construction, in fair condition. The exterior doors in the overall facility are equipped with aluminum frame and transoms with tempered insulated glazing, in good condition, with the exception of the main entrance doors which contain transoms with insulated metal panels in fair to poor condition. Exterior door vision panels are tempered insulated glazing. The school does not contain any skylights. The school does not contain any clerestories. Interior glass is OSDM-compliant. Window security screens are provided for 4 ground floor windows, and are in good condition. There is not a Greenhouse associated with this school.

Rating: 2 Needs Repair

Typical Aluminum Windows of the Original Construction

Recommendations: Replace the existing glass block in the Original Construction with a new insulated window system to match existing insulated system and comply with Ohio School Design Manual requirements. Recaulk window perimeters through the overall facility. Replace interior window insect screens as required through the overall facility. Replace the main entrance door transoms due to existing conditions. Install surface mounted blinds to the existing windows in the overall facility.

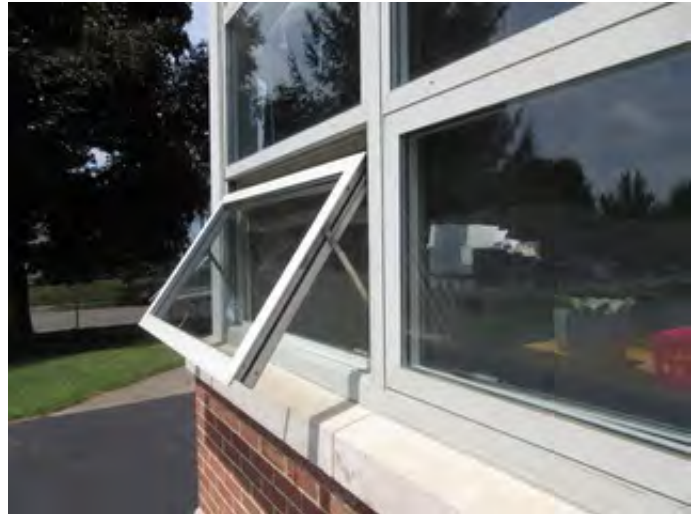
Typical Awning Windows

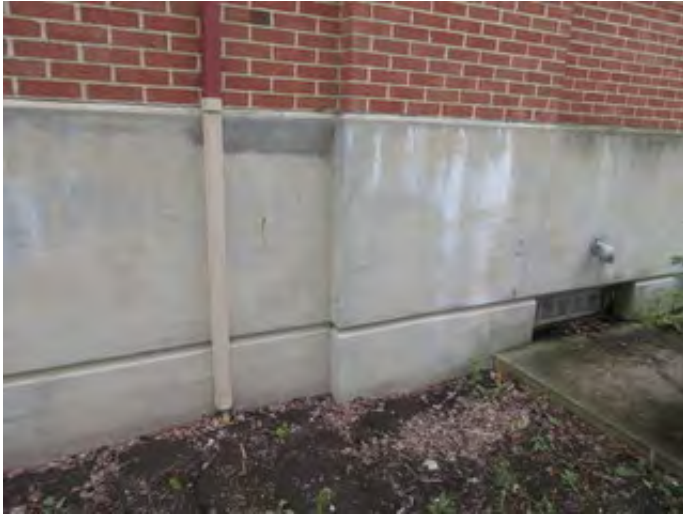
Description: The overall facility is equipped with concrete foundation walls on concrete footings, which displayed no locations of significant differential settlement, cracking, or leaking, and are in fair condition. Areas of minor cracking and spalling were observed through the overall facility. The District reports that there has been no past leaking. No grading or site drainage deficiencies were noted around the perimeter of the structure that are contributing or could contribute to foundation / wall structural deterioration.

Rating: 2 Needs Repair

Typical Concrete Foundation

Recommendations: Repair areas of cracking and spalling through the overall facility.

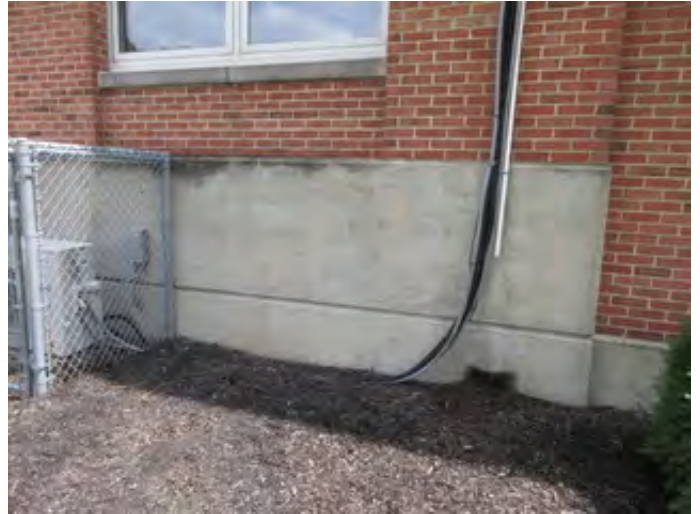
Minor Foundation Repair

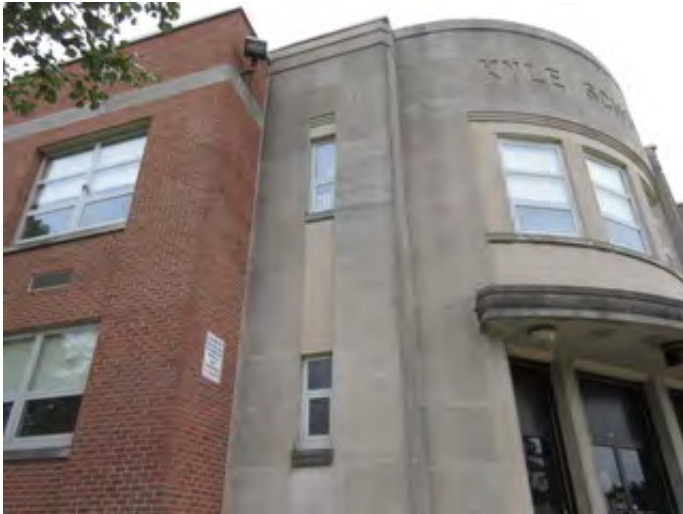
Description: The overall facility has a brick veneer on load bearing masonry wall system, which displayed minor locations of deterioration, and is in good condition. Control joints are not provided and are not needed. The school does have sufficient expansion joints at the joint between the Original Construction and the 1974 Kitchen Addition, and they are in fair condition. Exterior walls in the Original Construction are inadequately insulated. Brick veneer masonry walls are not cavity walls. Exterior walls in the 1974 Addition are inadequately insulated. Brick veneer masonry walls are cavity walls. Weep holes and vents are not provided or required. The exterior masonry has been cleaned and sealed in recent years, showing little evidence of mortar deterioration. Architectural exterior accent materials consist of stone, which is in fair condition. Exterior building fenestration in the Original Construction represents 15.76% of the exterior surfaces. Exterior building fenestration in the 1974 Kitchen Addition represents 3.05% of the exterior surfaces. Many classrooms in the Original Construction have unit ventilators which will be removed. Masonry infill will be required. Interior Corridor and demising walls are concrete masonry units and glazed block partition walls, project full height from floor to bottom of deck, and are in good condition. Interior masonry appears to have adequately spaced and caulked control joints in good condition. Interior soffits are of plaster type construction, and in good condition. The window sills are stone, and are in good condition. The exterior lintels are steel, and are in good condition. There are no chimneys. Canopies over entrances are of concrete and plaster type construction in good condition, and wood type construction in fair condition. Exterior soffits are of wood type construction, and in fair condition. The school is provided with a covered concrete and masonry conventional loading dock to facilitate the receipt of product, supplies, and foodstuffs, 73 square feet in size and featuring conventional man doors. The dock itself is in good condition, and is equipped with bumper pads in poor condition.

Rating: 2 Needs Repair

Stone Accent at Entrance

Recommendations: Provide tuckpointing in all areas of mortar deterioration as required through the overall facility. Provide masonry cleaning and sealing as required through the overall facility. Recauk existing expansion joints. Prep and paint exterior wood soffits and canopies through the overall facility. Exterior wall insulation deficiencies are addressed in Item J. Infill masonry openings from removed unit ventilators. Replace the loading dock bumper pads.

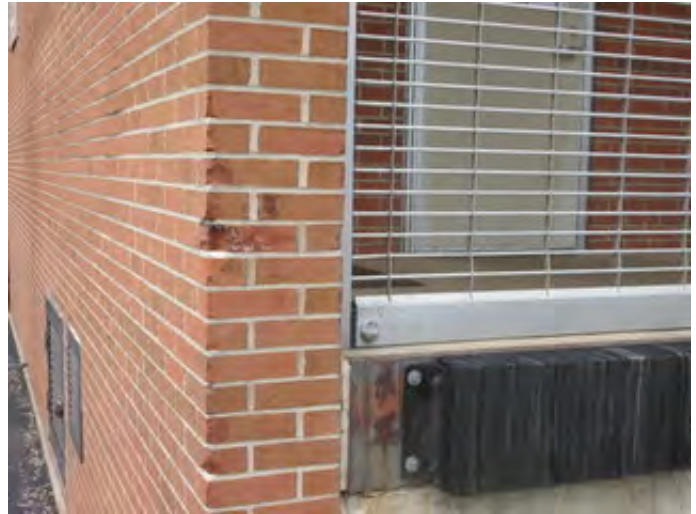
Tuckpointing Required

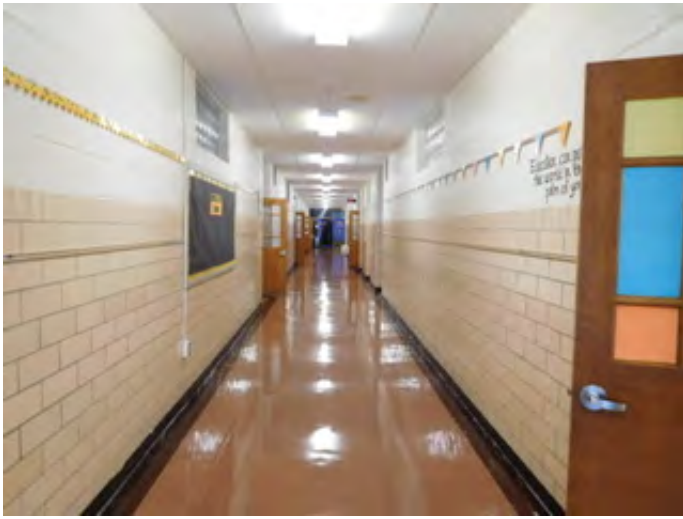
Description: The 1950 Original Construction features conventionally partitioned Classrooms with VAT, VCT, or marmoleum type flooring, acoustical tile type ceilings, as well as glazed block and painted block type wall finishes, and they are in fair condition. The 1950 Original Construction has Corridors with terrazzo or VAT type flooring, acoustical tile type ceilings, as well as glazed block type wall finishes, and they are in fair condition. The overall facility has Restrooms with terrazzo type flooring, acoustical tile type ceilings, as well as glazed block and painted block type wall finishes, and they are in fair condition. Toilet partitions are metal, and are in good to fair condition. The 1974 Addition features a single Classroom in the basement with a Warming Kitchen above. The Classroom features marmoleum type flooring, acoustical tile type ceilings, as well as painted block type wall finishes, and they are in fair condition. The Warming Kitchen features quarry tile type flooring, acoustical tile type ceilings, as well as painted block type wall finishes, and they are in fair condition. There are no Restrooms or Corridors in the 1974 Addition. Classroom casework in the overall facility is wood type construction with plastic laminate tops, is inadequately provided, and in fair to poor condition. The typical Classroom contains 8 lineal feet of casework, and Classroom casework provided ranges from 0 to 20 feet. Classrooms are provided adequate chalkboards, markerboards, and tackboards which are in fair to poor condition. The Classroom storage cubbies, located in the Classrooms, are adequately provided, and in fair condition. The Art program is not equipped with a kiln. The facility is equipped with wood non-louvered interior doors that are partially recessed with and without proper ADA hardware and clearances, and in fair to poor condition. The Gymnasium space has VAT type flooring, acoustical tile type ceilings, as well as glazed block and painted block type wall finishes, and they are in fair condition. Gymnasium stands are not provided. Two Gymnasium basketball backboards are a fixed type, and are in fair condition. The Media Center, located on the second floor, has carpet and VCT type flooring, acoustical tile type ceilings, as well as glazed block and painted block type wall finishes, and they are in fair condition. Student Dining shares the Gymnasium space. OSDM-required fixed equipment for Stage is inadequately provided, and in fair to poor condition. Existing Gymnasium, Media Center, and Music spaces are inadequately provided with appropriate sound attenuation acoustical surface treatments. The existing Kitchen is a Warming Kitchen only, is correctly sized based on current enrollment, and the existing Kitchen equipment, installed over 20 years ago, is in fair condition. The Kitchen hood is in fair condition, and is not equipped with the required UL 300 compliant wet chemical fire suppression system. The required 6" overhang on all three exposed sides of the cooking equipment is provided by the hood. Kitchen hood exhaust ductwork is of proper construction, material, insulation, and installed as required by the OSDM and OBCMC. Reach-in coolers and freezers are located within the Kitchen spaces, and are in fair condition.

Rating: 3 Needs Replacement

Typical Corridor Finishes

Recommendations: Provide complete replacement of finishes and casework due to condition and installation of systems outlined in Items A, C, D, E, I, K, L, M, N, T, U, and W. Provide for the replacement of toilet accessories. Provide for the replacement of interior doors due to age and condition. Funding for replacement of five interior doors with inadequate clearances is provided in Item O. Provide for the repair of terrazzo flooring due to condition. Provide for the replacement of basketball backboards due to age and condition. Provide for Gymnasium bleachers. Provide for an Art program kiln, with funding for exhaust system provided in Item C. Provide for additional wall insulation. Provide for the replacement of Warming Kitchen equipment due to age and condition. Provide for the replacement of walk-in cooler and freezer due to age and condition. Provide for the replacement of the Warming Kitchen Hood. Provide for appropriate sound attenuation acoustical surface treatments in the Multipurpose Room, Media Center, and Music Room. Provide for the replacement of Stage Equipment due to age and condition. Remove Corridor transfer grilles, fill voids, and coordinate with adjacent finishes.

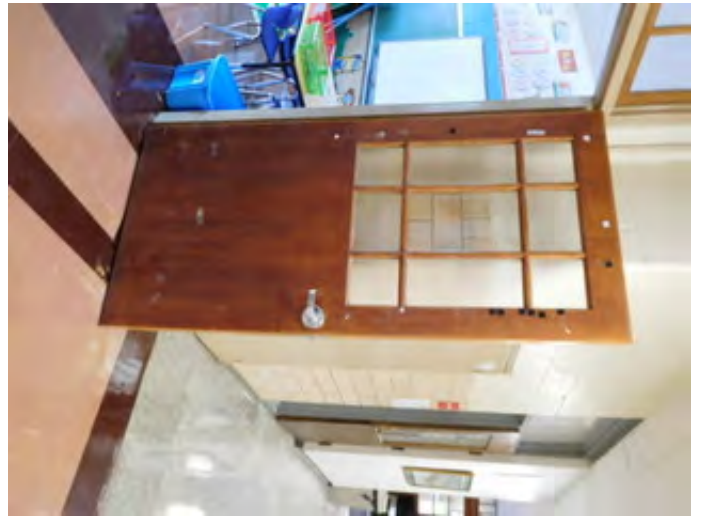
Typical Classroom Door

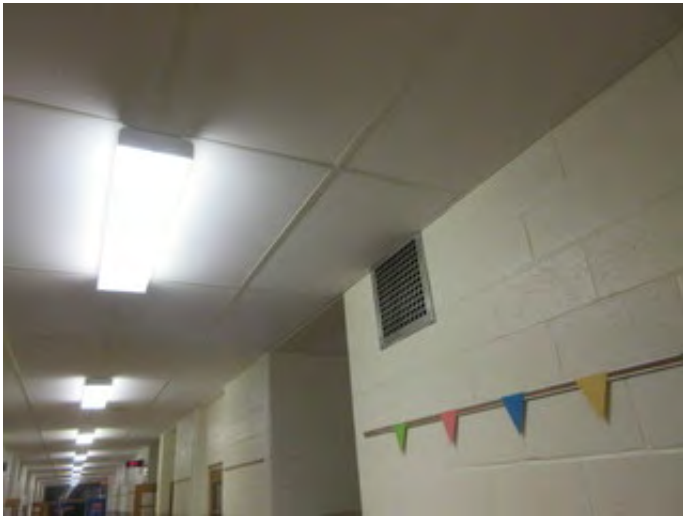
Description: The typical Classrooms in the overall facility are equipped with T-8 2x4 lay-in direct fluorescent fixture type lighting, with dual level switching. Classroom fixtures are in fair condition, providing an average illumination of 55 FC, thus complying with the 40 FC recommended by the OSDM. The typical Corridors in the overall facility are equipped with T-8 2x4 lay-in direct and T-8 1x4 surface mount fluorescent fixture type lighting, with single level switching. Corridor fixtures are in fair condition, providing an average illumination of 17 FC, thus complying with the 15 FC recommended by the OSDM. The Multi-Purpose Room (Gymnasium/Student Dining) spaces are equipped with T-8 2x4 lay-in direct fluorescent fixture type lighting, in fair condition, providing an average illumination of 37 FC, which is less than the 40 FC recommended by the OSDM. The Media Center is equipped with T-8 2x4 lay-in direct fluorescent fixture type lighting, in fair condition, providing an average illumination of 58 FC, thus complying with the 30 FC recommended by the OSDM. The Kitchen spaces are equipped with T-8 2x4 lay-in direct fluorescent fixture type lighting, with single level switching. Kitchen fixtures are in fair condition, providing an average illumination of 43 FC, which is less than the 50 FC recommended by the OSDM. The Service Areas in the overall facility are equipped with surface mount incandescent and T-8 1x4 suspended and surface mount fluorescent fixture type lighting, in fair condition, providing inadequate illumination based on OSDM requirements. The typical Administrative spaces in the overall facility are equipped with T-8 2x4 lay-in direct fluorescent fixture type lighting, in fair condition, providing inadequate illumination based on OSDM requirements. The overall lighting systems of the facility are not fully compliant with Ohio School Design Manual requirements due to age and condition, utilization of incandescent fixtures, inadequate lighting levels, and lack of multi-level switching.

Rating: 3 Needs Replacement

Corridor Fluorescent Light Fixtures

Recommendations: Provide complete replacement of lighting system due to age, condition, lighting levels, lack of multilevel switching, utilization of incandescent fixtures, and installation of systems outlined in Items A, C, J, and U.

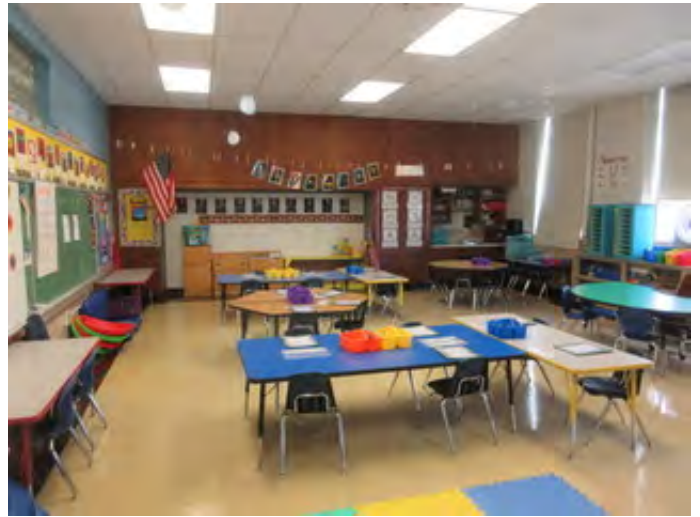
Classroom Fluorescent Light Fixtures

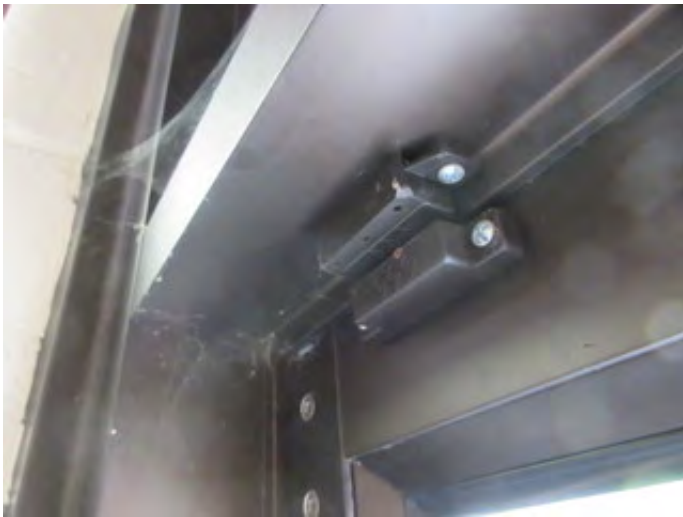
Description: The overall facility contains a Sonitrol motion detector, CCTV, door contact type security system in fair condition. Motion detectors are inadequately provided in main entries, central gathering areas, offices, main Corridors, and spaces where 6 or more computers are located. Exterior doors are inadequately equipped with door contacts. An automatic visitor control system is provided. Compliant color CCTV cameras are inadequately provided at main entry areas, parking lots, central gathering areas, and main Corridors. CCTV is monitored in Administrative Area with the use of a LCD monitor. A compliant computer controlled access control system integrating alarms and video signals, with appropriate UPS backup, is not provided. The system is equipped with card / biometric readers. The security system is not adequately provided throughout, and the system is not fully compliant with Ohio School Design Manual guidelines. Playground fencing is not adequately provided, with play areas not separated from the parking lot. The exterior site lighting system is equipped with surface mounted incandescent, HID high pressure sodium, and LED entry lights in fair condition. Pedestrian walkways are not illuminated onsite. Parking and bus pick-up / drop off areas are illuminated by pole mounted LED fixtures in fair condition. The exterior site lighting system provides inadequate illumination due to insufficient fixture capacity and sparse placement of fixtures.

Security System Door Contacts

Recommendations: Provide complete replacement of security system to meet Ohio School Design Manual guidelines. Provide complete replacement of exterior site lighting system to meet Ohio School Design Manual guidelines. Provide OSDM-compliant playground fencing, with funding included in complete replacement of security system.

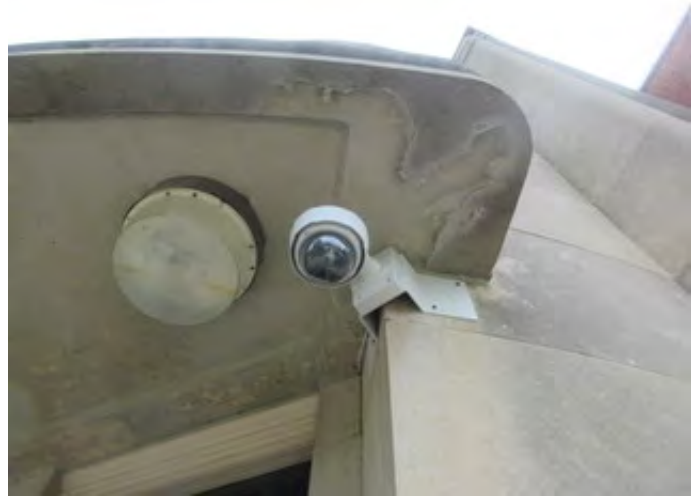
Security System CCTV Camera

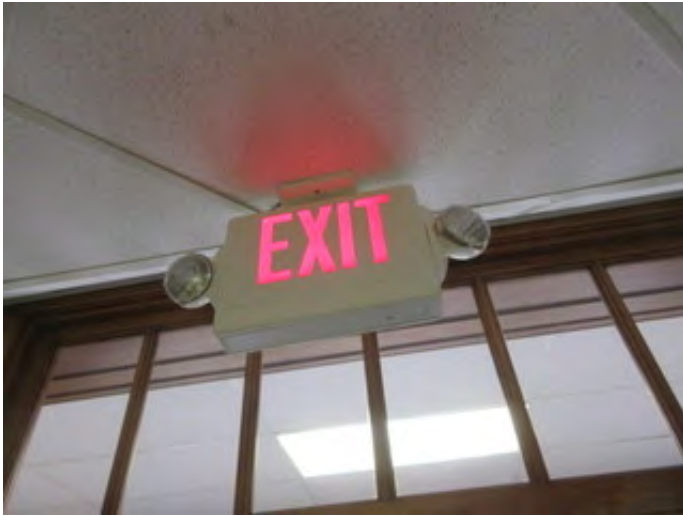
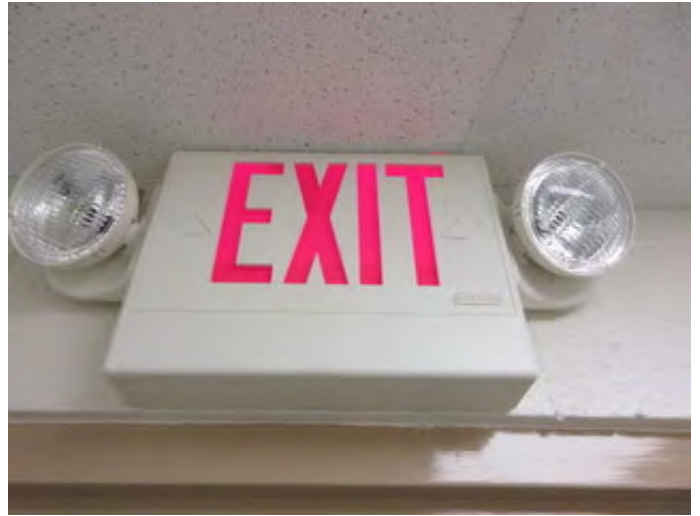
Exit Sign with Emergency Egress Lighting

Recommendations: Provide complete replacement of emergency / egress lighting system to meet Ohio School Design Manual and Ohio Building Code guidelines.

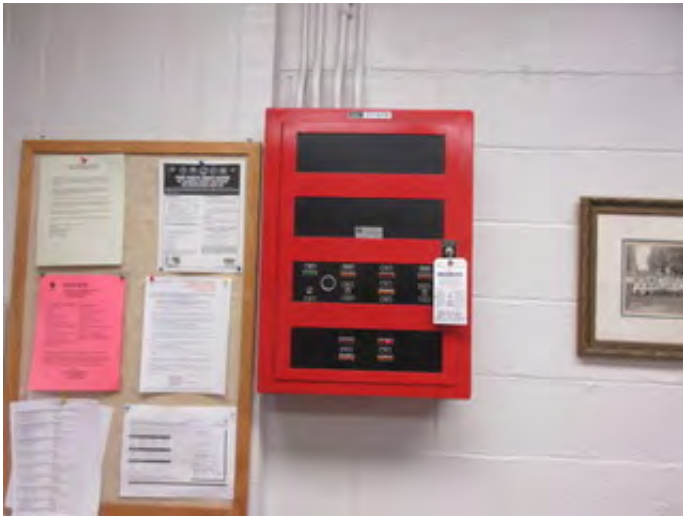
Fire Alarm System Control Panel

Recommendations: Provide complete replacement of fire alarm systems to meet OBC, NFPA, and Ohio School Design Manual guidelines.

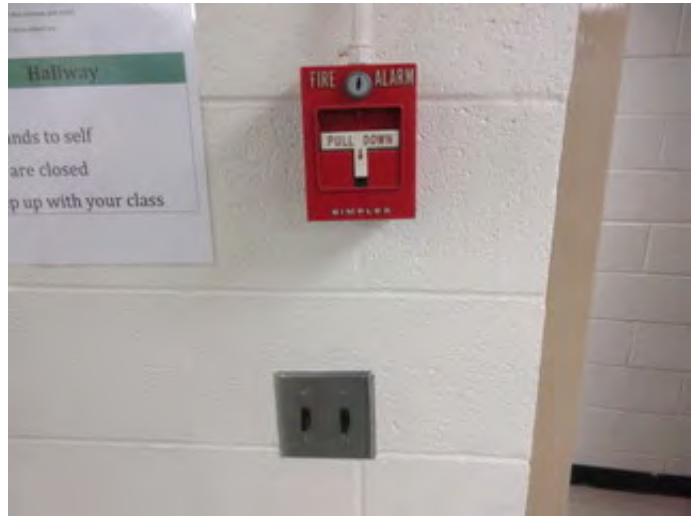
Fire Alarm System Manual Pull Station

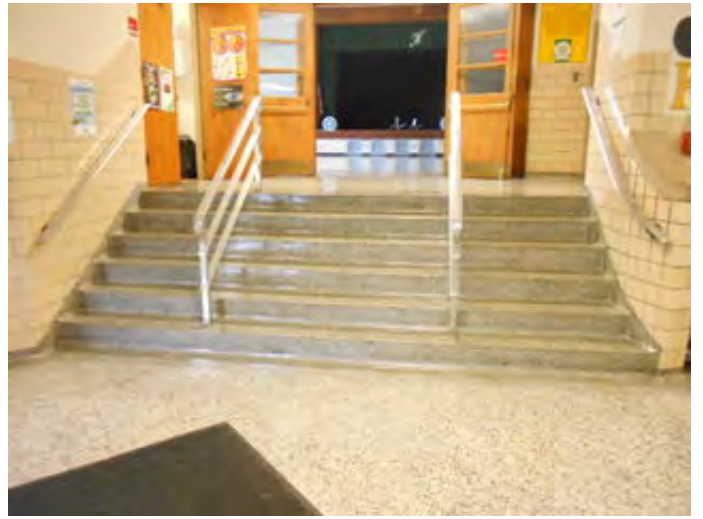
Non-Compliant Access to Gym/Cafeteria

Other: Non-Slip Tread Strips	\$400.00	unit		5 Required		\$2,000.00	Provide non slip tread strips on all stairways. Funding provided is per stairway.
Other: Reconfigure Toilet Room for ADA Compliance	\$10,000.00	per restroom		2 Required		\$20,000.00	Reconfigure existing restroom to meet ADA requirements. Includes fixtures, walls, door and hardware, supply lines, drains, full set of accessories and grab bars.
Other: Reconfigure Toilet Stall to meet ADA Compliance	\$2,500.00	per restroom		4 Required		\$10,000.00	Reconfigure existing toilet compartment to create ADA compliant stall. Includes fixture, accessories, grab bars, demolition, floor/wall repair and partitions.
Other: Wheelchair Stair Lift	\$15,000.00	per level		1 Required		\$15,000.00	Provide stairway chair lift. Includes lift, demolition, installation wall/floor repair.
Sum:			\$289,957.00	\$279,629.80	\$10,327.20

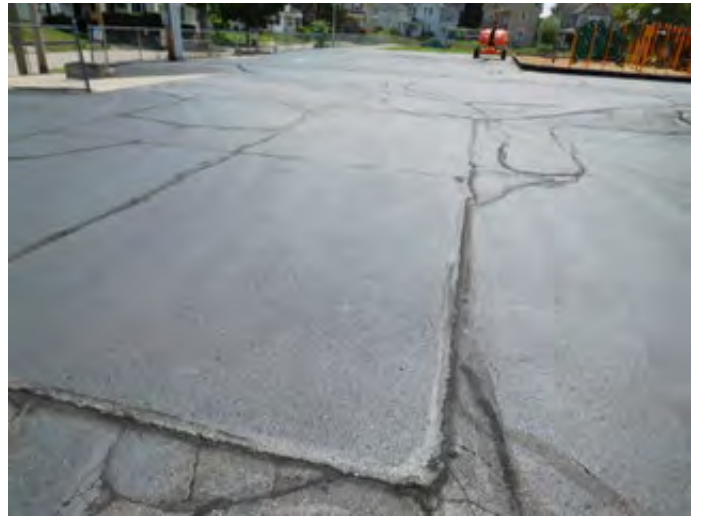
Typical Condition of Asphalt

Other: Basketball Backboards	\$500.00	each		2 Required		2 Required		\$1,000.00	Provide for replacement of exterior basketball backboards due to age and condition.
Other: Exterior Furnishings	\$600.00	each		5 Required	1 Required	5 Required	1 Required	\$3,600.00	Provide for exterior furnishings for an outdoor learning environment.
Sum:			\$231,753.86	\$222,207.73	\$9,546.13

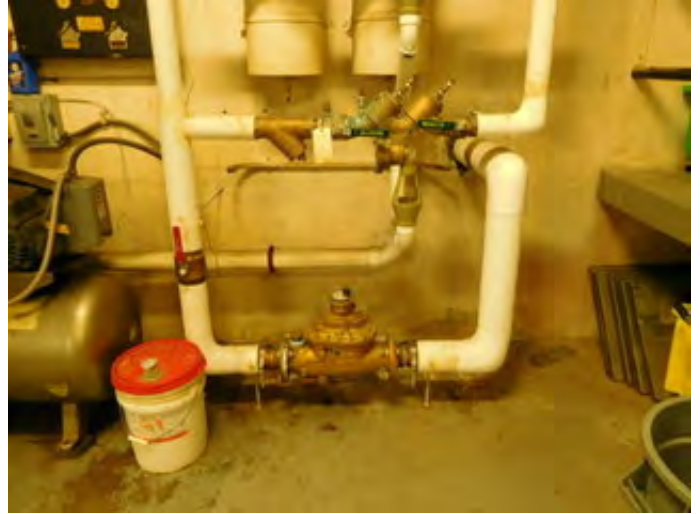
Incoming Domestic Water Service Line

Recommendations: Provide a new city water supply line of adequate capacity to support the existing needs of the facility, as well as a future automated fire suppression system. Funding provided in Item U.

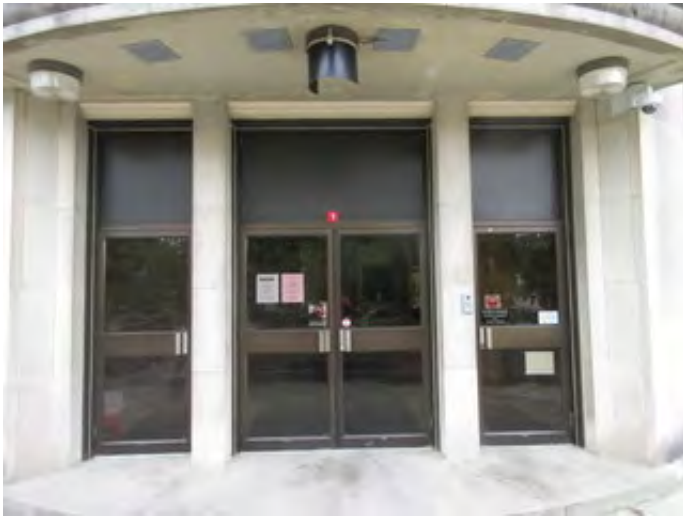
Main Entrance Doors

Recommendations: Replace the main entrance doors in the Original Construction. Replacement of the main entrance door transoms is addressed in Item F.

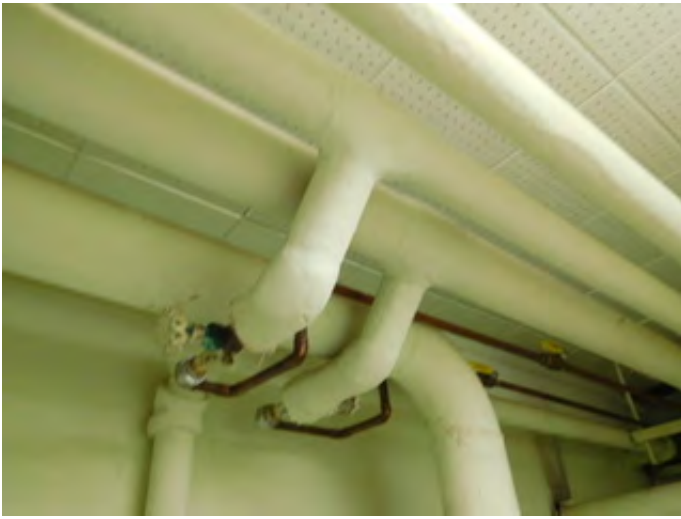
Mud Elbow Fittings and Pipe Insulation

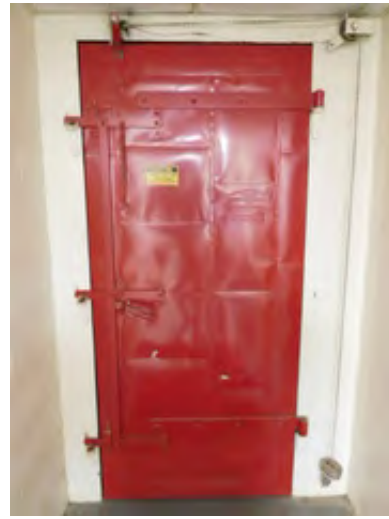
Fire Door

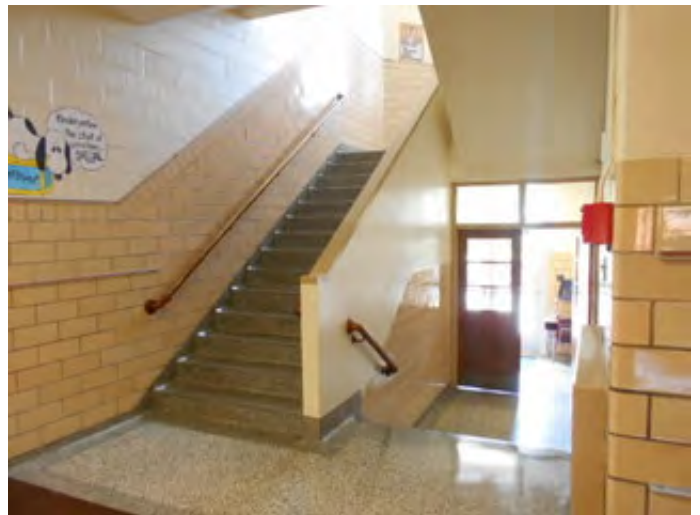
Non-Compliant Stair Tower

Item	Cost	Unit	Whole Building	Original Construction (1950)	Kitchen and Classroom Addition (1974)	Sum	Comments
Sprinkler / Fire Suppression System:	\$3.20	sq.ft. (Qty)		31,149 Required	1,636 Required	\$104,912.00	(includes increase of service piping, if required)
Interior Stairwell Closure:	\$5,000.00	per level		6 Required		\$30,000.00	(includes associated doors, door frames and hardware)
Handrails:	\$5,000.00	level		12 Required		\$60,000.00	
Provide Fire Extinguisher and Wall Cabinet:	\$585.00	each		1 Required		\$585.00	(includes preparation of wall to receive recessed cabinet)
Sum:			\$195,497.00	\$190,261.80	\$5,235.20
