**Building Information - Troy City (44925) - Troy High**

Program Type	Classroom Facilities Assistance Program (CFAP) - Regular
Setting	Small City
Assessment Name	Troy High School (37598) FINAL
Assessment Date (on-site; non-EEA)	2016-08-09
Kitchen Type	Full Kitchen
Cost Set:	2016
Building Name	Troy High
Building IRN	37598
Building Address	151 Staunton Road
Building City	Troy
Building Zipcode	45373
Building Phone	(937) 332.6710
Acreage	49.54
Current Grades:	9-12
Teaching Stations	73
Number of Floors	3
Student Capacity	1105
Current Enrollment	1369
Enrollment Date	2016-08-09
Enrollment Date is the date in which the current enrollment was taken.	
Number of Classrooms	65
Historical Register	<b>NO</b>
Building's Principal	Ms. Katherine Weaver
Building Type	High

Troy High School, which is not on the National Register of Historic Buildings, and originally constructed in 1958 is a three story, 237,430 square foot brick and stone school building located in a small town residential setting, on a school and community campus consisting of athletic facilities, parks, and community pool. The existing facility features a conventionally partitioned design, and does not utilize modular buildings. T

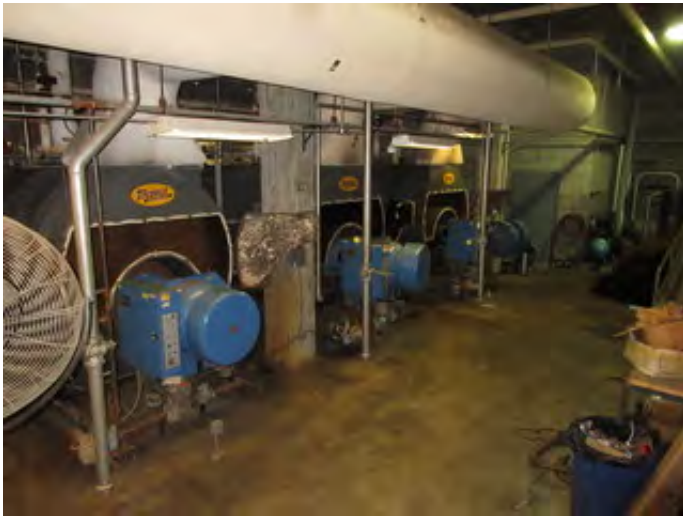
**Description:** The existing system for the 1958 Original Construction is a natural gas fired heated boiler type system, installed in 1958, and is in fair condition. The systems in the 1958 Auditorium Fixed Seating Area and 2006 Addition is an extension of that found in the 1958 Original Construction. 2-pipe vs. 4-pipe designations are not applicable in this facility, as no central air conditioning is provided. The (3) heated water boilers were manufactured by Titusville, were installed in 1958, and are in fair condition. Heating water is distributed to terminal units consisting of unit ventilators, fin tubes, cabinet heaters, unit heaters, air handlers, and roof top units. Some terminal equipment, specifically the roof top units, are electric fired. The terminal equipment is original to each addition and is in fair condition. The system does not appear to comply with the 15 CFM per person fresh air requirements of the Ohio Building Code mechanical code and Ohio School Design Manual. The pneumatic and DDC type system temperature controls are original to each addition with recent upgrades and are in fair condition. The system does not feature individual temperature controls in all spaces required by the OSDM. The overall system does not feature any central energy recovery systems. The facility is not equipped with louvered interior doors to facilitate Corridor utilization as return air plenums. The existing system is ducted, but the ductwork cannot be integrated into a possible future system due to arrangement, air volume, and routing of existing ductwork. The overall heating system is evaluated as being in safe but inefficient working order, and long term life expectancy of the existing system is not anticipated. The structure is not equipped with central air conditioning. The site does not contain underground fuel tanks.

Natural Gas Fired Heated Water Boilers

**Recommendations:** Provide new overall heating, ventilating, and air conditioning system to achieve compliance with Ohio Building Code and Ohio School Design Manual standards. Replace existing ductwork to facilitate efficient exchange of conditioned air.

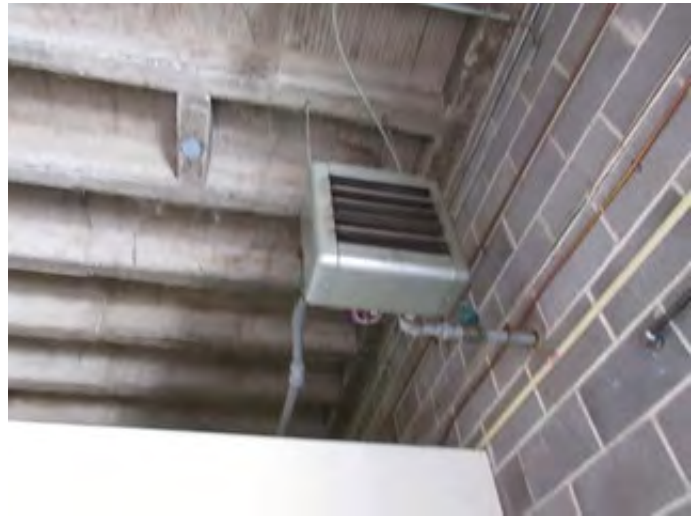
Unit Heater

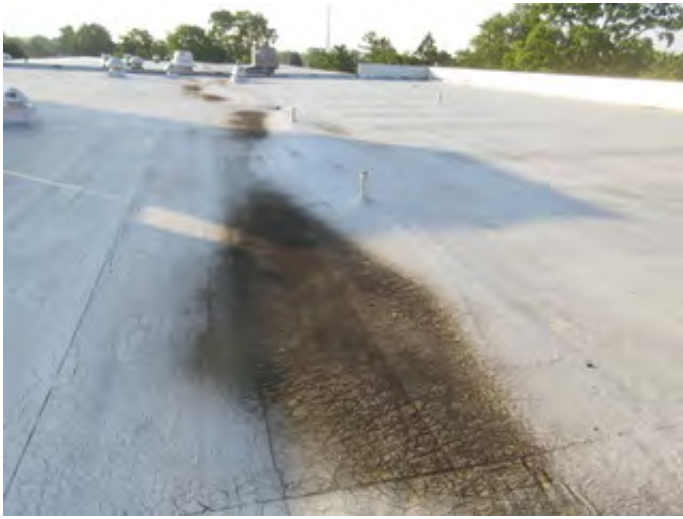
**Description:** The roof over portions of the Original Construction is a modified bitumen system by Tremco that was installed in phases between 2003 through 2008, is under a 15-year warranty, and is in fair to poor condition. There are District reports of current leaking. Blisters form in the roofing system and burst. Burst blisters adjacent to seams cause leaks. Signs of past leaking were observed during the physical assessment. The roof over the other portions of the Original Construction is an EPDM system by Firestone that was installed in phases between 2014 through 2016, is under a 20-year warranty, and is in good condition. Access to the roof was gained by access hatches, access ladders, and an access door that are in fair condition. Some low roof areas were not accessible. Fall safety protection cages are not required for most ladders, and are not provided. One ladder does require a safety protection cage, but is not provided. The roof over the 2006 Gymnasium & Classroom Addition is a modified bitumen system by Tremco that was installed in 2006, is under a 20-year warranty, and is in poor condition. There are District reports of current leaking. Blisters form in the roofing system and burst. Burst blisters adjacent to seams cause leaks. Signs of past leaking were observed during the physical assessment. Access to the roof was gained by access hatch and access ladder that are in good condition. Fall safety protection cages are required, have been provided, and are compliant, in good condition. There were observations of standing water on the roof. Metal cap flashings and copings are in fair to poor condition. Roof storm drainage is addressed through a system of gutters and downspouts, roof drains, and through-wall scuppers, which are properly located, and in fair to poor condition. The roof is equipped with overflow roof drains, though not in sufficient quantities. No problems requiring attention were encountered with any roof penetrations. There is a covered walkway attached to this structure. The 2006 Gymnasium & Classroom Addition has a covered walkway leading from the parking lot to the main entrance, made of standing seam metal, and in good condition.

Typical Tremco Roofing

**Recommendations:** The roof over the Tremco portions of the Original Construction and the 2006 Gymnasium & Classroom Addition requires replacement to meet Ohio School Design Manual guidelines due to condition and age of system and projected lifecycle. The flashing and / or coping over the Tremco portions of the Original Construction and 2006 Gymnasium & Classroom Addition require replacement due to condition and age of system and projected lifecycle. Due to existing conditions gutters and downspouts require replacement at portions of the Original Construction. Due to existing conditions three roof drains require replacement in the Original Construction. Provide five overflow drains for required areas in the Original Construction. Provide a safety protection cage for one ladder in the Original Construction. Provide five ladders for inaccessible low roof areas in the Original Construction. Install insulation in areas where the roof is being replaced throughout the overall facility.

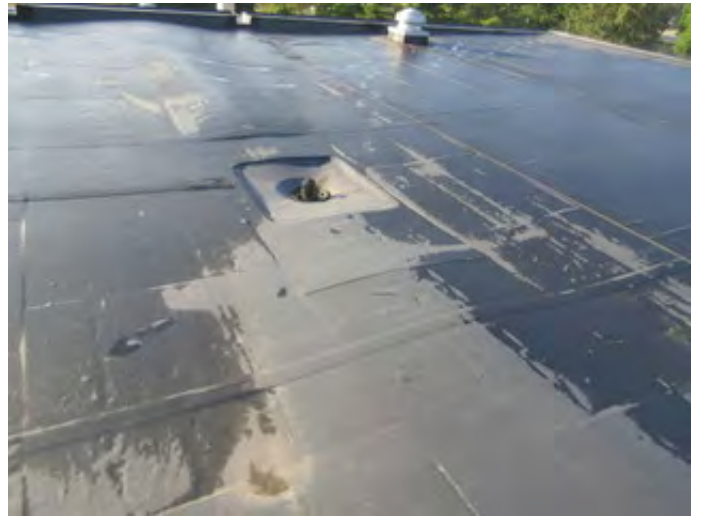
Typical EPDM Roofing

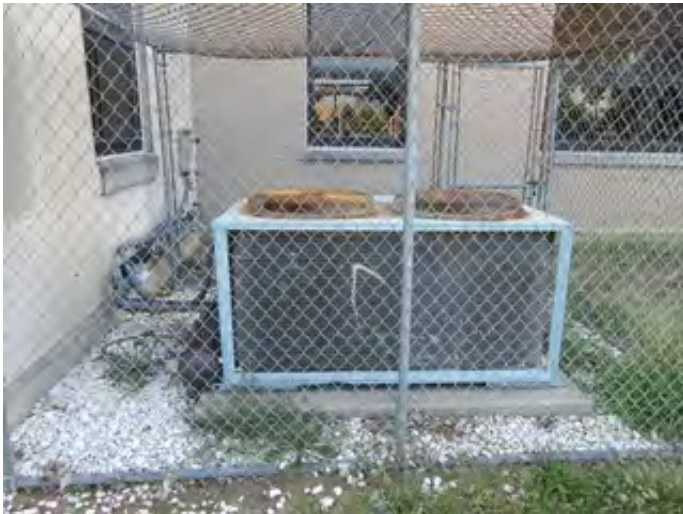
**Description:** The overall facility is not equipped with a central air conditioning system. Window units are present in multiple locations in the overall facility. Isolated room systems consisting of ducted packaged and split roof top HVAC units (with condensing units pad-mounted on the ground and roof) are located in the multiple locations throughout the overall facility. The ventilation system in the overall facility consists of unit ventilators, original to each addition and in fair condition, providing fresh air to Classrooms and air handlers, original to each addition and in fair condition, providing fresh air to other miscellaneous spaces such as the Gymnasium, Media Center, and Student Dining. Relief air venting is provided by unit ventilators, transfer grilles to corridors, central relief fans, and air handlers. The ventilation system does not appear to meet the Ohio Building Code 15 CFM per occupant fresh air requirement. The overall system is not compliant with Ohio Building Code and Ohio School Design Manual requirements. Dust collection systems are not required in this facility. The Art program is equipped with a kiln and the kiln ventilation system is inadequate. General building exhaust systems for Restrooms, Storage Rooms, Art Rooms, and Custodial Closets do not appear to be inadequately placed, and in fair condition.

Ducted Split HVAC Condensing Units

**Recommendations:** Provide an air conditioning system to meet with Ohio Building Code and Ohio School Design Manual requirements. Replace general building exhaust systems located in Restrooms, Storage Rooms, Art Rooms, and Custodial Closets. Pricing included in Item A. Provide the Art program with a kiln ventilation system to meet Ohio Building Code and Ohio School Design Manual requirements.

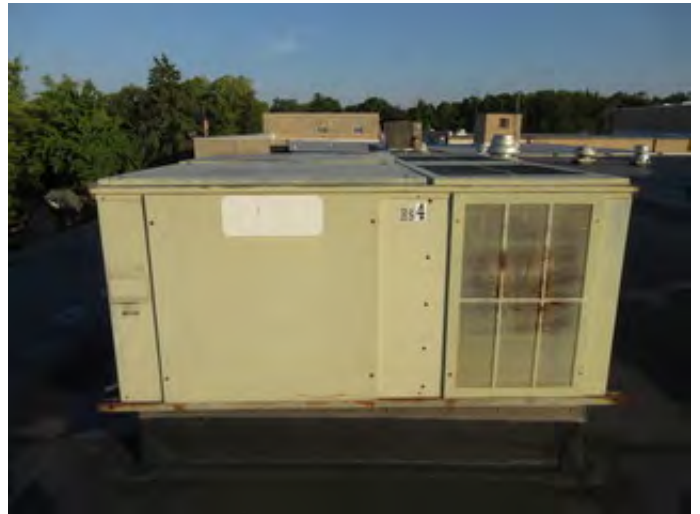
Packaged Roof Top Unit

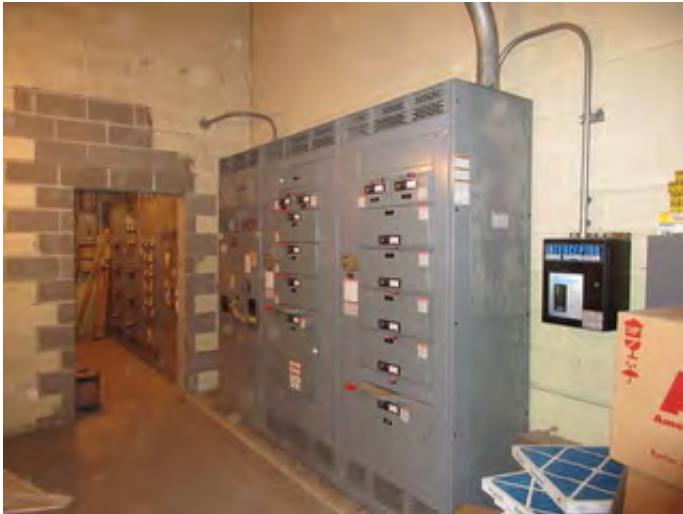
**Description:** The electrical system provided to the 1958 Original Construction is a 208Y/120 volts, 2,000 amp, 3 phase and 4 wire system installed in 1958 with upgrades in 1974, and is in fair condition. The system in the 1958 Auditorium Fixed Seating Area and 2006 Addition is an extension of that found in the 1958 Original Construction. Power is provided to the school by multiple utility owned, pad-mounted transformers located outside the Weight Room and Auxiliary Gymnasium, and are in fair condition. The Square D panel systems, original to each addition, are in fair condition, and for the most part cannot be expanded to add additional capacity. The Classrooms are not equipped with adequate electrical outlets. The typical Classroom contains (7) general purpose outlets, (0) dedicated outlets for each Classroom computer, and (1) dedicated outlet for each Classroom television. Some Classrooms are equipped with as many as (8) general purpose outlets, while others are equipped with as few as (6) general purpose outlets. There are not any spaces that have no electrical outlets. The Corridors appear to be equipped with adequate electrical outlets for servicing. Adequate GFI protected exterior outlets are not provided around the perimeter of the building. The facility is not equipped with an emergency generator. Adequate lightning protection safeguards do not appear to be provided. Stage lighting power system including control panel, breakers, and dimmers is inadequately provided, in fair condition and does not meet OSDM requirements. The overall electrical system does not fully meet Ohio School Design Manual requirements in supporting the current needs of the school, and will be inadequate to meet the facility's future needs.

Main Electrical Distribution Panel

**Recommendations:** The entire electrical system requires replacement to meet Ohio School Design Manual guidelines for overall capacity and due to age, condition, lack of OSDM-required features, and to accommodate the addition of an air conditioning system. Provide an emergency generator, with funding included in the electrical system replacement. Provide adequate lightning protection safeguards in the overall facility, including associated grounding system, with funding included in the electrical system replacement. Provide control panel, dimmers, and breakers to support the Stage lighting system, with funding included in the electrical system replacement.

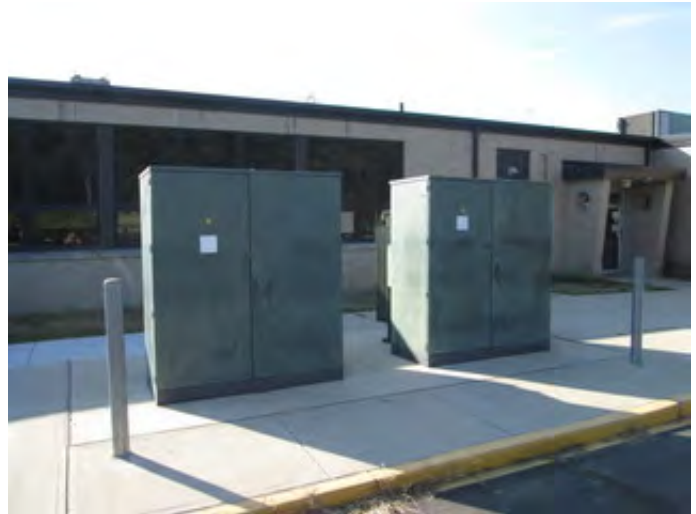
Pad Mounted Transformers

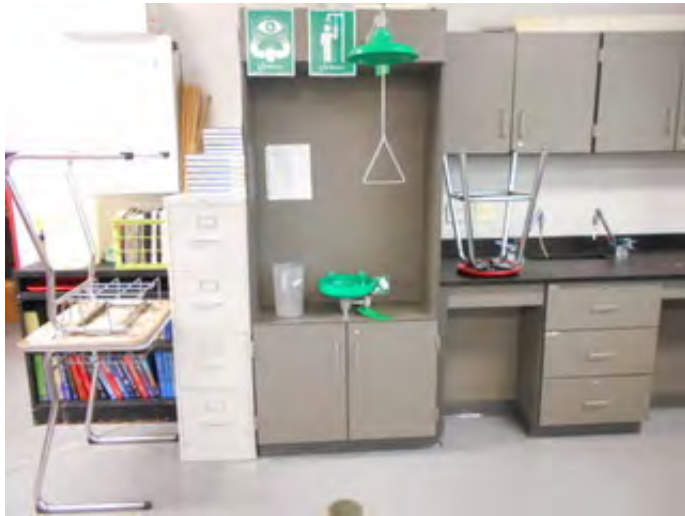
Emergency Shower and Eyewash-2006 Addition

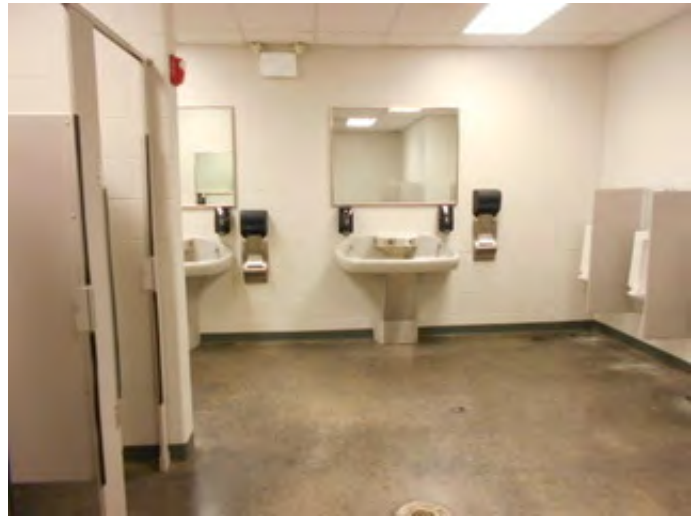
Large Group Restroom-Boys-2006 Addition

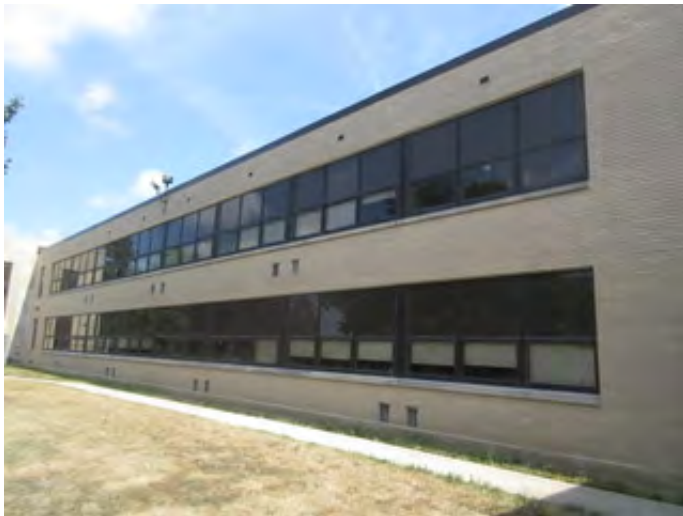
**Description:** The Original Construction is equipped with thermally broken aluminum frame windows with insulated glazing type window system, which was installed at an unknown date, and is in fair to poor condition. The window system features operable windows throughout the building, and operable windows not equipped with opening limiters and insect screens. Window system seals are in fair to poor condition, with no or minimal air and water infiltration being experienced. Window system hardware is in fair to poor condition. The window system features surface mounted blinds, which are in fair condition, or no blinds. This facility is not equipped with any curtain wall systems. This facility does not feature any glass block windows. The 2006 Gymnasium & Classroom Addition is equipped with thermally broken aluminum frame windows with insulated glazing type window system, which was installed in 2006, and is in good condition. The window system features operable windows throughout the building, and operable windows are not equipped with opening limiters, but do have insect screens in good condition. Window system seals are in good condition, with no air and water infiltration being experienced. Window system hardware is in good condition. The window system features integral blinds, which are in good condition. This facility is not equipped with any curtain wall systems. This facility does not feature any glass block windows. The exterior doors in the Original Construction are equipped with aluminum sidelights and transoms with single pane glazing, in poor condition. Exterior door vision panels are single pane glazing. The exterior doors in the 2006 Gymnasium & Classroom Addition are equipped with thermally broken aluminum frame sidelights and transoms with tempered insulated glazing, in good condition. Exterior door vision panels are tempered insulated glazing. The school does not contain any skylights. The 2006 Gymnasium & Classroom Addition does contain four translucent panel type clerestories, and clerestory windows are in good condition. Interior glass is OSDM-compliant. Window security grilles are not provided for ground floor windows. There is not a Greenhouse associated with this school.

Typical Aluminum Windows of the Original Construction

**Recommendations:** Replace the existing window system in the Original Construction with a new insulated window system to match existing insulated system and comply with Ohio School Design Manual requirements. Replace window transoms and sidelights at exterior doors of the Original Construction. Caulk perimeter of window panels to remain in the Original Construction. Exterior door vision panel replacement is addressed in Item S in exterior door replacement scope.

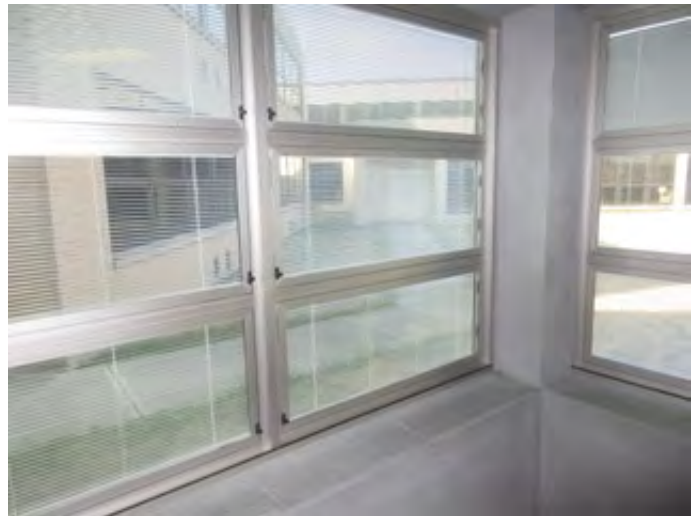
Typical Windows with Integral Blinds in the 2006 Gymnasium & Classroom Addition

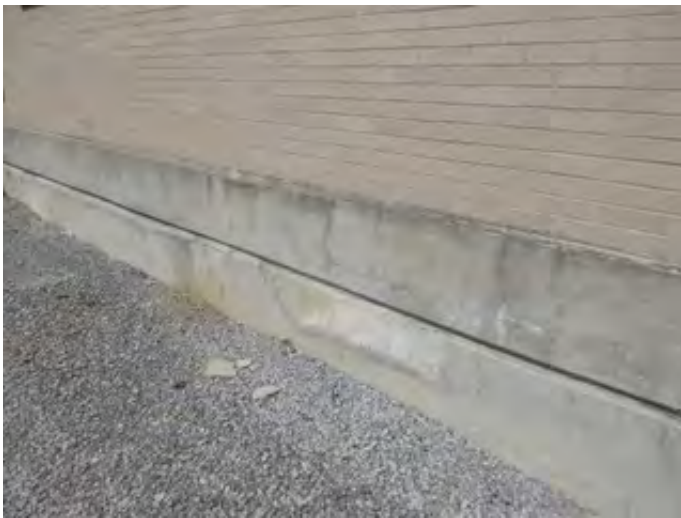
**Description:** The Original Construction is equipped with concrete foundation walls on concrete footings, which displayed no locations of significant differential settlement, cracking, or leaking, and are in good to fair condition. Areas of minor cracking and spalling were observed through the Original Construction. The 2006 Gymnasium & Classroom Addition is equipped with concrete masonry unit foundation walls on concrete footings, which displayed no locations of significant differential settlement, cracking, or leaking, and are in good condition. No significant issues related to foundation cracking or spalling were encountered. The District reports that there has been minor past leaking in the Mechanical Room basement below the Kitchen. No grading or site drainage deficiencies were noted around the perimeter of the structure that are contributing or could contribute to foundation / wall structural deterioration.

Minor Foundation Repair

**Recommendations:** Repair areas of cracking and spalling through the Original Construction.

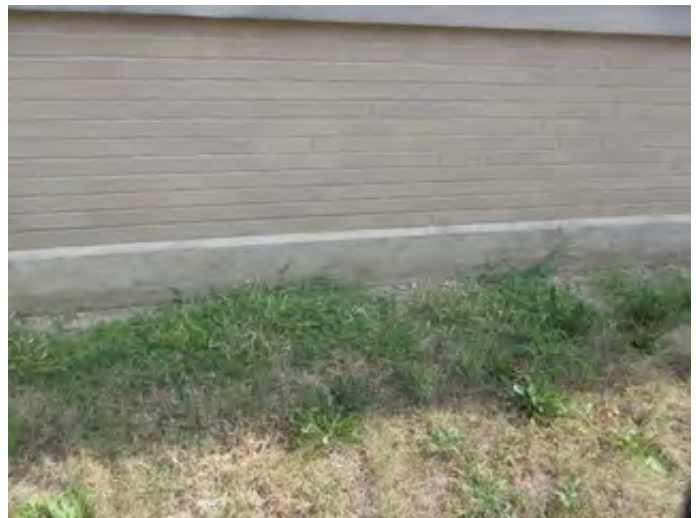
Typical Foundation

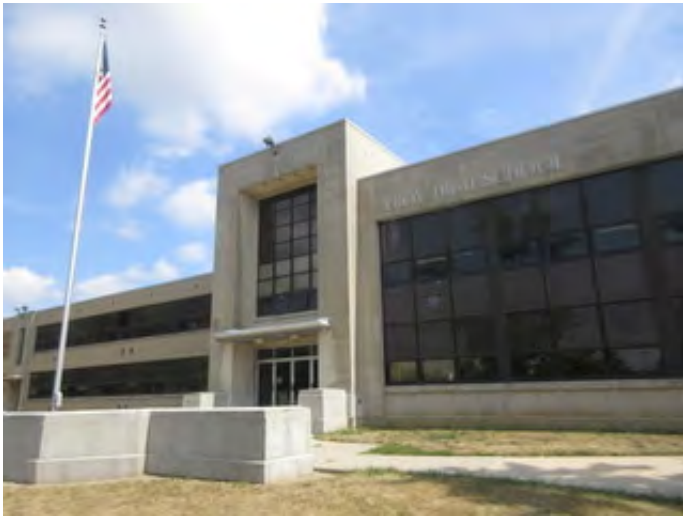
Stone Accent at Entrance

**Recommendations:** Provide minor tuckpointing in all areas of mortar deterioration as required in the Original Construction. Provide masonry cleaning and sealing as required through the overall facility. Recaulk existing control and expansion joints through the overall facility. Exterior wall insulation deficiencies are addressed in Item J. Infill masonry openings from removed unit ventilators. Replace the loading dock bumper pads.

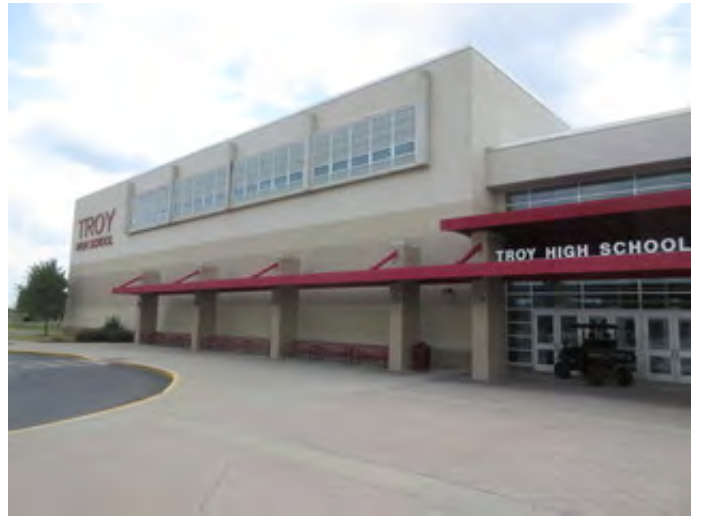
Exterior Facade of the 2006 Gymnasium & Classroom Addition

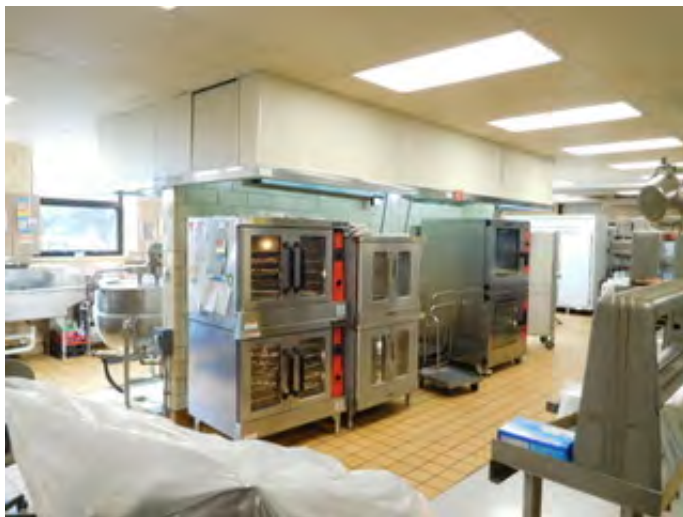
Kitchen Hood

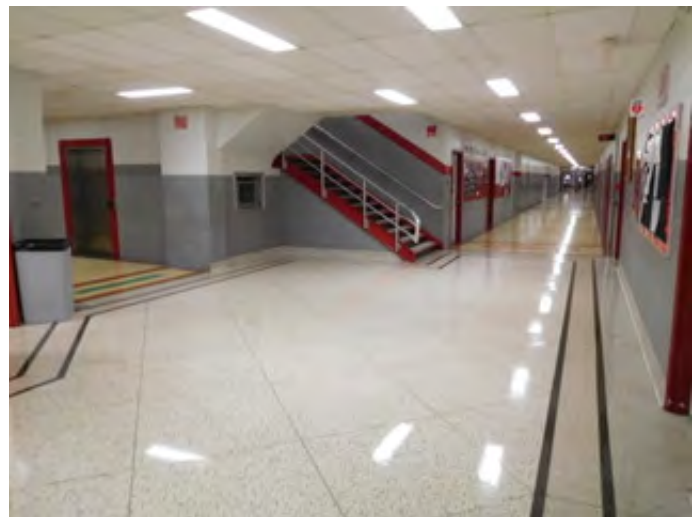
Typical Corridor Finishes

**Recommendations:** Provide complete replacement of finishes and casework in the 1958 Original Construction, excluding renovated areas in 2006, due to age, condition and installation of systems outlined in Items A, C, D, E, I, K, L, M, N, T, U, and W. Provide for the replacement of interior doors in the 1958 Original Construction due to age and condition. Provide for the replacement of Kitchen equipment due to age and condition. Provide for the replacement of walk-in cooler and freezers due to age and condition. Provide for the replacement of the Kitchen hood due to age and condition. Provide for replacement or Art program kilns due to age and condition, with funding for proper exhaust provided in Item C. Provide for Stage equipment allowances due to age. Provide for additional wall insulation. Provide for terrazzo flooring repair due to age and condition. Provide for the replacement of toilet accessories. Provide for appropriate sound attenuation acoustical surface treatments in the Primary and Auxiliary Gymnasium, Student Dining, and Media Center. Remove Corridor transfer grilles, fill voids, and coordinate with adjacent finishes. Provide for the replacement of Hard Plaster, Gypsum Board, and Laboratory Counter tops due to work in Item T. Funding for the replacement of resilient flooring and acoustical ceiling tile due to work in item T is provided for in Complete Replacement of Finishes.

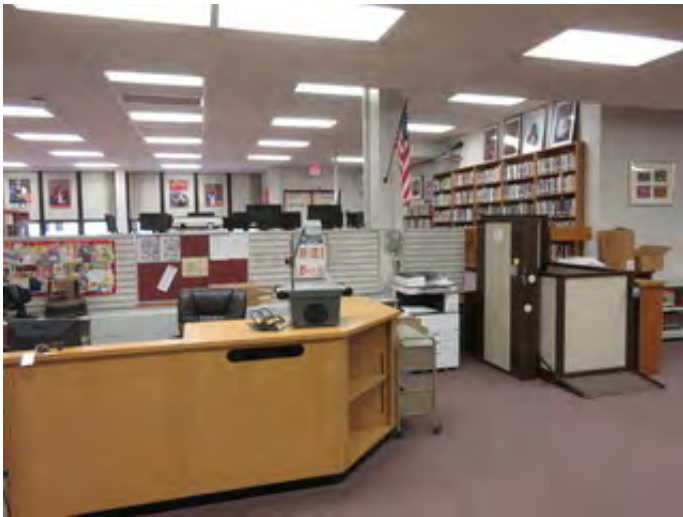
Media Center Fluorescent Light Fixtures

**Recommendations:** Provide complete replacement of lighting system due to age, condition, lighting levels, lack of multilevel switching, utilization of incandescent, and installation of systems outlined in Items A, C, J, and U.

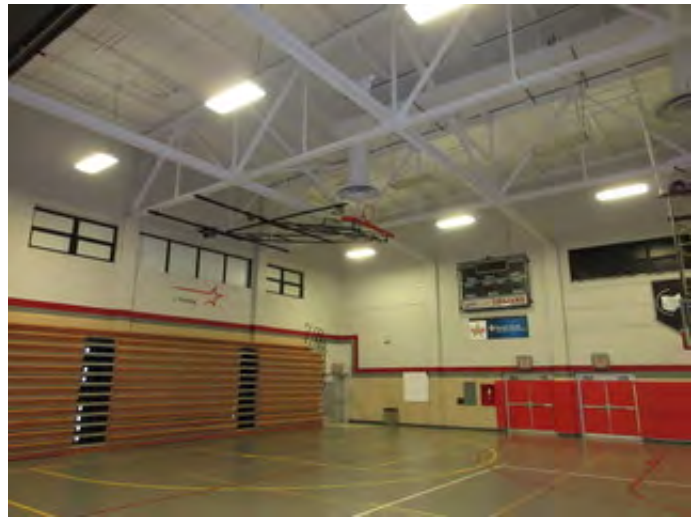
Auxiliary Gymnasium Fluorescent Light Fixtures

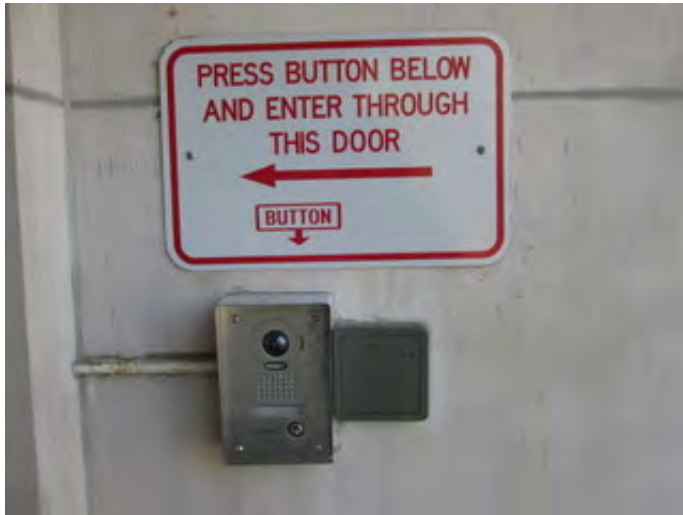
Security System Visitor Control System

**Recommendations:** Provide complete replacement of security system to meet Ohio School Design Manual guidelines. Provide complete replacement of exterior site lighting system to meet Ohio School Design Manual guidelines.

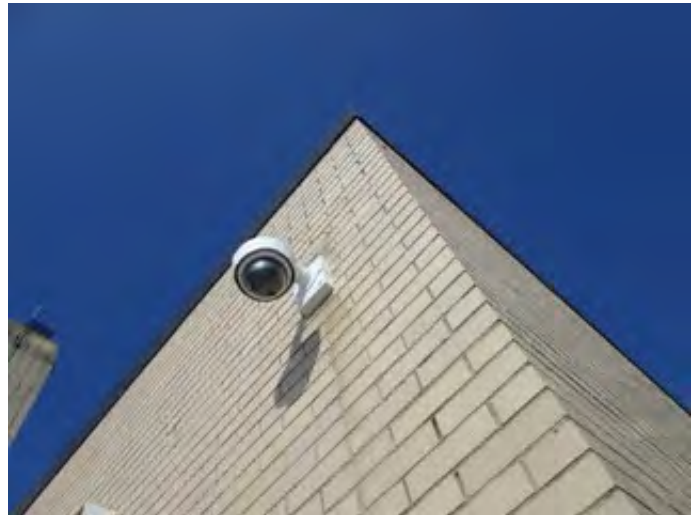
Security System CCTV Camera

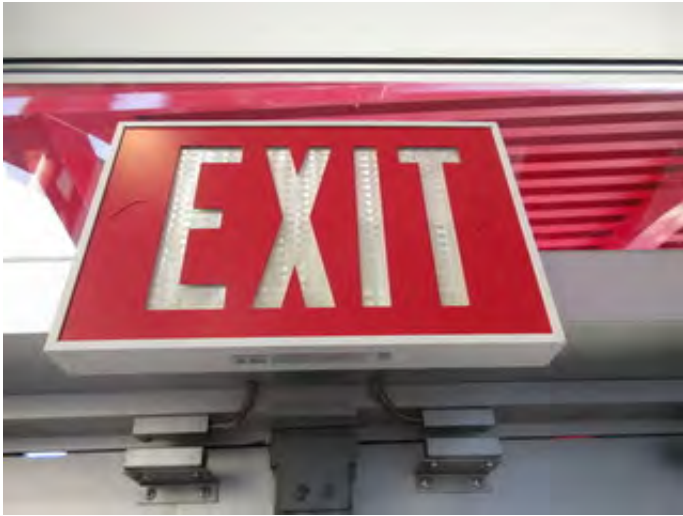
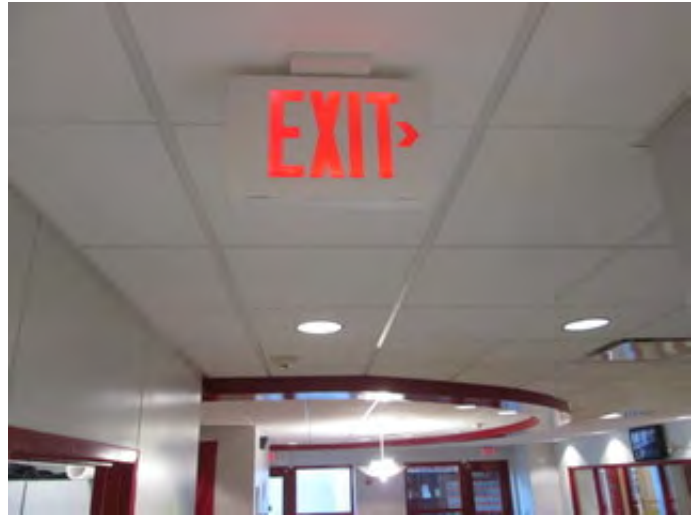
Exit Sign

**Recommendations:** Provide complete replacement of emergency / egress lighting system to meet Ohio School Design Manual and Ohio Building Code guidelines.

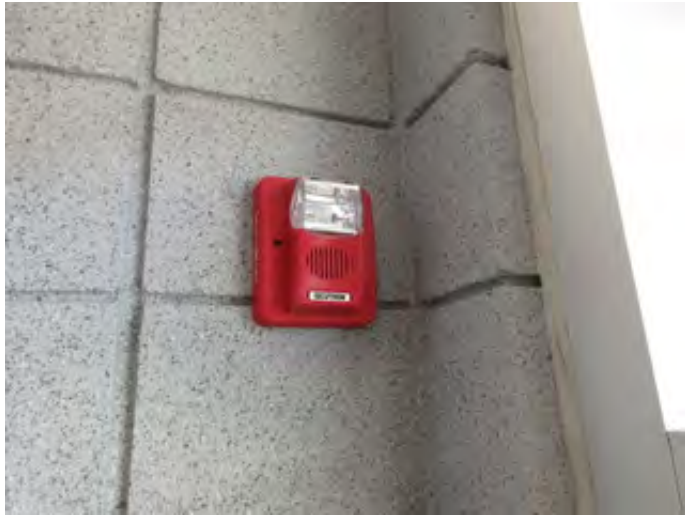
Fire Alarm System Audible Horn and Visual Strobe Indicating Device

**Recommendations:** Provide complete replacement of fire alarm systems to meet OBC, NFPA, and Ohio School Design Manual guidelines.

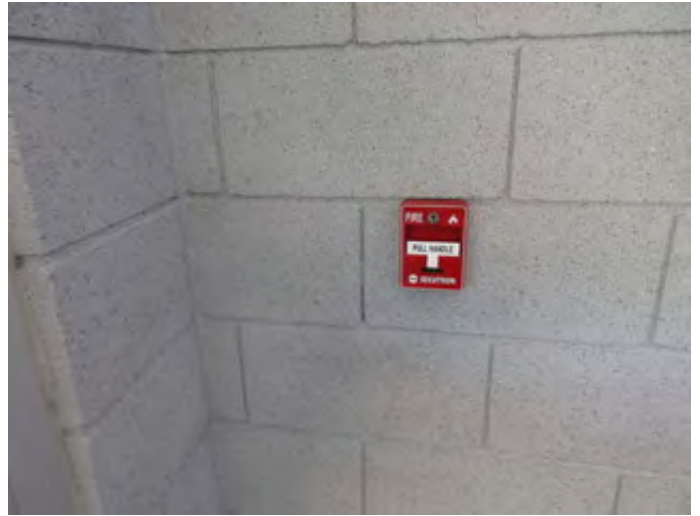
Fire Alarm System Manual Pull Station

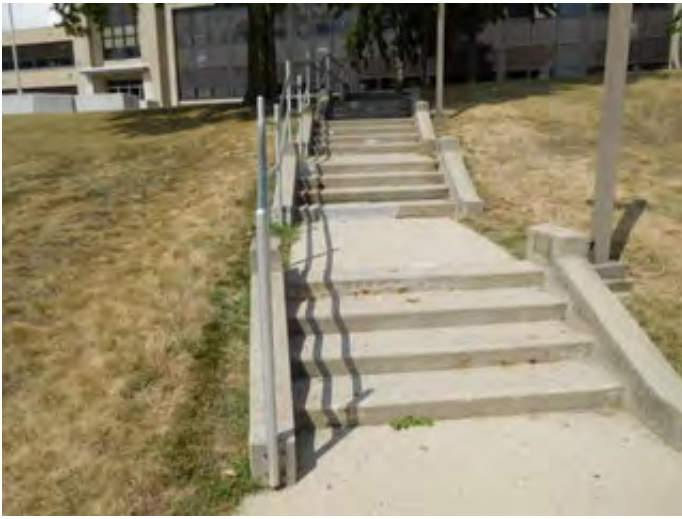
Concrete Steps, Sidewalk, and Handrails

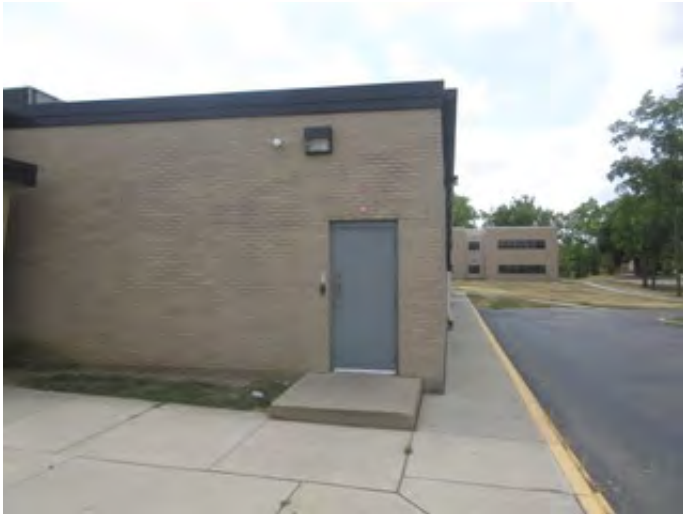
Typical Exterior Door

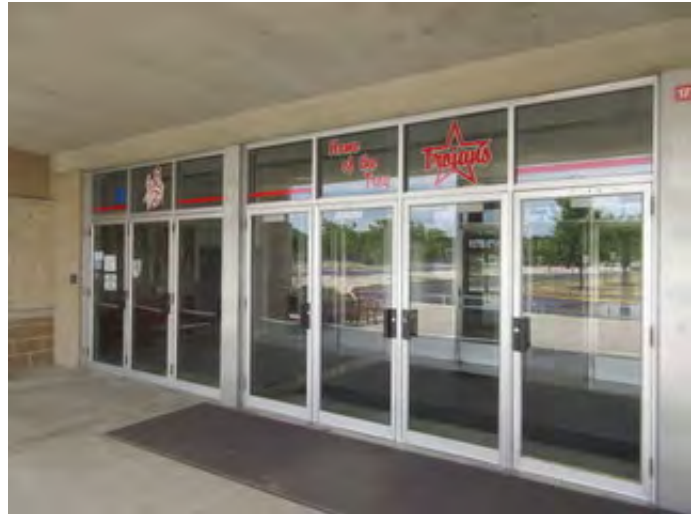
Entrance Doors of the Original Construction

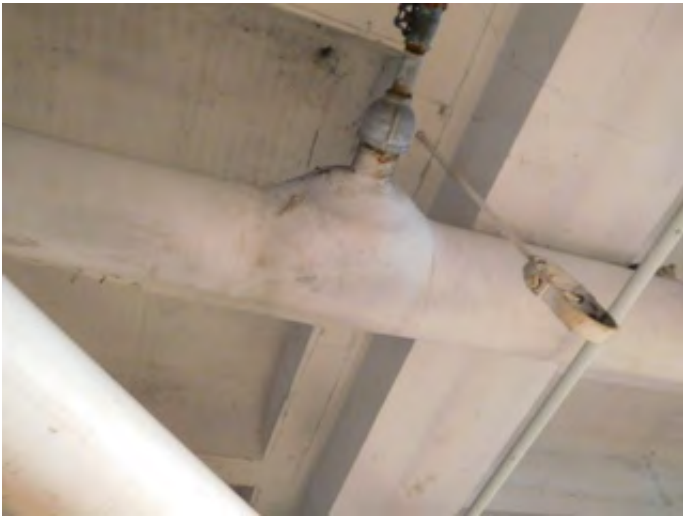
Mud Pipe Insulation

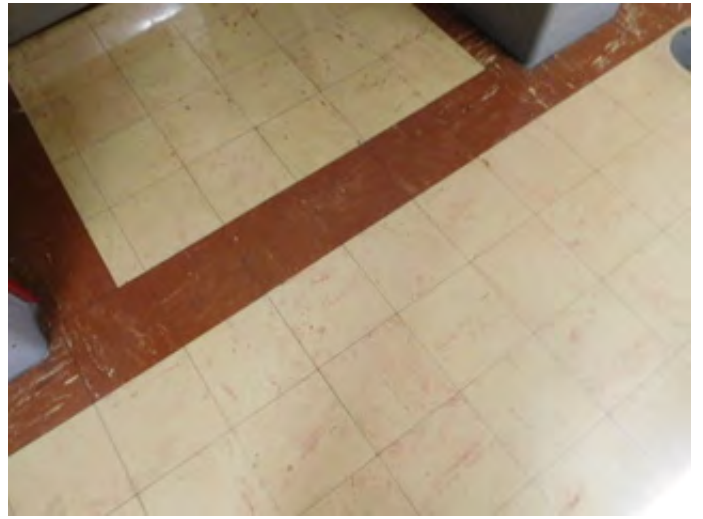
VAT Flooring

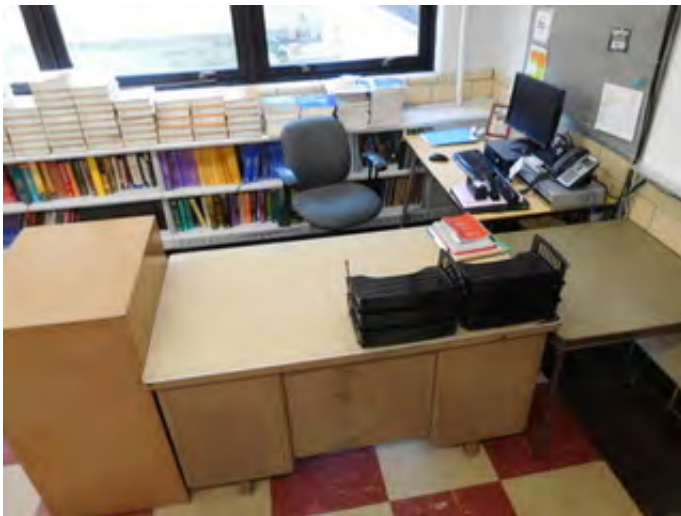
Typical Teacher Desk and Chair

**Recommendations:** Provide for replacement of outdated or inadequate furnishings in the 1958 Original Construction.

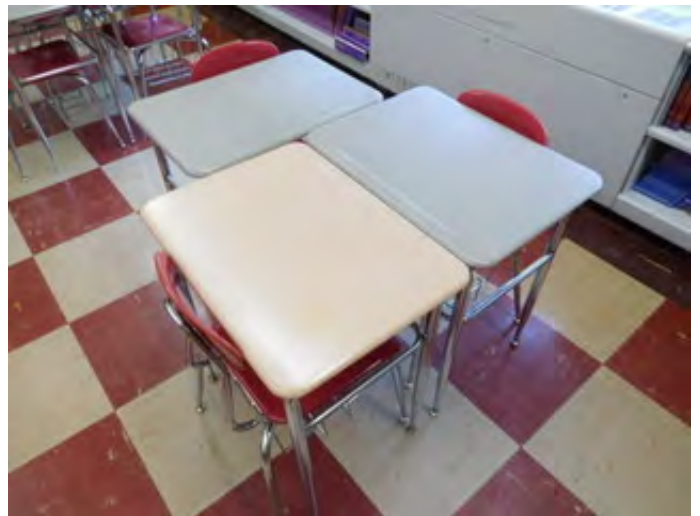
Typical Student Desk and Chair
