**Building Information - Troy City (44925) - Troy Junior High**

Program Type	Classroom Facilities Assistance Program (CFAP) - Regular
Setting	Small City
Assessment Name	Troy Junior High School (65292) FINAL
Assessment Date (on-site; non-EEA)	2016-08-06
Kitchen Type	Full Kitchen
Cost Set:	2016
Building Name	Troy Junior High
Building IRN	65292
Building Address	556 Adams Street
Building City	Troy
Building Zipcode	45373
Building Phone	(937) 332.6720
Acreage	49.54
Current Grades:	7-8
Teaching Stations	45
Number of Floors	2
Student Capacity	975
Current Enrollment	706
Enrollment Date	2016-08-06
Enrollment Date is the date in which the current enrollment was taken.	
Number of Classrooms	39
Historical Register	<b>NO</b>
Building's Principal	Mr. Dave Dilbone
Building Type	Middle

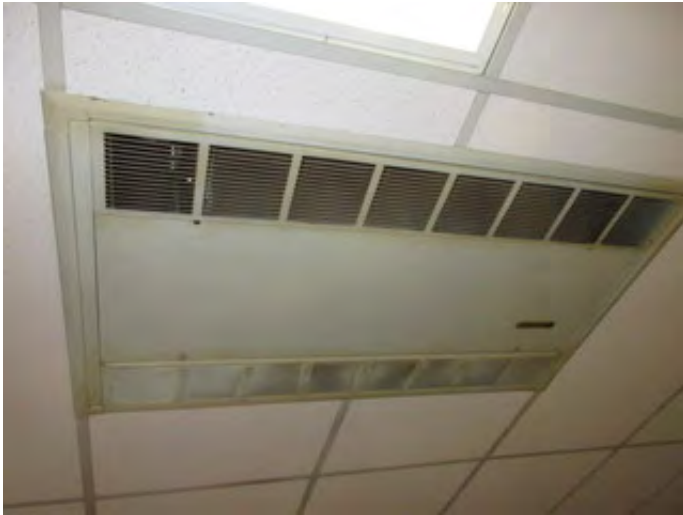
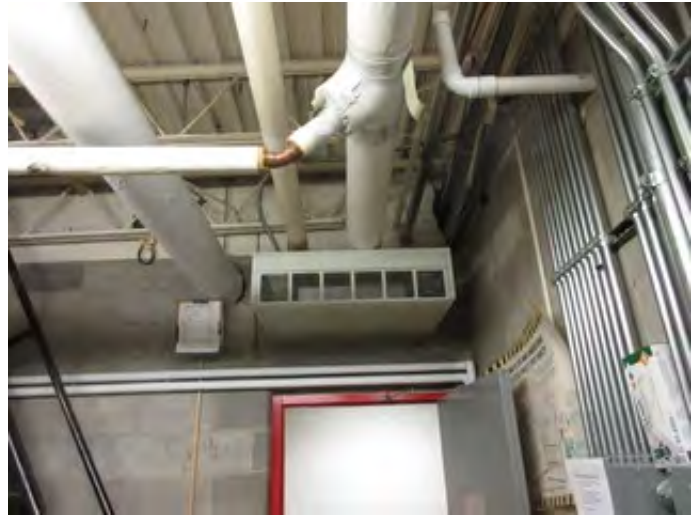
**Description:** The existing system for the overall facility is a natural gas fired ducted packaged roof top unit type heating system, installed in 1973, and is in fair condition. 2-pipe vs. 4-pipe designations are not applicable in this facility due to the central air condition system being a DX/refrigerant type cooling system. Heated air is distributed via multiple 20-ton multi-zone ducted packaged roof top units, manufactured by Carrier, installed in 1973, and in fair condition. The system does not appear to comply with the 15 CFM per person fresh air requirements of the Ohio Building Code mechanical code and Ohio School Design Manual. The electric and DDC type system temperature controls were installed in 1973 with upgrades in 1995 and are in fair condition. The system does not feature individual temperature controls in all spaces required by the OSDM. The overall system does not feature any central energy recovery systems. The facility is equipped with widespread louvered interior doors to facilitate Corridor utilization as return air plenums. The existing system is ducted, but the ductwork cannot be integrated into a possible future system due to arrangement, air volume, and routing of existing ductwork. The overall heating system is evaluated as being in safe but inefficient working order, and long term life expectancy of the existing system is not anticipated. The structure is equipped with central air conditioning. The site does not contain underground fuel tanks.

**Rating:** 3 Needs Replacement

Cabinet Heater

**Recommendations:** Provide new overall heating, ventilating, and air conditioning system to achieve compliance with Ohio Building Code and Ohio School Design Manual standards. Replace existing ductwork to facilitate efficient exchange of conditioned air.

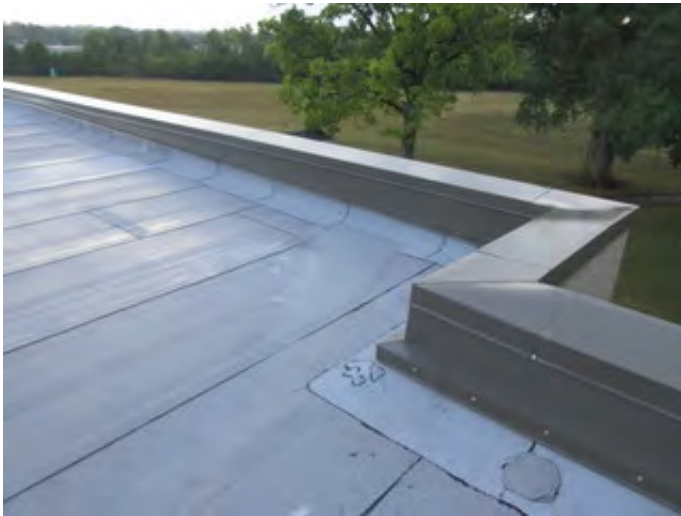
**Description:** The roof over the overall facility is a modified bitumen system that was installed in 2014, and is in good condition. There are no District reports of current leaking. No signs of past leaking were observed during the physical assessment. Access to the roof was gained by access hatch and access ladders that are in fair condition. Fall safety protection cages are not required, and are not provided. There were no observations of standing water on the roof. Metal cap flashings copings are in good condition. Roof storm drainage is addressed through a system of roof drains, which are properly located, and in good condition. The roof is equipped with overflow roof drains in sufficient quantity and in good condition. No problems requiring attention were encountered with any roof penetrations. There are not any covered walkways attached to this structure.

Typical Coping and Roofing

**Recommendations:** Existing conditions require no renovation or replacement at the present time.

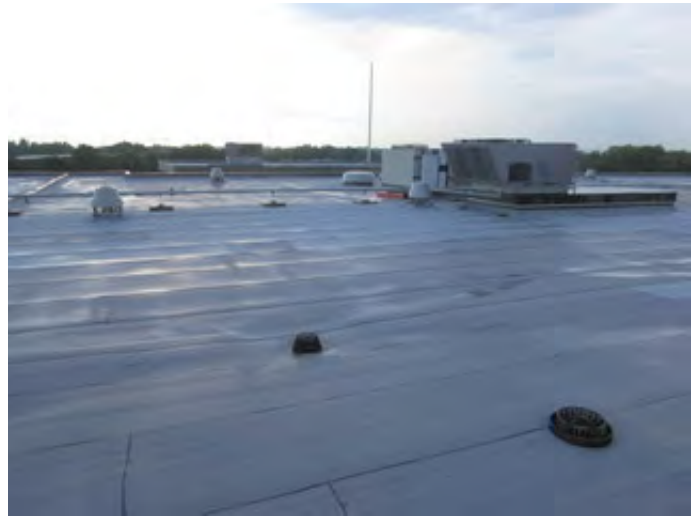
Typical Primary and Overflow Drains

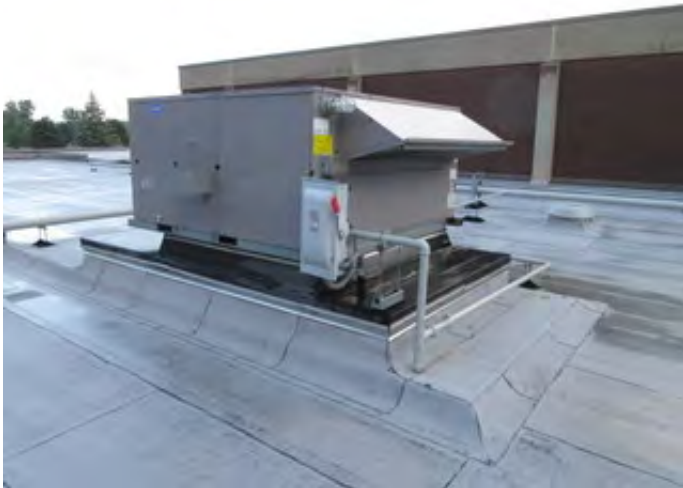
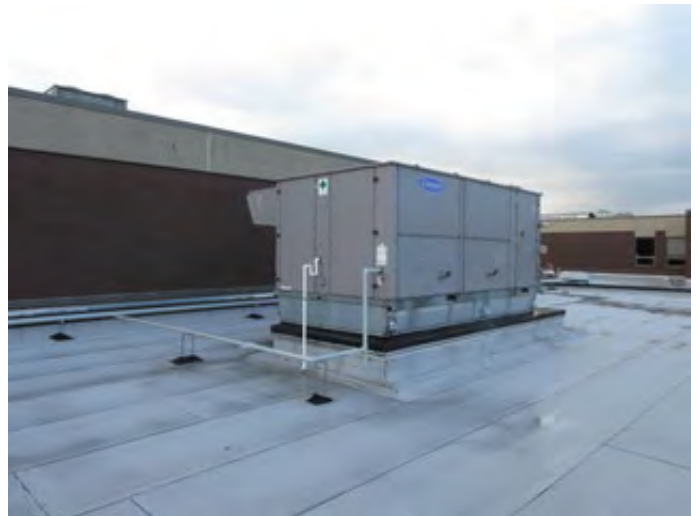
**Description:** The overall facility is equipped with an electric fired DX/refrigerant type central air conditioning system, installed in 1973, and in fair condition. The system consists of multiple 20-ton multi-zone ducted packaged roof top units, manufactured by Carrier, installed in 1973, and in fair condition. Window units and isolated room systems are not present in the overall facility. The ventilation system in the overall facility consists of multiple roof top units, installed in 1973 and in fair condition, providing fresh air to Classrooms, and other miscellaneous spaces such as Gymnasiums, Student Dining, and Media Center. Relief air venting is provided by louvered interior doors, ceiling plenums, and the RTUs. The ventilation system does not appear to meet the Ohio Building Code 15 CFM per occupant fresh air requirement. The overall system is not compliant with Ohio Building Code and Ohio School Design Manual requirements. Dust collection systems are not required in this facility. The Art program is equipped with a kiln and the kiln ventilation system is inadequate. General building exhaust systems for Restrooms, Storage Rooms, Art Rooms, and Custodial Closets do not appear to be adequately placed, and in fair condition.

**Rating:** 2 Needs Repair

Carrier RTUs

**Recommendations:** Provide an air conditioning system to meet with Ohio Building Code and Ohio School Design Manual requirements. Replace general building exhaust systems located in Restrooms, Storage Rooms, Art Rooms, and Custodial Closets. Pricing included in Item A. Provide the Art program with a kiln ventilation system to meet Ohio Building Code and Ohio School Design Manual requirements.

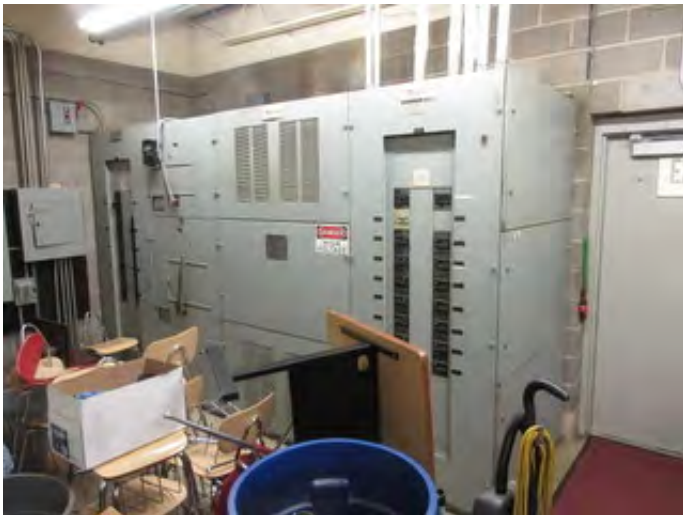
**Description:** The electrical system provided to the overall facility is a 277/480 volts, 3,000 amp, 3 phase and 4 wire system installed in 1973, and is in fair condition. Power is provided to the school by a single utility owned, pad-mounted transformer located outside the Mechanical Room, and in fair condition. The Arrow Hart Continental Division panel system, installed in 1973, is in fair condition, and for the most part cannot be expanded to add additional capacity. The Classrooms are not equipped with adequate electrical outlets. The typical Classroom contains (5) general purpose outlets, (0) dedicated outlets for each Classroom computer, and (1) dedicated outlet for each Classroom television. Some Classrooms are equipped with as many as (6) general purpose outlets, while others are equipped with as few as (4) general purpose outlets. There are not any spaces that have no electrical outlets. The Corridors are equipped with adequate electrical outlets for servicing. Adequate GFI protected exterior outlets are not provided around the perimeter of the building. The facility is not equipped with an emergency generator. Adequate lightning protection safeguards are not provided. Stage lighting power system including control panel, breakers, and dimmers is inadequately provided, in fair condition and does not meet OSDM requirements. The overall electrical system does not fully meet Ohio School Design Manual requirements in supporting the current needs of the school, and will be inadequate to meet the facility's future needs.

**Rating:** 3 Needs Replacement

Main Electrical Distribution Panel

**Recommendations:** The entire electrical system requires replacement to meet Ohio School Design Manual guidelines for overall capacity and due to age, condition, lack of OSDM-required features, and to accommodate the addition of an air conditioning system. Provide an emergency generator, with funding included in the electrical system replacement. Provide adequate lightning protection safeguards in the overall facility, including associated grounding system, with funding included in the electrical system replacement. Provide control panel, dimmers, and breakers to support the Stage lighting system, with funding included in the electrical system replacement.

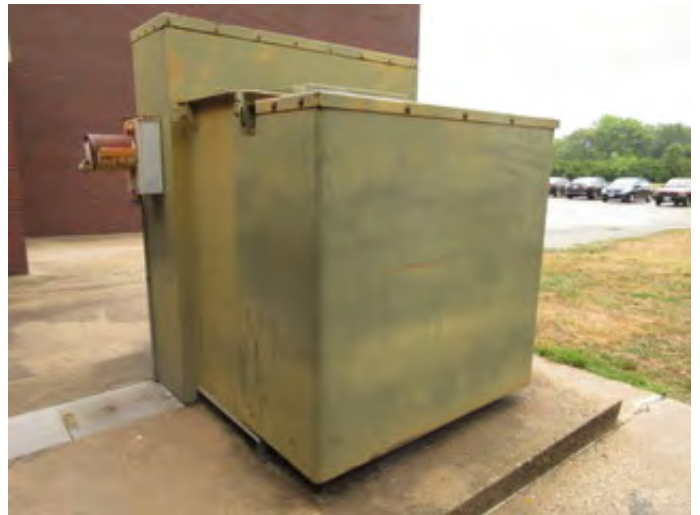
Pad Mounted Transformer

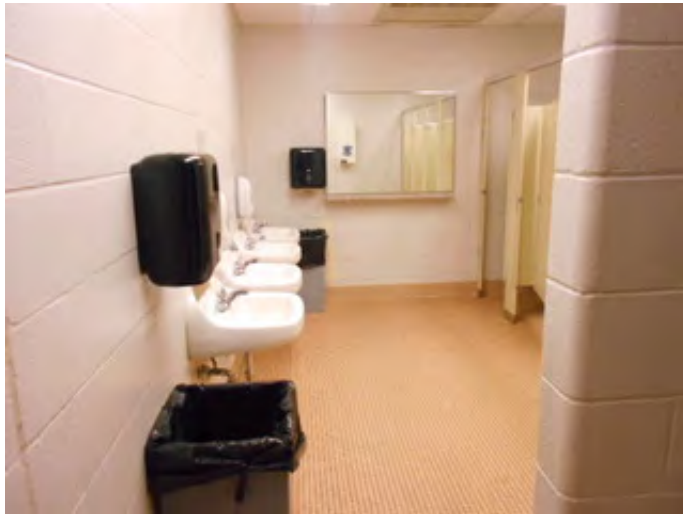
Large Group Restroom-Girl's

**Recommendations:** In the overall facility, replace the remaining galvanized steel domestic water piping and the remaining cast iron waste piping due to age and condition. Water treatment system is currently being installed. Due to age and condition and to facilitate the school's compliance with OBC and OSFC fixture requirements, in the overall facility, replace 29 toilets, 19 lavatories (include ADA compliant faucets), 5 urinals and 2 electric water coolers. Provide 2 additional electric water coolers. Due to age, condition, LEED, OBC and OSFC, replace 165 faucets and valves throughout the overall facility. Provide 1 in Classroom sink with deck mounted drinking fountain. Replace 2 shower towers in Boy's Locker Room. Shower towers to have 1 ADA compliant shower head. Provide (12) 4 station lab workstations with dual faucet/gas/compressed air connection combination. Provide 6 ADA compliant lab workstations. Provide 6 emergency safety shower/eyewash combinations. Provide 6 utility sinks. Provide 3 instructor prep/demo workstations with faucet/gas/compressed air connection combinations. Provide 6 point of use acid waste and neutralization tanks. All fixtures, whether new or replaced, to be mounted at ADA compliant heights. See Item O for replacement of fixtures related to ADA requirements, as well as reconfiguration of toilet stalls in Boys and Girls Locker Rooms and 1 stall in Girl's Restroom. Full reconfiguration of 4 Staff Restrooms and partial reconfiguration of 6 Staff Restrooms including 2 Staff Restrooms in the Locker Rooms and 2 Staff Restrooms in the Health Clinic. Funding for fixtures and equipment replacement in Kitchen is provided for in Item J. Water treatment system for Kitchen was recently installed; no funding is required.

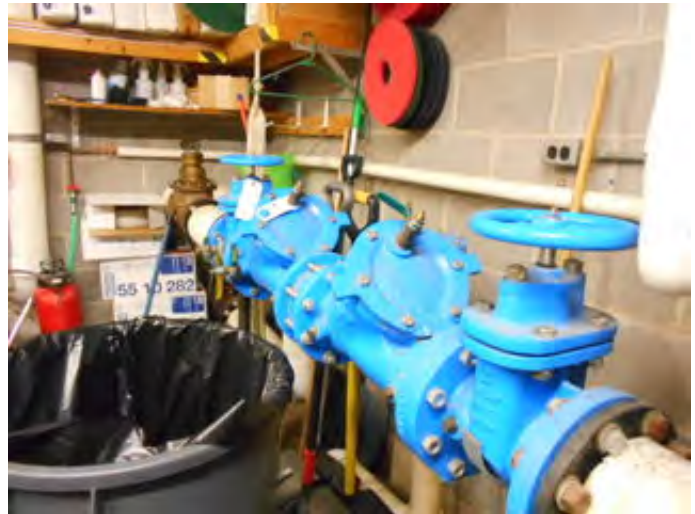
Reduced Pressure Backflow Preventer

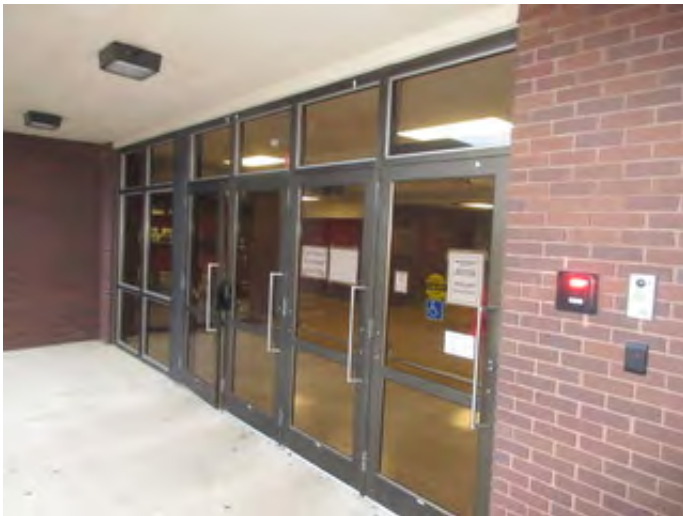
Typical Sidelights and Transoms

**Recommendations:** Provide a new insulated window system with integral blinds to meet with Ohio School Design Manual requirements. Replace window transoms and sidelights at exterior doors of the overall facility. Exterior door vision panel replacement is addressed in Item S in exterior door replacement scope.

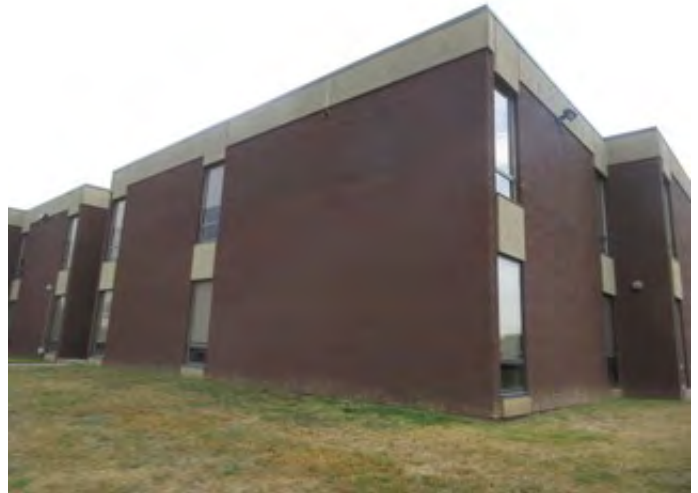
**Description:** The overall facility is equipped with aluminum frame windows with single glazed type window system, which was installed in 1973, and is in poor condition. The window system features operable windows throughout the building, and operable windows are not equipped with opening limiters and insect screens. Window system seals are in fair to poor condition, with moderate air and water infiltration being experienced. Window system hardware is in poor condition. The window system features no blinds. This facility is not equipped with any curtain wall systems. This facility does not feature any glass block windows. The exterior doors in the overall facility are equipped with aluminum frame sidelights and transoms with tempered single pane glazing, in poor condition. Exterior door vision panels are tempered single pane glazing. The school does not contain any skylights. The school does not contain any clerestories. Interior glass is OSDM-compliant. Window security grilles are not provided for ground floor windows. There is not a Greenhouse associated with this school.

**Rating:** 3 Needs Replacement

Typical Aluminum Windows

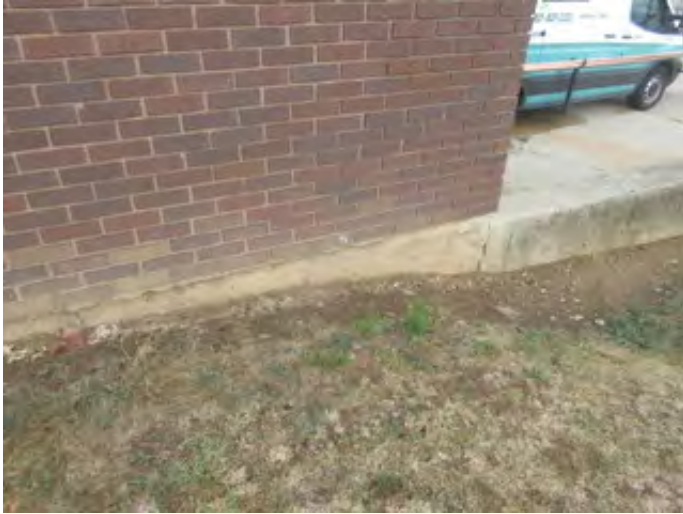
**Description:** The overall facility is equipped with concrete foundation walls on concrete footings, which displayed no locations of significant differential settlement, cracking, or leaking, and are in fair condition. Areas of minor cracking and spalling were observed through the overall facility. The District reports that there has been no past leaking. No grading or site drainage deficiencies were noted around the perimeter of the structure that are contributing or could contribute to foundation / wall structural deterioration.

Typical Concrete Foundation

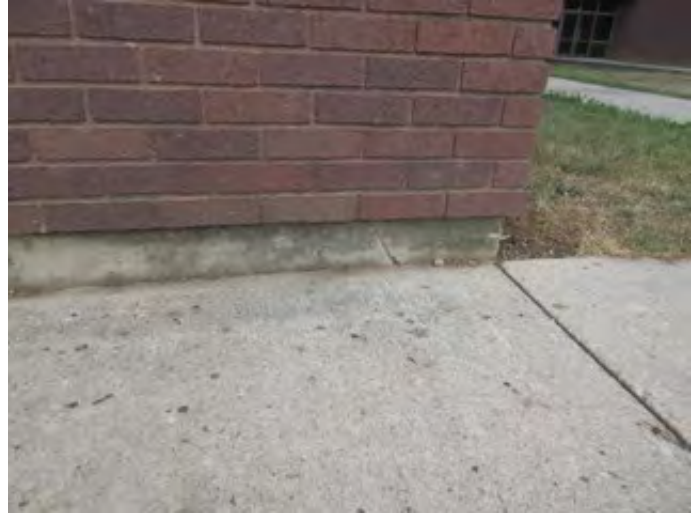
**Rating:** 2 Needs Repair

Minor Foundation Repair

**Recommendations:** Repair areas of minor cracking and spalling through the overall facility.

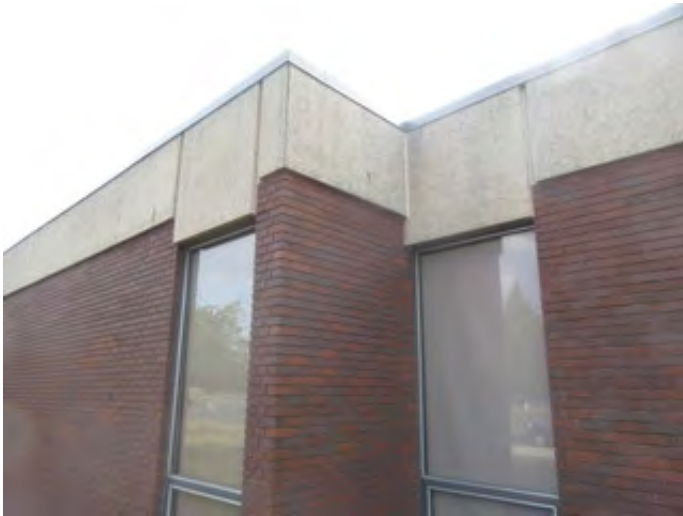
Precast Concrete Panels

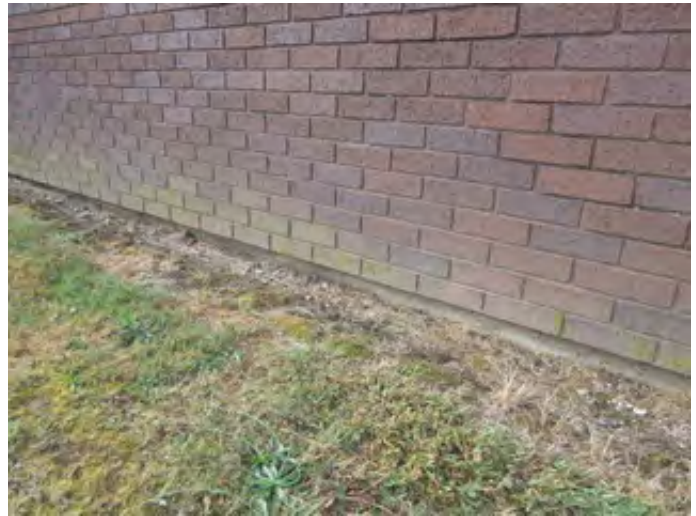
**Description:** The overall facility has a brick veneer on load bearing masonry wall system, which displayed minor locations of deterioration, and is in good to fair condition. The exterior masonry appears to have appropriately spaced and adequately caulked control joints in fair condition. Control joints are provided at lintel locations, at doors and windows, building corners, and wall offsets and are in fair condition. The school does have sufficient expansion joints, and they are in fair condition. Exterior walls in the overall facility are inadequately insulated. Brick veneer masonry walls are not cavity walls. Weep holes and vents are not provided or required. The exterior masonry has not been cleaned and sealed in recent years, and has locations of efflorescence and mold. Architectural exterior accent materials consist of precast concrete aggregate panels, which are in fair condition. Exterior building fenestration in the overall facility represents 10.71% of the exterior surfaces. Interior Corridor and demising walls are concrete masonry units and brick, project full height from floor to bottom of deck, and are in good condition. Interior masonry appears to have adequately spaced and caulked control joints in good condition. Interior soffits are of plaster type construction, and in good condition. The window sills are an element of the aluminum window system, and are in fair condition. The exterior lintels are steel, and are in good condition. There are no chimneys. Canopies over entrances are plaster type construction, and are in good condition. There are no exterior soffits. The school is provided with a covered concrete and masonry conventional loading dock to facilitate the receipt of product, supplies, and foodstuffs, 244 square feet in size and featuring hollow metal type conventional man doors. The dock itself is in poor condition, and is equipped with bumper pads in poor condition. The concrete steps and metal railing for the loading dock are in poor condition.

Masonry Cleaning

**Recommendations:** Provide tuckpointing in all areas of mortar deterioration as required through the overall facility. Provide masonry cleaning and sealing as required through the overall facility. Recaulk existing control joints. Exterior wall insulation deficiencies are addressed in Item J. Replace the loading dock bumper pads. Replace the loading dock steps and railing.

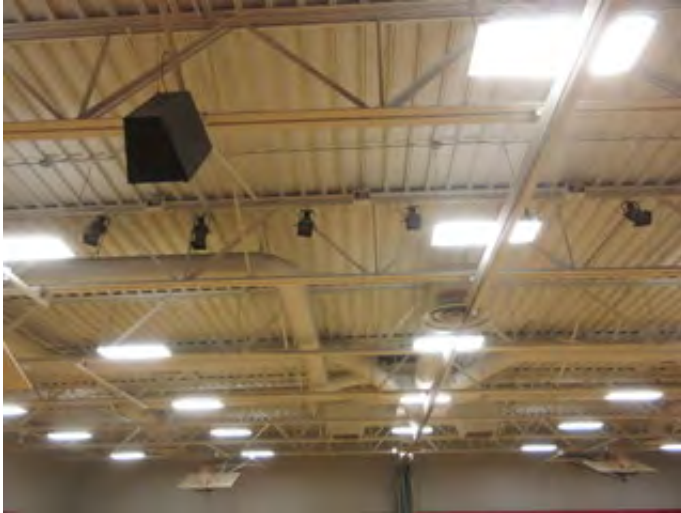
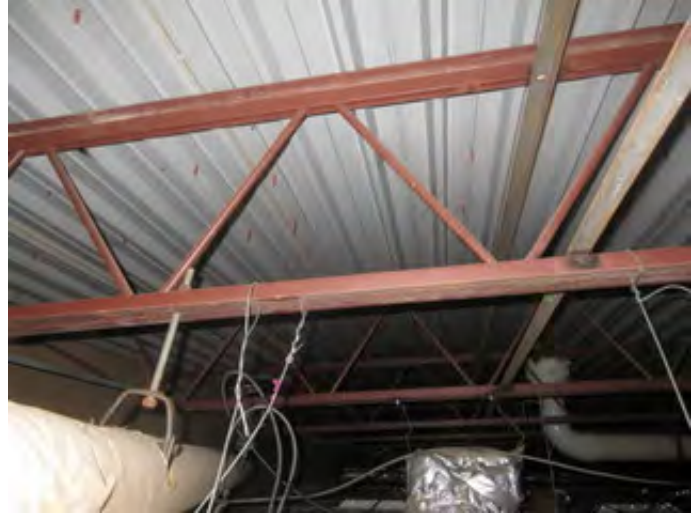
**Description:** The floor construction of the base floor of the overall facility is concrete slab on grade type construction, and is in fair condition. There is no crawl space. The floor construction of the second floor of the overall facility is steel deck on steel joist type construction, and is in good condition. Ceiling to structural deck spaces are sufficient to accommodate HVAC, electrical, and plumbing scopes of work in required renovations. The roof construction of the overall facility is steel deck on steel joist type construction, and is in good condition.

Steel Joist Roof Structure

**Recommendations:** Existing conditions require no renovation or replacement at the present time.

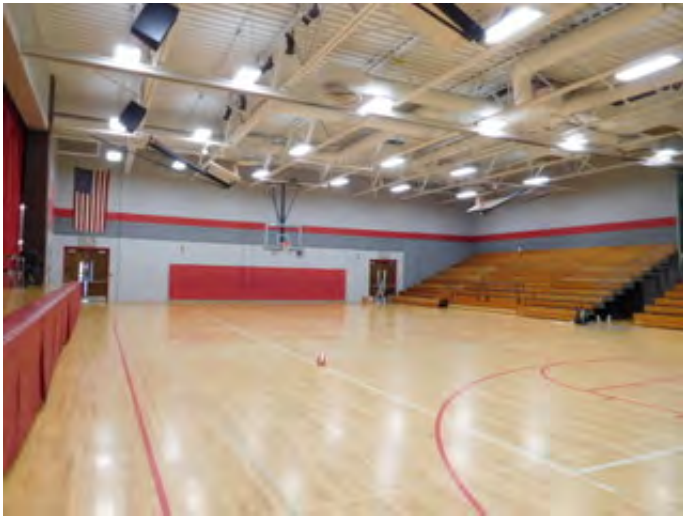
**Description:** The overall facility features conventionally partitioned Classrooms with marmoleum or VAT type flooring, acoustical tile type ceilings, as well as painted block type wall finishes, and they are in fair condition. The overall facility has Corridors with terrazzo, marmoleum type flooring, acoustical tile type ceilings, as well as painted block, painted plaster, and brick type wall finishes, and they are in fair condition. The overall facility has Restrooms with ceramic tile type flooring, acoustical tile type ceilings, as well as painted block type wall finishes, and they are in fair condition. Toilet partitions are metal, and are in good to fair condition. Classroom casework in the overall facility is wood type construction with plastic laminate or black resin tops, is inadequately provided, and in fair to poor condition. The typical Classroom contains 0 lineal feet of casework, and Classroom casework provided ranges from 0 to 24 feet. Classrooms are provided adequate chalkboards, markerboards, tackboards which are in fair condition. The lockers, located in the Corridors, are adequately provided, and in fair condition. The Art program is equipped with a kiln in good condition, and existing kiln ventilation is inadequate. The facility is equipped with wood louvered interior doors that are flush mounted, and in fair condition. Most doors are not equipped with proper ADA hardware. Two doors in the overall facility do not have proper clearances. The Gymnasium space has wood type flooring, exposed type ceilings, as well as painted block, painted plaster, and brick type wall finishes, and they are in fair condition. Wood Gymnasium flooring has been well maintained, will accommodate multiple future sandings and refinishing, and is rated at a median stage of its product lifecycle. Gymnasium telescoping stands are a wood and metal type construction in fair to poor condition. Gymnasium basketball backboards are electrically operated type, and are in good to fair condition. The Media Center, openly located between Corridors, has marmoleum type flooring, acoustical tile type ceilings, as well as painted block and brick type wall finishes, and they are in fair condition. Student Dining, has VCT type flooring, acoustical tile type ceilings, as well as painted block and painted plaster type wall finishes, and they are in fair condition. OSDM-required fixed equipment for Stage is adequately provided, and in fair to poor condition. Existing Gymnasium, Student Dining, and Media Center spaces are inadequately provided with appropriate sound attenuation acoustical surface treatments. Existing Music spaces are adequately provided with appropriate sound attenuation acoustical surface treatments. The existing Kitchen is full service, is oversized based on current enrollment, and the existing Kitchen equipment, installed over 20 years ago, is in fair condition. The Kitchen hood is in fair condition, and is equipped with the required UL 300 compliant wet chemical fire suppression system. The required 6" overhang on all three exposed sides of the cooking equipment is provided by the hood. Kitchen hood exhaust ductwork is of proper construction, material, insulation, and installed as required by the OSDM and OBCMC. Walk-in cooler and freezer are located within the Kitchen spaces, and are in fair condition.

**Rating:** 3 Needs Replacement

Gymnasium Finishes

**Recommendations:** Provide complete replacement of finishes and casework due to condition and installation of systems outlined in Items A, C, D, E, I, K, L, M, N, T, U, and W. Provide for the complete replacement of interior doors due to age and condition. Funding for replacement of two interior doors with inadequate clearances is provided in Item O. Provide for the replacement of kitchen equipment due to age and condition. Provide for the replacement of walk-in cooler and freezer due to age and condition. Provide for the replacement of Kitchen hood due to age and condition. Provide for terrazzo floor repair due to condition. Provide for replacement of toilet accessories. Provide for additional wall insulation. Provide for Stage equipment allowance. Provide for the replacement of Gymnasium bleachers due to age and condition. Provide for appropriate sound attenuation acoustical surface treatments in the Gymnasium, Media Center, and Student Dining. Provide for the replacement of Hard Plaster, Gypsum Board, and Laboratory Counter tops due to work in Item T. Funding for the replacement of resilient flooring due to work in Item T is provided for in Complete Replacement of Finishes.

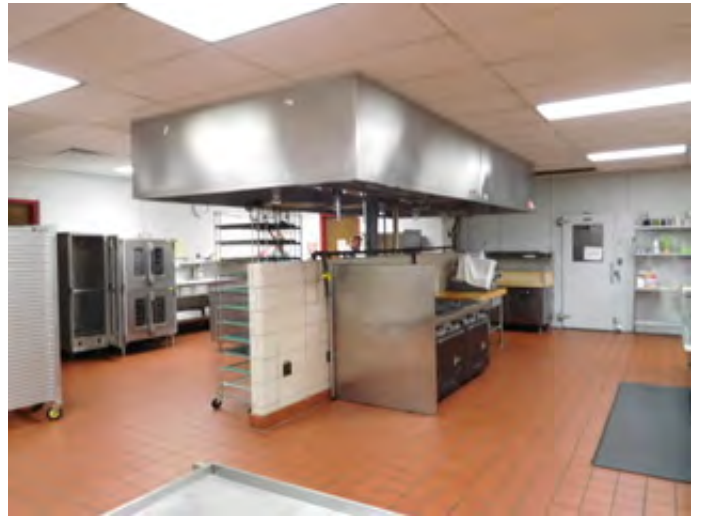
Kitchen Hood

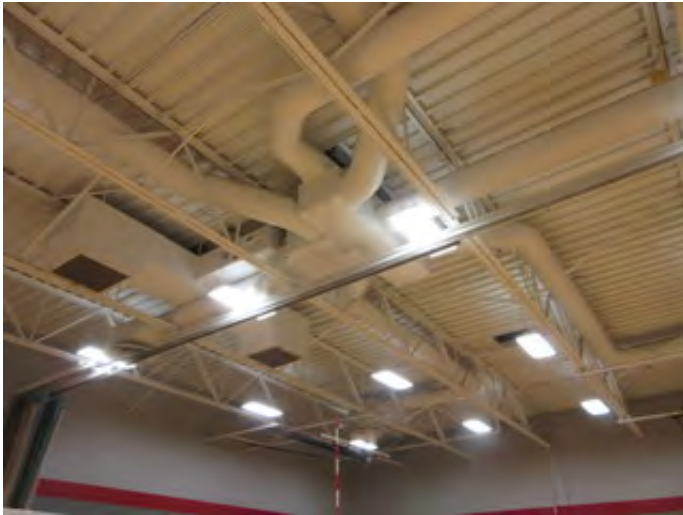
**Description:** The typical Classrooms in the overall facility are equipped with T-8 2x4 lay-in direct fluorescent fixture type lighting, with dual level switching. Classroom fixtures are in fair condition, providing an average illumination of 58 FC, thus complying with the 40 FC recommended by the OSDM. The typical Corridors in the overall facility are equipped with T-8 2x4 lay-in direct fluorescent fixture type lighting, with single level switching. Corridor fixtures are in fair condition, providing an average illumination of 29 FC, thus complying with the 15 FC recommended by the OSDM. The Gymnasium spaces are equipped with T-8 2x4 surface mount and suspended fluorescent fixture type lighting, in fair condition, providing an average illumination of 38 FC, which is less than the 40 FC recommended by the OSDM. The Media Center is equipped with T-8 2x4 lay-in direct fluorescent fixture type lighting, in fair condition, providing an average illumination of 57 FC, thus complying with the 30 FC recommended by the OSDM. The Student Dining spaces are equipped with T-8 2x4 lay-in direct fluorescent fixture type lighting, in fair condition, providing an average illumination of 37 FC, which is less than the 40 FC recommended by the OSDM. The Kitchen spaces are equipped with T-8 2x4 lay-in direct fluorescent fixture type lighting, with single level switching. Kitchen fixtures are in fair condition, providing an average illumination of 42 FC, which is less than the 50 FC recommended by the OSDM. The Service Areas in the overall facility are equipped with T-8 1x4 suspended and surface mount fluorescent fixture type lighting, in fair condition, providing inadequate illumination based on OSDM requirements. The typical Administrative spaces in the overall facility are equipped with T-8 2x4 lay-in direct fluorescent fixture type lighting, in fair condition, providing inadequate illumination based on OSDM requirements. The overall lighting systems of the facility are not fully compliant with Ohio School Design Manual requirements due to age and condition, inadequate lighting levels, and lack of multi-level switching.

**Rating:** 3 Needs Replacement

Gymnasium Fluorescent Lighting Fixtures

**Recommendations:** Provide complete replacement of lighting system due to age, condition, lighting levels, lack of multilevel switching, and installation of systems outlined in Items A, C, J, and U.

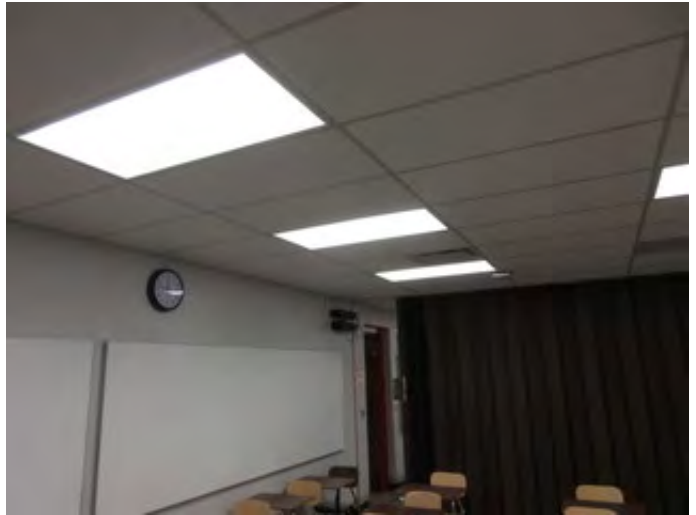
Classroom Fluorescent Lighting Fixtures

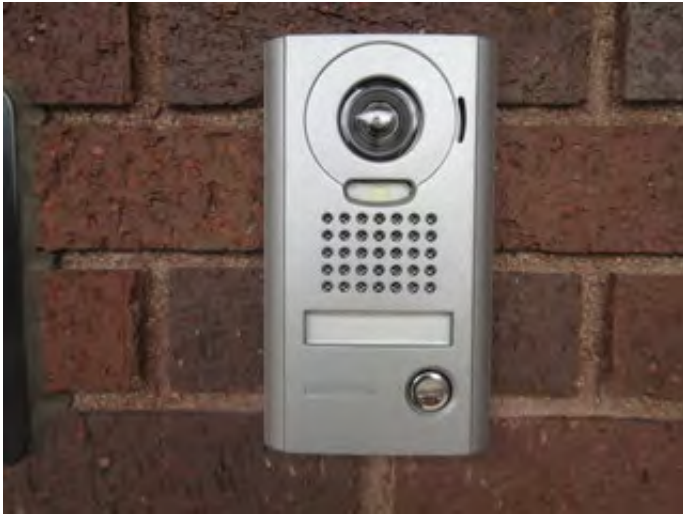
**Description:** The overall facility contains a Sonitrol motion detector, CCTV, door contact type security system in fair condition. Motion detectors are inadequately provided in main entries, central gathering areas, offices, main Corridors, and spaces where 6 or more computers are located. Exterior doors are inadequately equipped with door contacts. An automatic visitor control system is provided. Compliant color CCTV cameras are inadequately provided at main entry areas, parking lots, central gathering areas, and main Corridors. CCTV is monitored in Administrative Area with the use of a LCD monitor and computer based hard disk recording device. A compliant computer controlled access control system integrating alarms and video signals, with appropriate UPS backup, is not provided. The system is not adequately equipped with card / biometric readers. The security system is not adequately provided throughout, and the system is not fully compliant with Ohio School Design Manual guidelines. There are no playground fencing issues requiring attention. The exterior site lighting system is equipped with surface mounted LED and HID high pressure sodium entry lights in good to fair condition. Pedestrian walkways are illuminated with surface mounted LED and HID high pressure sodium fixtures in good to fair condition. Parking and bus pick-up / drop off areas are illuminated by pole mounted HID high pressure sodium fixtures in fair condition. The exterior site lighting system provides inadequate illumination due to insufficient fixture capacity and sparse placement of fixtures.

**Rating:** 3 Needs Replacement

Security System Automatic Visitor Control

**Recommendations:** Provide complete replacement of security system to meet Ohio School Design Manual guidelines. Provide complete replacement of exterior site lighting system to meet Ohio School Design Manual guidelines.

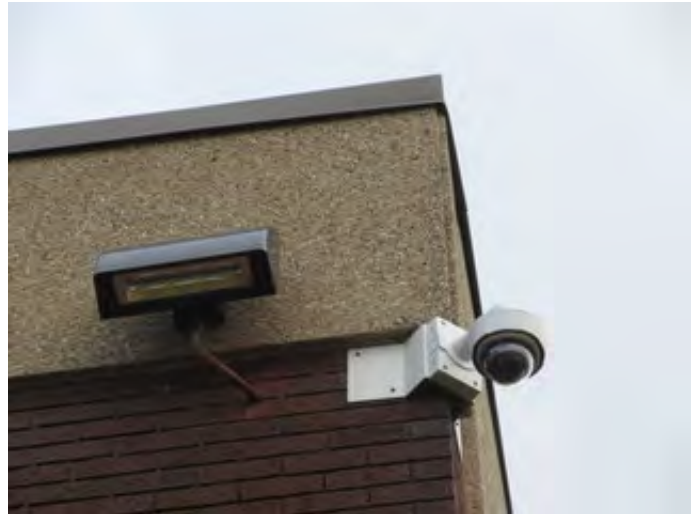
Security System CCTV Camera

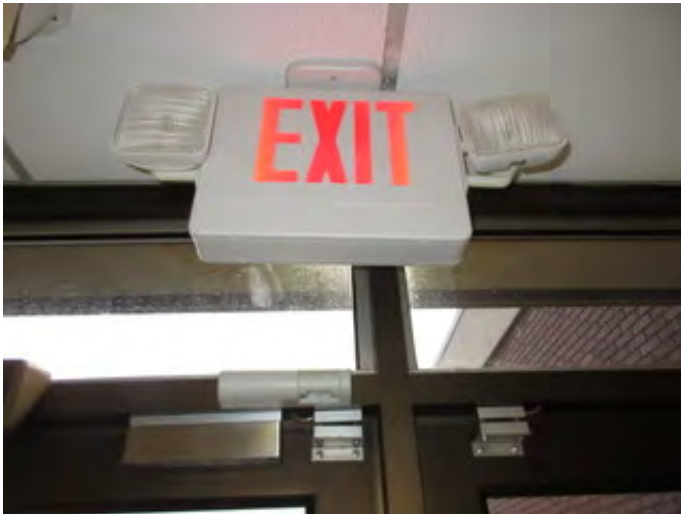
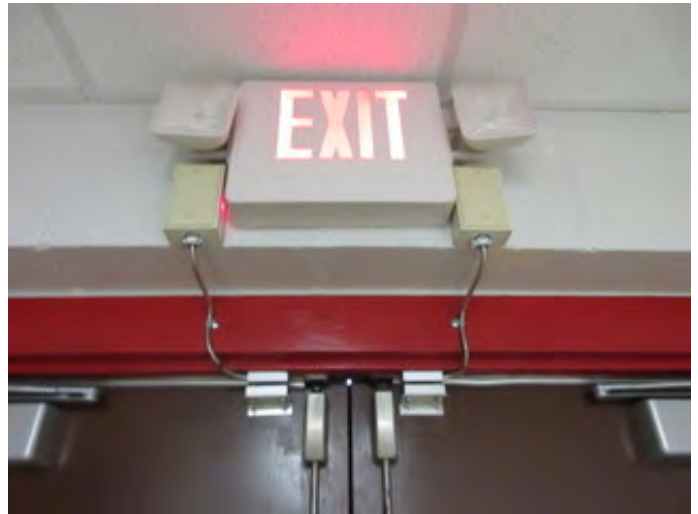
**Description:** The overall facility is inadequately equipped with an emergency egress lighting system consisting of non-compliant non-illuminated and plastic construction exit signs, as well as OSDM compliant red lettered and LED illuminated exit signs, and the system is in fair condition. The facility is inadequately equipped with emergency egress floodlighting (which consists mainly of emergency egress lighting attached to exit signs), but is also equipped with some recessed fluorescent lighting used as emergency egress lighting, and the system is in fair condition. The system is not provided with appropriate battery backup or emergency generator on separate circuits. The system is not adequately provided throughout, and does not meet Ohio School Design Manual and Ohio Building Code requirements.

**Rating:** 3 Needs Replacement

Exit Sign with Emergency Egress Lighting

**Recommendations:** Provide complete replacement of emergency / egress lighting system to meet Ohio School Design Manual and Ohio Building Code guidelines.

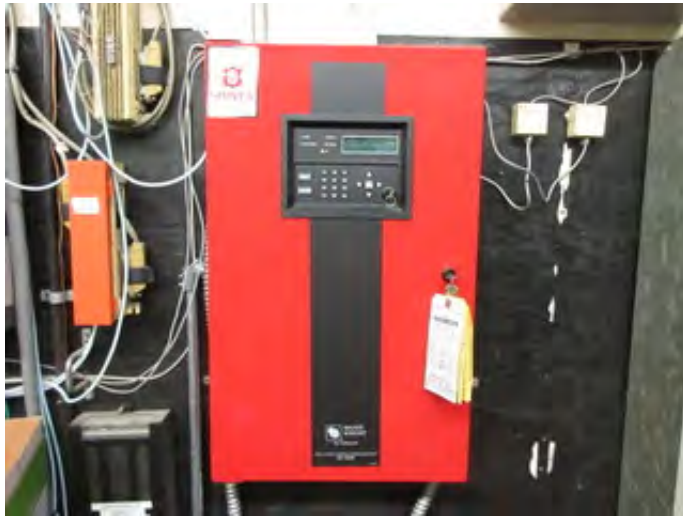
**Description:** The overall facility is equipped with a Honeywell Silent Knight SK-5208 addressable type fire alarm system, installed in 1973 with incremental upgrades, and in fair condition, consisting of manual pull stations and horn and strobe indicating devices. The system is automatic and is monitored by a third party. The system appears to be equipped with sufficient audible horns and strobe indicating devices. The system does not appear to be equipped with sufficient smoke detectors and heat sensors. The system is not equipped with any flow switches and tamper switches. The systems thus will not support future fire suppression systems. The systems are not adequately provided throughout, and does not have additional zone capabilities. The systems are not fully compliant with Ohio Building Code, NFPA, and Ohio School Design Manual requirements.

**Rating:** 3 Needs Replacement

Fire Alarm System Control Panel

**Recommendations:** Provide complete replacement of fire alarm systems to meet OBC, NFPA, and Ohio School Design Manual guidelines.

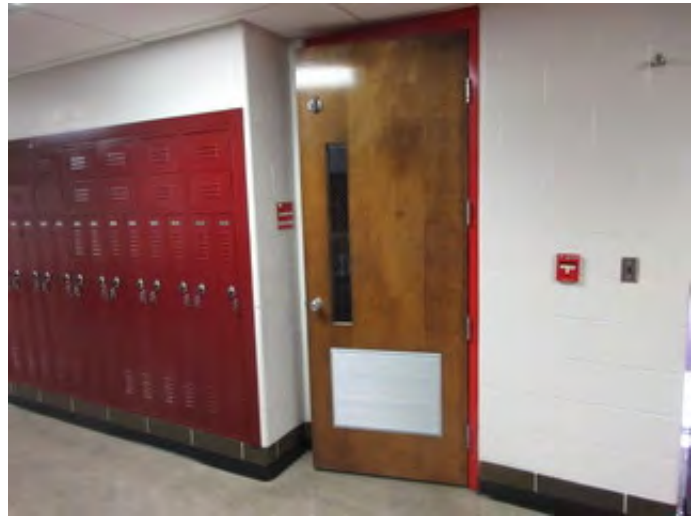
Fire Alarm System Manual Pull Station

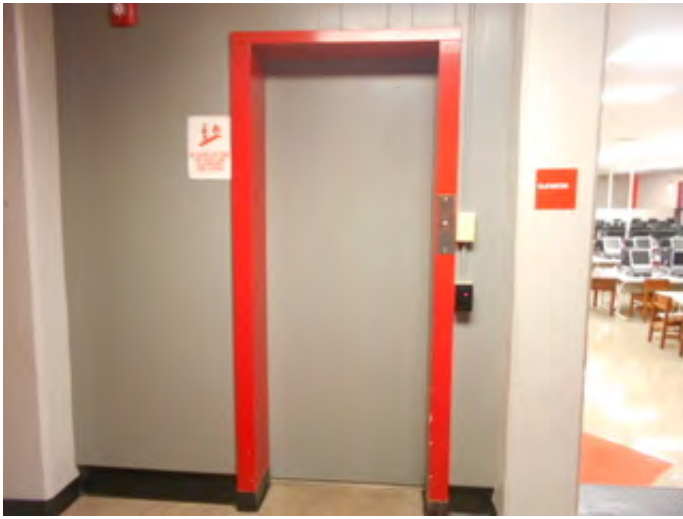
Compliant Elevator

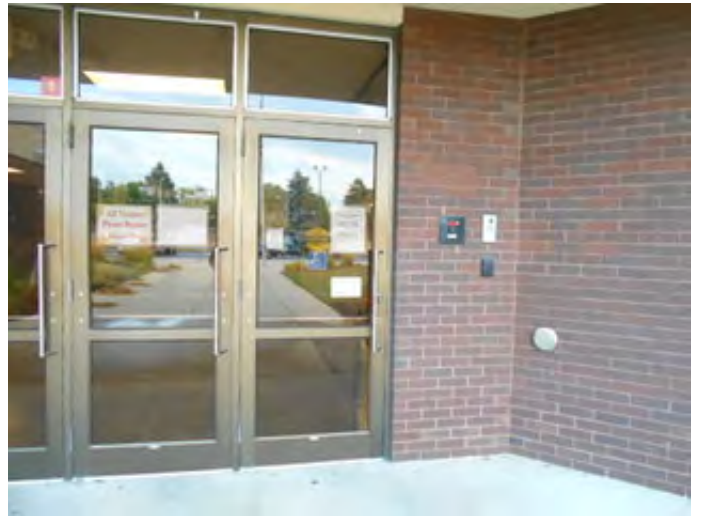
Compliant Power Assisted Door

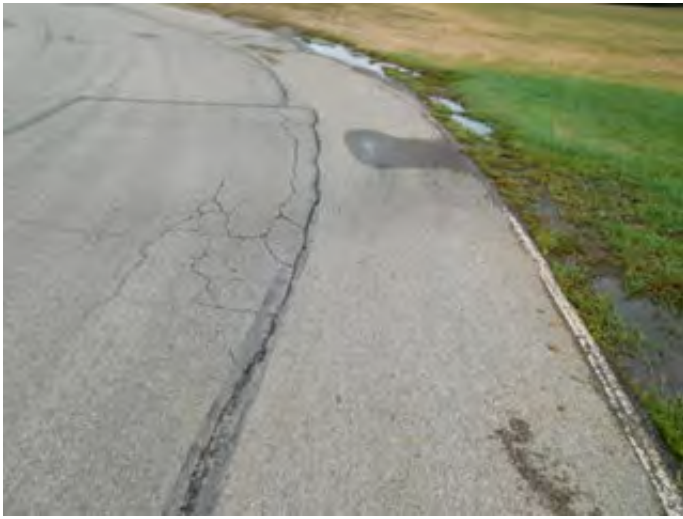
2 Needs Repair

Ponding at Pavement Edges

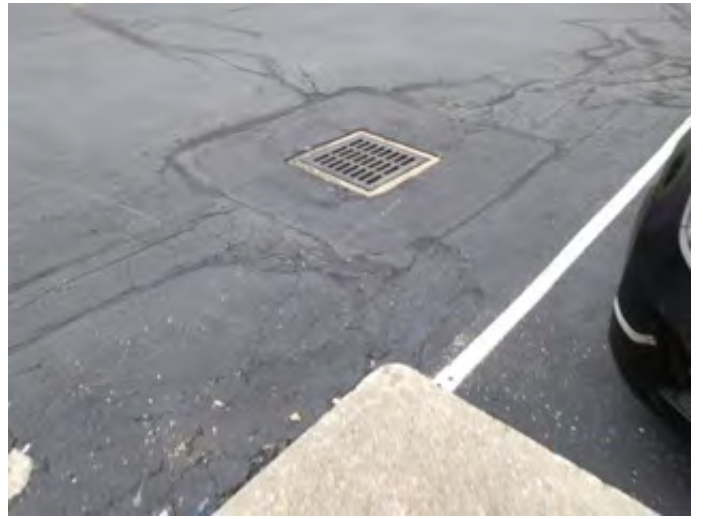
Parking Lot Catch Basin

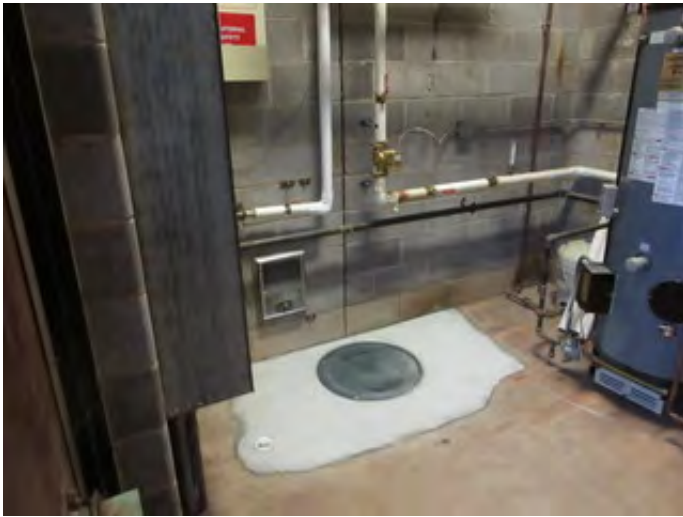
Kitchen Grease Trap Interceptor

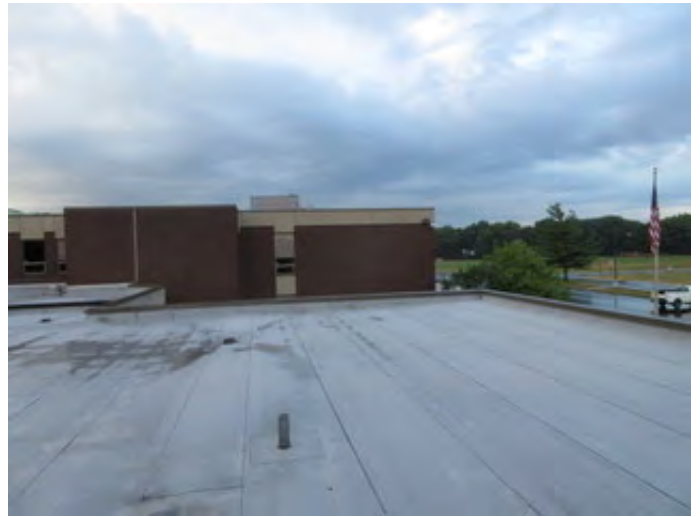
Waste Vent Piping

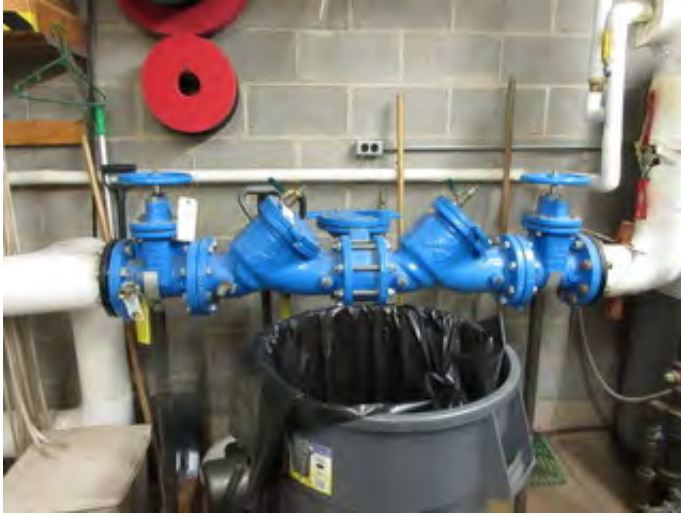
Incoming Domestic Water Service Line

**Recommendations:** Provide a new city water supply line of adequate capacity to support the existing needs of the facility, as well as a future automated fire suppression system. Funding provided in Item U.

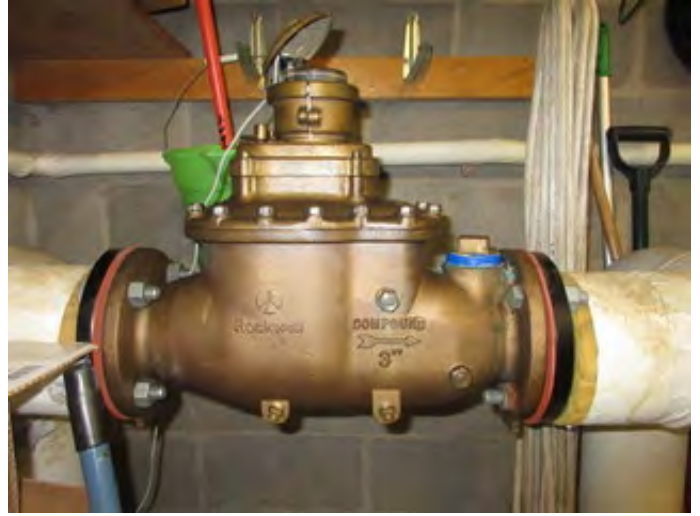
Incoming Domestic Water Service Meter

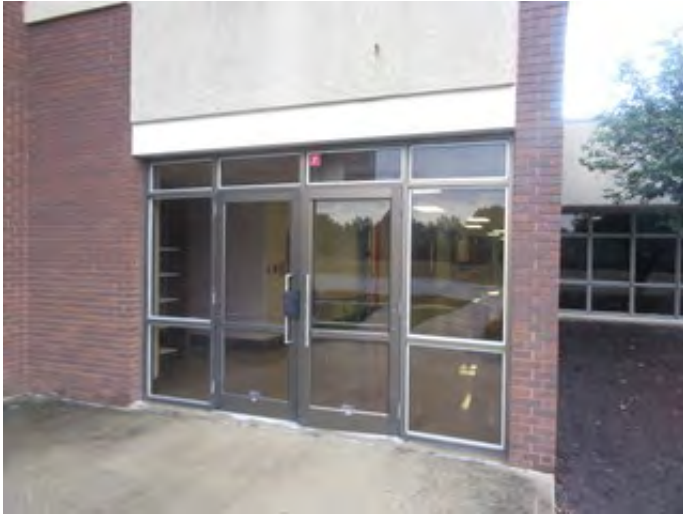
**Rating:** 3 Needs Replacement

Typical Entrance Doors

**Recommendations:** Replace all exterior and entrance doors, except for the Locker Room doors, due to poor condition. Replacement of single glazed transoms and sidelights is addressed in Item F.

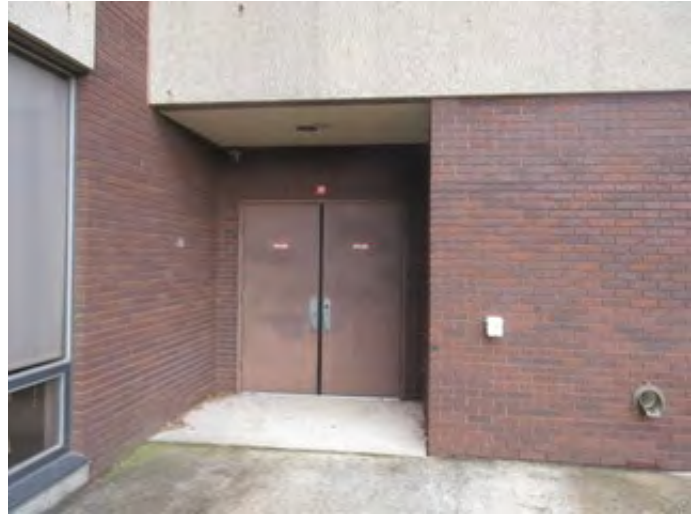
Typical Exterior Doors

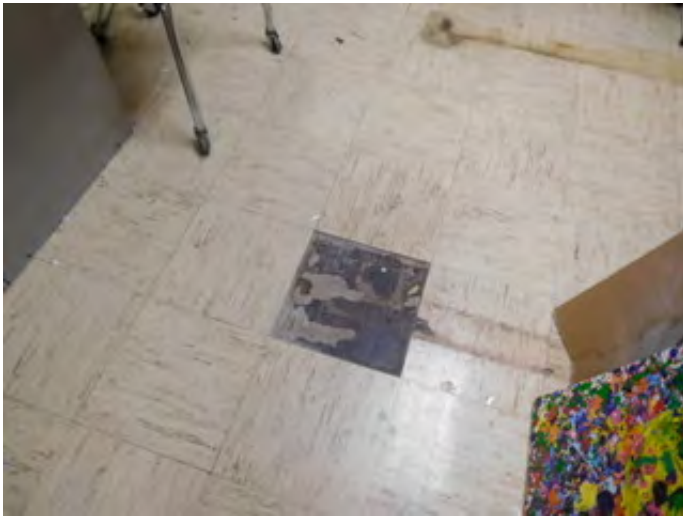
VAT Flooring

Resilient Flooring Removal, Including Mastic	\$3.00	sq.ft. (Qty)		15,930 Required	\$47,790.00	See J
Sink Undercoating Removal	\$100.00	each		19 Required	\$1,900.00	
<b>Other:</b> Carpet and Mastic Removal	\$3.00	sq.ft. (Qty)		2,370 Required	\$7,110.00	Provide for removal of carpet and associated mastic.
<b>Other:</b> Chalk Board Mastic Removal	\$1.00	sq.ft. (Qty)		7,000 Required	\$7,000.00	Chalk Board Mastic Removal.
<b>Other:</b> Cove Base Mastic Removal	\$2.00	sq.ft.		7,140 Required	\$14,280.00	Removal of cove base mastic
<b>Other:</b> Marmoleum and Mastic Removal	\$3.00	sq.ft. (Qty)		41,535 Required	\$124,605.00	Provide for removal of marmoleum flooring and associated mastic
<b>Other:</b> Remove Insulated Retractable Wall	\$2.00	sq.ft. (Qty)		250 Required	\$500.00	Provide for removal of one insulated retractable wall.
<b>Other:</b> Stage Curtain Removal	\$1.00	sq.ft. (Qty)		1,000 Required	\$1,000.00	Provide for the removal of the Stage Curtain.

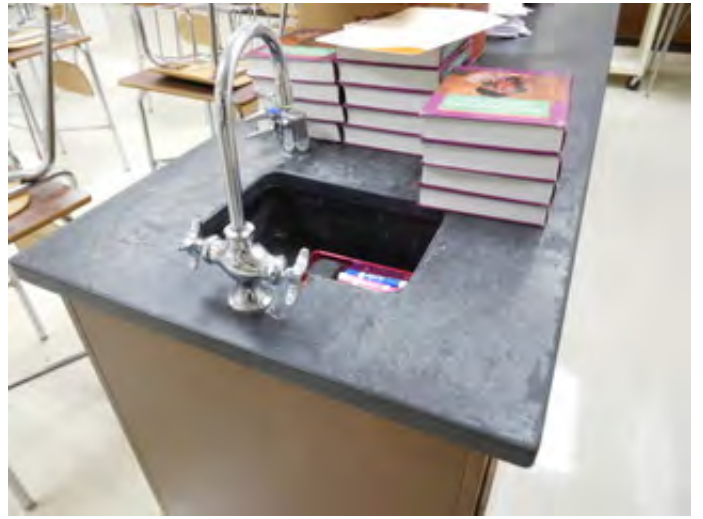
Laboratory Countertops

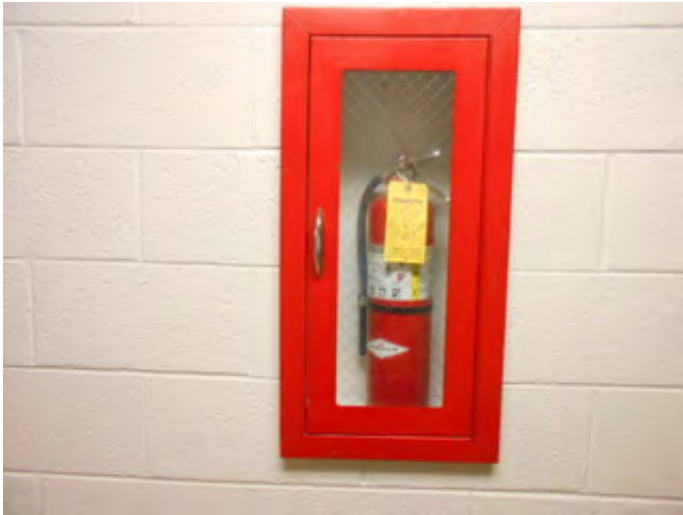
Compliant Fire Extinguisher
