**Building Information - Troy City (44925) - Troy Junior High**

Program Type	Classroom Facilities Assistance Program (CFAP) - Regular
Setting	Small City
Assessment Name	Troy Junior High School (65292) FINAL
Assessment Date (on-site; non-EEA)	2016-08-06
Kitchen Type	Full Kitchen
Cost Set:	2016
Building Name	Troy Junior High
Building IRN	65292
Building Address	556 Adams Street
Building City	Troy
Building Zipcode	45373
Building Phone	(937) 332.6720
Acreage	49.54
Current Grades:	7-8
Teaching Stations	45
Number of Floors	2
Student Capacity	975
Current Enrollment	706
Enrollment Date	2016-08-06
Enrollment Date is the date in which the current enrollment was taken.	
Number of Classrooms	39
Historical Register	<b>NO</b>
Building's Principal	Mr. Dave Dilbone
Building Type	Middle

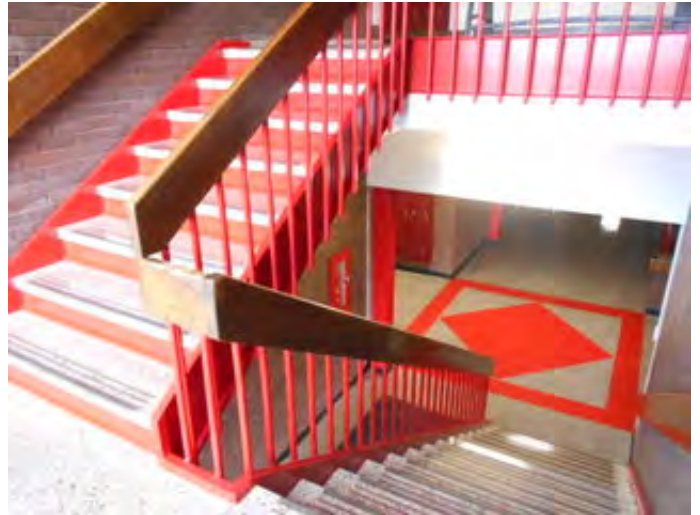
Non-Compliant Stair Tower

**Recommendations:** Provide new automated fire suppression system to meet Ohio School Design Manual guidelines. Provide increased water service of a capacity sufficient to support the fire suppression system, funding included in fire suppression funding. Provide new emergency generator, with funding provided via complete replacement of electrical system in Item D. Provide new guard and handrails at all interior stairways in the overall facility. Provide fire-rated enclosure around 3 existing stair towers in the overall facility. Funding for replacement of Kitchen hood is provided for in Item J.

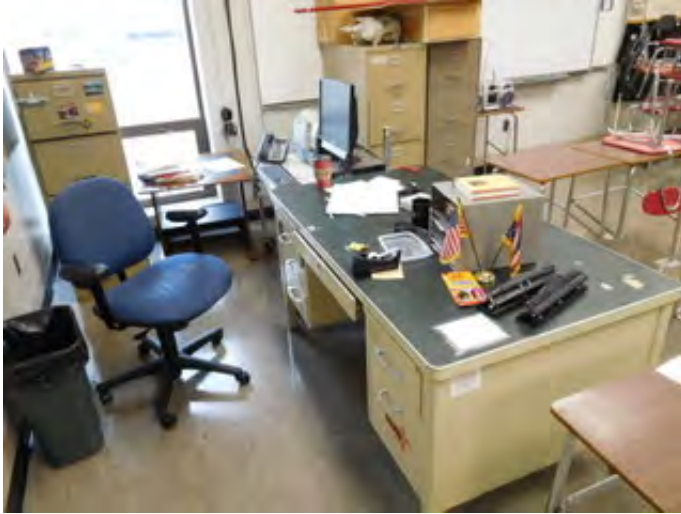
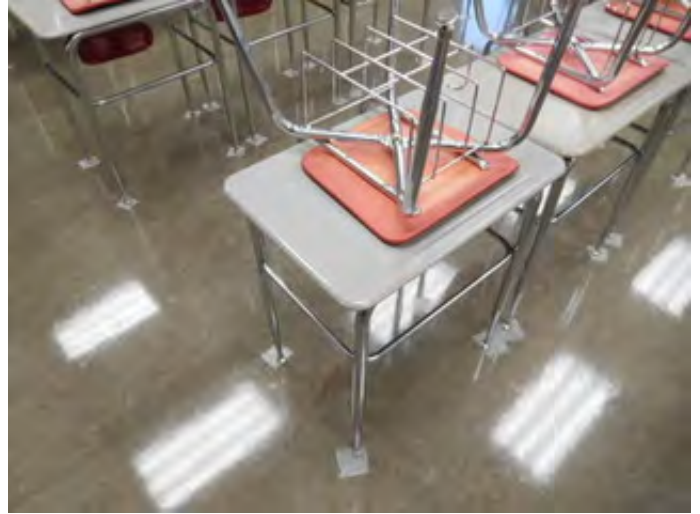
Typical Teacher Desk and Chair

Typical Student Desk and Chair

**Recommendations:** Provide for replacement of outdated or inadequate furnishings.

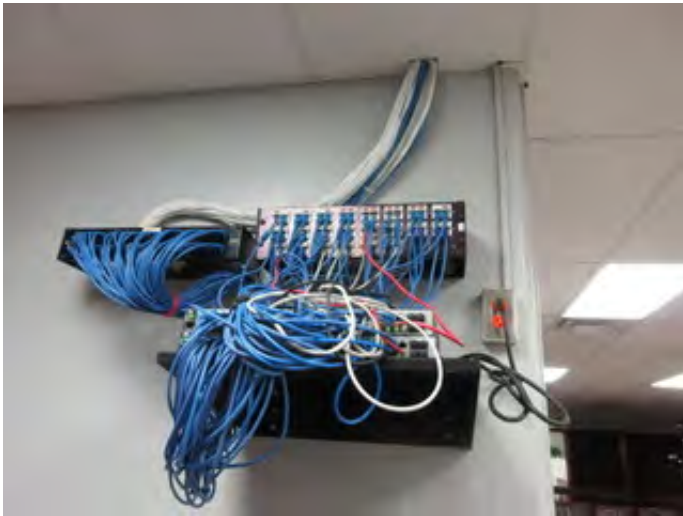
IT Data Rack

**Recommendations:** Provide complete replacement of technology systems to meet Ohio School Design Manual requirements.

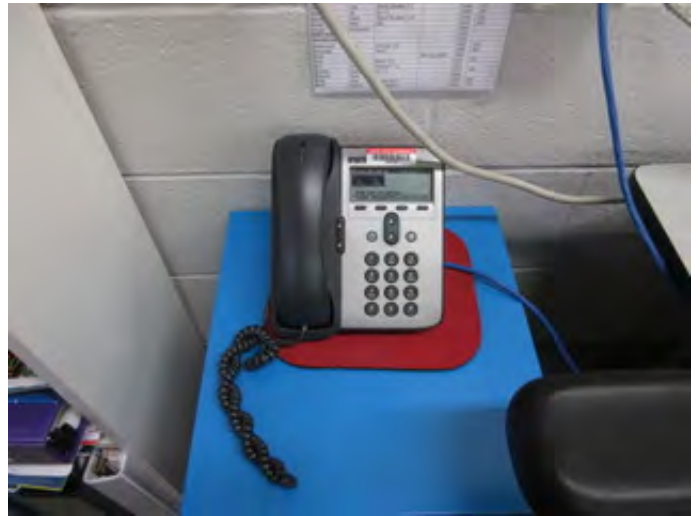
Classroom Digitally Based Phone
