Building Information - Troy City (44925) - Van Cleve Elementary

Program Type	Classroom Facilities Assistance Program (CFAP) - Regular
Setting	Small City
Assessment Name	Van Cleve Elementary School (66498) FINAL
Assessment Date (on-site; non-EEA)	2016-08-08
Kitchen Type	Warming Kitchen
Cost Set:	2016
Building Name	Van Cleve Elementary
Building IRN	66498
Building Address	617 East Main Street
Building City	Troy
Building Zipcode	45373
Building Phone	(937) 332.6780
Acreage	4.30
Current Grades:	PK, 6
Teaching Stations	40
Number of Floors	2
Student Capacity	633
Current Enrollment	353
Enrollment Date	2016-08-08
Enrollment Date is the date in which the current enrollment was taken.	
Number of Classrooms	34
Historical Register	NO
Building's Principal	Mr. Matt Sieftring
Building Type	Elementary/Middle

Building Construction Information - Troy City (44925) - Van Cleve Elementary (66498)

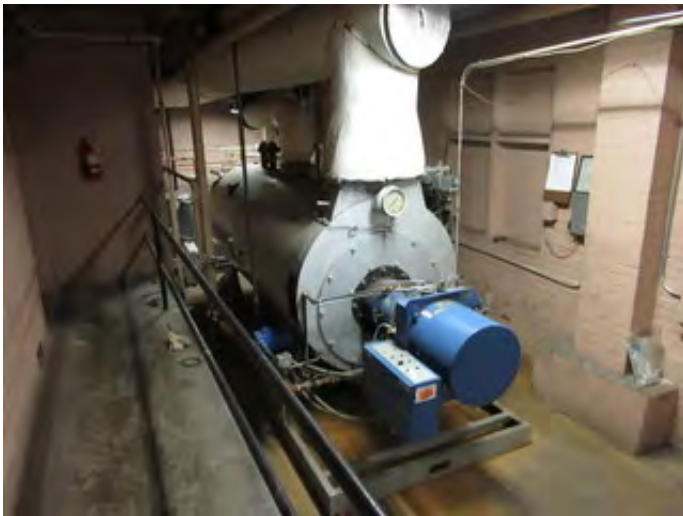
Description: The existing system for the 1913 Original Construction is a natural gas fired steam boiler type system, installed in 1955, and is in poor condition. The system in the 1930 Addition is an extension of that found in the 1913 Original Construction. The existing system for the 1951 Addition is a natural gas fired heated water boiler type system, installed in 1951, with upgrades in 1970 and 2015, and is in fair condition. 2-pipe vs. 4-pipe designations are not applicable in this facility, as no central air conditioning is provided. The (2) steam boilers, that serve the 1913 Original Construction, were manufactured by Cyclotherm, were installed in 1913, with upgrades in 1950, and are in fair to poor condition. Steam is converted to hot water for the 1913 Original Construction. Steam and heating water are distributed to terminal units consisting of radiators, unit ventilators, cabinet heaters, unit heaters, and air handlers. The terminal equipment is original to each addition and is in fair condition. The (1) heated water boiler, that serves the 1951 Addition, was manufactured by Weil-McLain, was installed in 1951, with upgrades in 1970, and is in fair condition. Heating water is distributed to terminal units consisting of Trane Odyssey air handling units. The terminal equipment was installed in 2015 and is in good to fair condition. The system does not appear to comply with the 15 CFM per person fresh air requirements of the Ohio Building Code mechanical code and Ohio School Design Manual. The pneumatic and digital type system temperature controls are original to each addition and are in fair to poor condition. The system does not feature individual temperature controls in all spaces required by the OSDM. The overall system does not feature any central energy recovery systems. The facility is not equipped with louvered interior doors to facilitate Corridor utilization as return air plenums. The existing systems in the 1913 Original Construction and 1930 Addition are not ducted, and floor to structural deck heights will accommodate the installation of properly sized ductwork for a future Ohio School Design Manual approved system. The existing system in the 1951 Addition is ducted, but the ductwork cannot be integrated into a possible future system due to arrangement, air volume, and routing of existing ductwork. The overall heating system is evaluated as being unsafe and in inefficient working order, and long term life expectancy of the existing system is not anticipated. The structure is not equipped with central air conditioning. The site does not contain underground fuel tanks.

Rating: 3 Needs Replacement

Natural Gas Fired Boiler

Recommendations: Provide new overall heating, ventilating, and air conditioning system to achieve compliance with Ohio Building Code and Ohio School Design Manual standards. Convert the 1913 Original Construction and 1930 Addition to ducted system to facilitate efficient exchange of conditioned air. Replace existing ductwork in the 1951 Addition to facilitate efficient exchange of conditioned air.

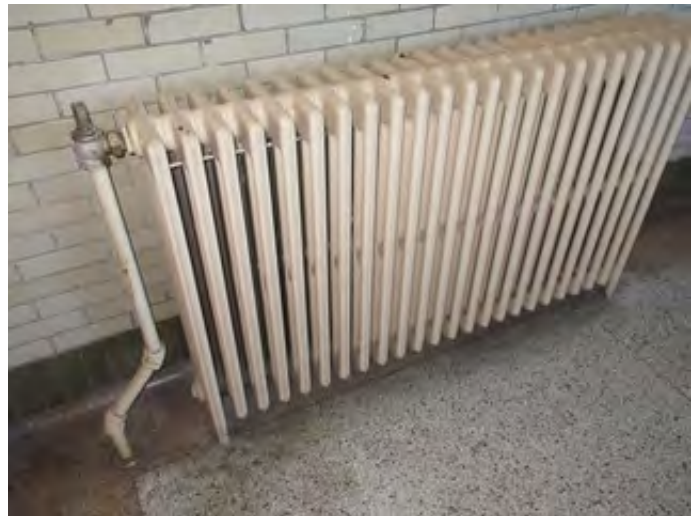
Radiator

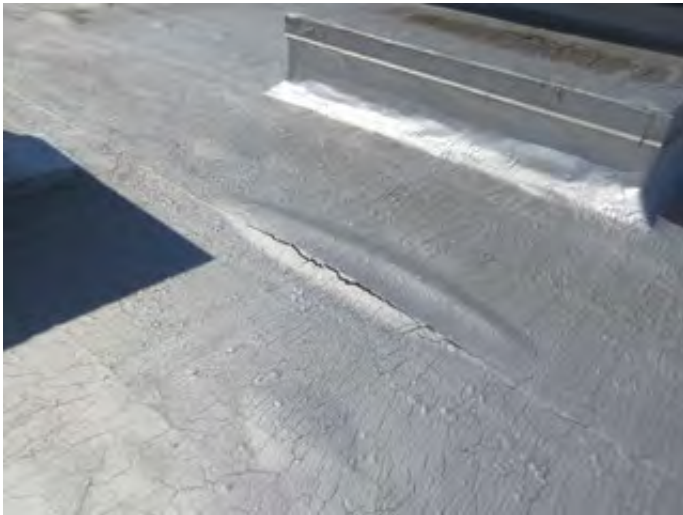
Description: The roof over the Original Construction is a modified bitumen system by Tremco that was installed in 2007 and 2008, is under a 15-year warranty, and is in poor condition. There are District reports of current leaking. Blisters form in the roofing system and burst. Burst blisters adjacent to seams cause leaks. Signs of past leaking were observed during the physical assessment. Access to the roof was gained by access hatch and access ladders that are in fair condition. Some low roof areas were not accessible. Fall safety protection cages are not required and are not provided. The roof over the 1930 Gymnasium Addition is a modified bitumen system by Tremco that was installed in 2005, 2007 and 2008, is under a 15-year warranty, and is in poor condition. There are District reports of current leaking. Blisters form in the roofing system and burst. Burst blisters adjacent to seams cause leaks. Signs of past leaking were observed during the physical assessment. Access to the roof was gained by access hatch and access ladders that are in fair condition. Some low roof areas were not accessible. Fall safety protection cages are not required and are not provided. The roof over the 1951 Pre-Kindergarten Annex is a modified bitumen system by Tremco that was installed in 2005, is under a 15-year warranty, and is in poor condition. There are District reports of current leaking. Blisters form in the roofing system and burst. Burst blisters adjacent to seams cause leaks. Signs of past leaking were observed during the physical assessment. Access to the roof is not provided. There were no observations of standing water on the roof. Metal cap flashings and stone copings are in fair to poor condition. Roof storm drainage is addressed through a system of gutters and downspouts, roof drains, and through-wall scuppers, which are properly located, and in fair to poor condition. The roof is equipped with overflow scuppers in areas with roof drains, in sufficient quantity and in fair condition. No problems requiring attention were encountered with any roof penetrations. There are not any covered walkways attached to this structure.

Rating: 3 Needs Replacement

Typical Blisters & Cracking

Recommendations: The roof over the overall facility requires replacement to meet Ohio School Design Manual guidelines due to condition and age of system and projected lifecycle. The metal flashing for the Original Construction requires replacement due to condition. Due to existing conditions downspouts require replacement. Due to existing conditions roof drains require replacement. Provide ladders to low areas which are currently inaccessible in the Original Construction and 1930 Gymnasium Addition. Provide an access hatch and ladder in the 1951 Pre-Kindergarten Annex. Install insulation in areas where the roof is being replaced throughout the overall facility.

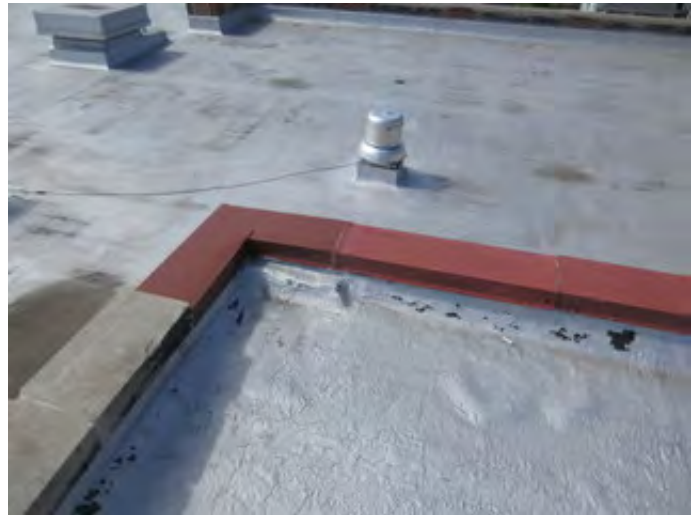
Blisters and Metal Coping

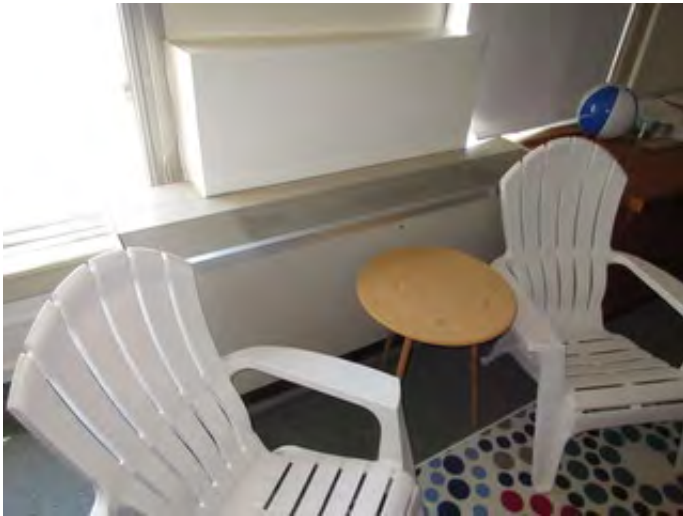
Description: The overall facility is not equipped with a central air conditioning system. Window units are provided in the Teacher's Lounge location of the overall facility. An isolated room system consisting of a ductless split AC unit (with the pad-mounted condensing units located on the exterior of the facility) is provided in the 1913 Original Construction Administrative Offices location. An isolated room system consisting of multiple Trane Odyssey light-commercial ducted split AC units (with the pad-mounted condensing units located on the exterior of the facility) is provided in throughout the 1951 Addition. The ventilation system in the overall facility consists of unit ventilators, original to each addition, with upgrades in 1970 and in fair condition, providing fresh air to Classrooms, Student Dining, and the Media Center, and an air handling unit, installed in 1930 and in fair to poor condition, providing fresh air to the Gymnasium. Relief air venting is provided by transfer grilles to corridor, ceiling plenums, central relief fans, and an air handler. The ventilation system does not meet the Ohio Building Code 15 CFM per occupant fresh air requirement. The overall system is not compliant with Ohio Building Code and Ohio School Design Manual requirements. Dust collection systems are not required in this facility. The Art program is equipped with a kiln and the kiln ventilation system is inadequate. General building exhaust systems for Restrooms, Storage Rooms, Art Rooms, and Custodial Closets are inadequately placed, and in fair to poor condition.

Rating: 2 Needs Repair

Unit Ventilator

Recommendations: Provide an air conditioning system to meet with Ohio Building Code and Ohio School Design Manual requirements. Replace general building exhaust systems located in Restrooms, Storage Rooms, Art Rooms, and Custodial Closets. Pricing included in Item A. Provide the Art program with a kiln ventilation system to meet Ohio Building Code and Ohio School Design Manual requirements.

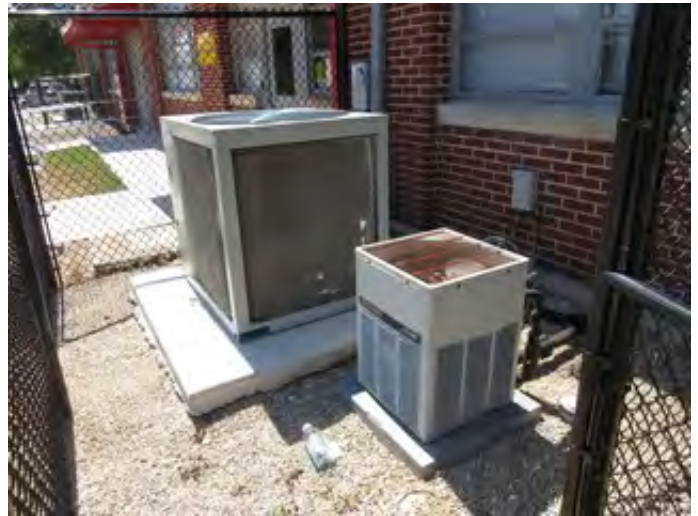
Air Condition System Condenser

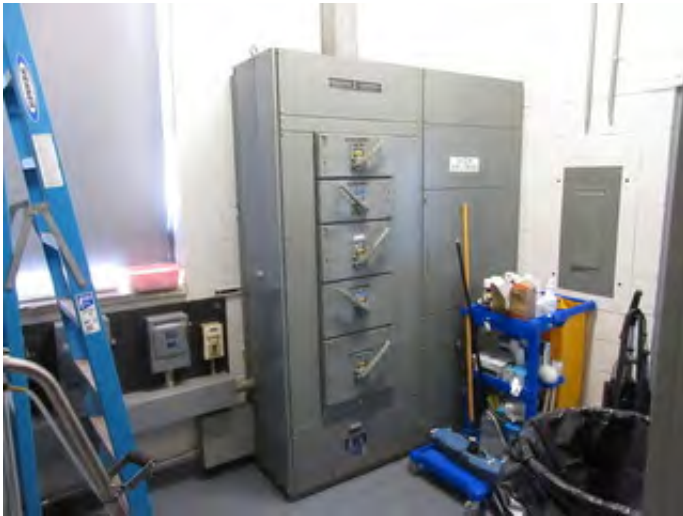
Description: There are multiple electrical systems provided to the overall facility. The electrical system provided to the 1913 Original Construction is a 120/240 volts, 600 amp, 3 phase and 4 wire system installed in 1913 with upgrades in 1970, and is in fair to poor condition. The system in the 1930 Addition is an extension of that found in the 1913 Original Construction. The electrical system provided to the 1951 Addition is a 120/240 volts, 2,000 amp, 3 phase and 4 wire system installed in 1951 with upgrades and replacements to the switchgear in 2015, and is in fair condition. Power is provided to the school by multiple utility owned, pole-mounted transformers located outside the Mechanical Room, and in fair condition. The panel systems, are original to each addition, with some upgrades, are in fair condition, and for the most part cannot be expanded to add additional capacity. The Classrooms are not equipped with adequate electrical outlets. The typical Classroom contains (4) general purpose outlets, (0) dedicated outlets for each Classroom computer, and (1) dedicated outlet for each Classroom television. Some Classrooms are equipped with as many as (6) general purpose outlets, while others are equipped with as few as (3) general purpose outlets. There are not any spaces that have no electrical outlets. The Corridors are not fully equipped with adequate electrical outlets for servicing. Adequate GFI protected exterior outlets are not provided around the perimeter of the building. The facility is not equipped with an emergency generator. Adequate lightning protection safeguards are not provided. Stage lighting power system including control panel, breakers, and dimmers is inadequately provided, in fair to poor condition and does not meet OSDM requirements. The overall electrical system does not fully meet Ohio School Design Manual requirements in supporting the current needs of the school, and will be inadequate to meet the facility's future needs.

Rating: 3 Needs Replacement

Main Electrical Distribution Panel

Recommendations: The entire electrical system requires replacement to meet Ohio School Design Manual guidelines for overall capacity and due to age, condition, lack of OSDM-required features, and to accommodate the addition of an air conditioning system. Provide an emergency generator, with funding included in the electrical system replacement. Provide adequate lightning protection safeguards in the overall facility, including associated grounding system, with funding included in the electrical system replacement. Provide control panel, dimmers, and breakers to support the Stage lighting system, with funding included in the electrical system replacement.

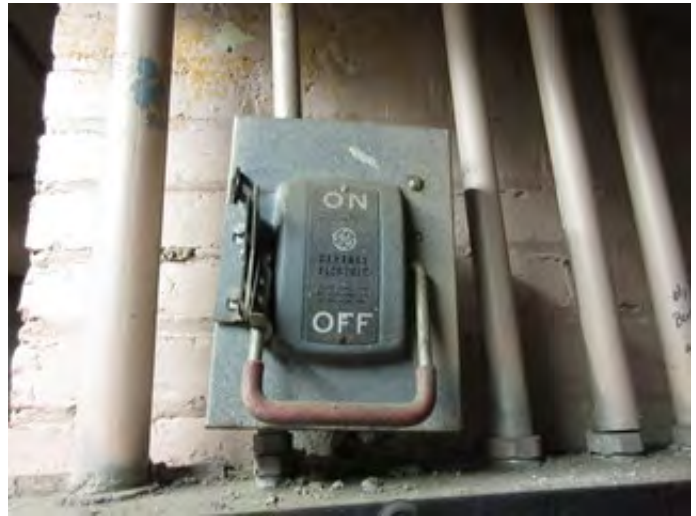
Electrical Disconnect

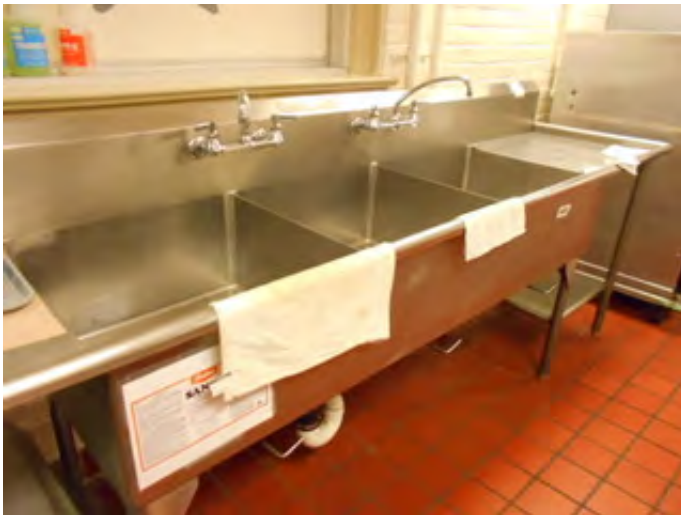
Rating: 3 Needs Replacement

Triple Compartment Sink-Kitchen

Recommendations: In the overall facility, replace the remaining galvanized steel domestic water piping and the remaining cast iron waste piping due to age and condition. Due to age and condition and to facilitate the school's compliance with OBC and OSFC fixture requirements, throughout the overall facility, replace 9 toilets, 8 urinals, 10 lavatories (include ADA compliant faucets) and 4 electric water coolers. Provide 1 additional electric water cooler in the 1930 Addition. Due to age, condition, LEED, OBC and OSFC, replace 70 faucets and valves throughout the overall facility. Provide 3 in Classroom sinks with deck mounted drinking fountain. Provide (4) 4 station lab workstations (with dual faucet sinks, gas and compressed air connections), 4 ADA compliant work stations, 4 Instructor prep stations (with sink and compressed/ gas connections), 4 utility sinks and 4 eyewash/emergency showers. All fixtures, whether new or replaced, to be mounted at ADA compliant heights. Provide 10 additional wall hydrants throughout the facility. See Item O for replacement of fixtures related to ADA requirements, as well as reconfiguration of toilet stalls in Boys and Girls Restrooms, 2 Staff Restrooms, and 1 Health Clinic. Funding for fixtures and equipment replacement in Kitchen is provided for in Item J.

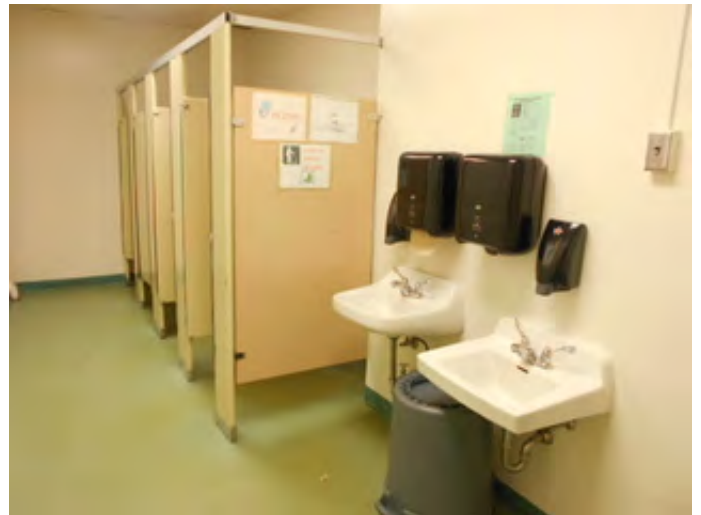
Large Group Restroom-Girls

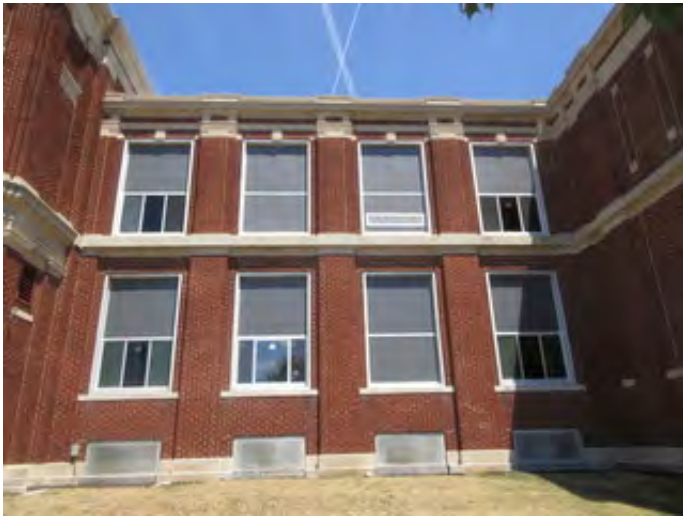
Description: The Original Construction and 1930 Gymnasium Addition are equipped with aluminum frame windows with single glazed type window system, with an unknown installation date, and is in fair to poor condition. The window system features operable and inoperable windows throughout the building, and operable windows are not equipped with opening limiters. Insect screens are provided in fair condition. Window system seals are in poor condition, with moderate air and water infiltration being experienced. Window system hardware is in fair condition. The window system features no blinds. This facility is not equipped with any curtain wall systems. This facility does not feature any glass block windows. The 1951 Pre-Kindergarten Annex is equipped with steel frame windows with single glazed type window system, which was installed in 1951, and is in poor condition. The window system features operable windows throughout the building, and operable windows are not equipped with opening limiters and insect screens. Window system seals are in poor condition, with moderate air and water infiltration being experienced. Window system hardware is in poor condition. The window system features no blinds. This facility is not equipped with any curtain wall systems. This facility does not feature any glass block windows. The exterior doors in the Original Construction and 1930 Gymnasium Addition are equipped with thermally broken aluminum frame transoms with tempered insulated glazing, in good condition. Exterior door vision panels are tempered insulated glazing. The exterior doors in the 1951 Pre-Kindergarten Annex are equipped with steel frame transoms with single pane glazing, in poor condition. Exterior door vision panels are single pane glazing. The school does not contain any skylights. The school does not contain any clerestories. Interior glass is OSDM-compliant. Window security grilles are provided for ground floor windows, and are in good condition. There is not a Greenhouse associated with this school.

Rating: 3 Needs Replacement

Typical Aluminum Windows of the Original Construction

Recommendations: Provide a new insulated window system with integral blinds to meet with Ohio School Design Manual requirements. Replace window transoms at exterior doors of the 1951 Pre-Kindergarten Annex.

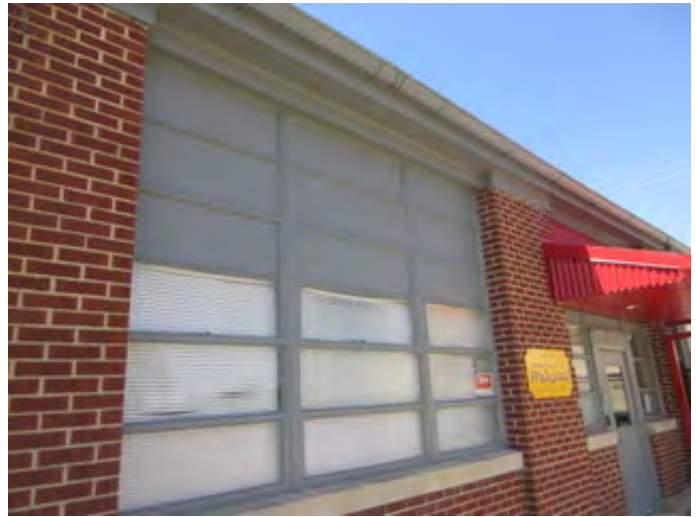
Typical Steel Windows of the 1951 Annex

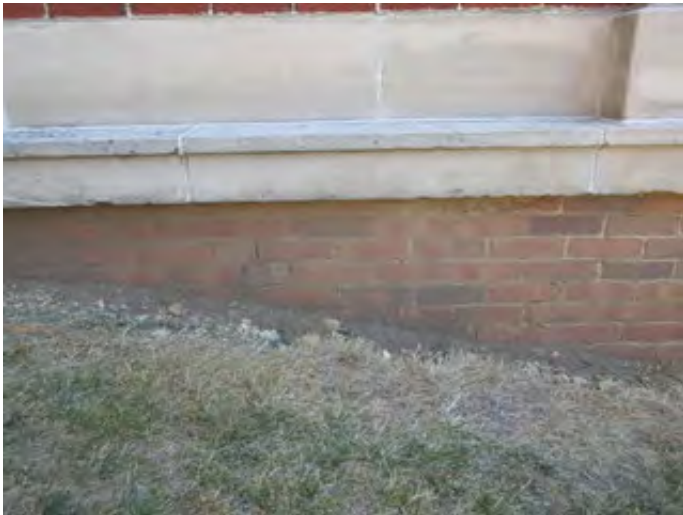
Description: The Original Construction is equipped with brick foundation walls on concrete footings, which displayed minimal locations of significant differential settlement, cracking, and leaking, and are in fair condition. The 1930 Gymnasium Addition is equipped with concrete foundation walls on concrete footings, which displayed minimal locations of significant differential settlement, cracking, or leaking, and are in fair condition. The 1951 Pre-Kindergarten Annex is equipped with concrete foundation walls on concrete footings, which displayed no locations of significant differential settlement, cracking, or leaking, and are in good condition. Areas of minor cracking and spalling were observed through the Original Construction and 1930 Gymnasium Addition. The District reports that there has been past leaking throughout the Original Construction and 1930 Gymnasium Addition. The courtyard was noted as draining poorly during occasional massive rainfalls due to the limited storm drainage piping size, but that it cannot be altered due to EPA issues.

Rating: 2 Needs Repair

Typical Masonry Foundation of the Original Construction

Recommendations: Provide sprayed on waterproofing system along the entire perimeter of the Original Construction and 1930 Gymnasium Addition. Provide drainage tile system along the entire perimeter of the Original Construction and the courtyard perimeter of the 1930 Gymnasium Addition due to leaking issues. Repair areas of cracking and spalling through the Original Construction and 1930 Gymnasium Addition.

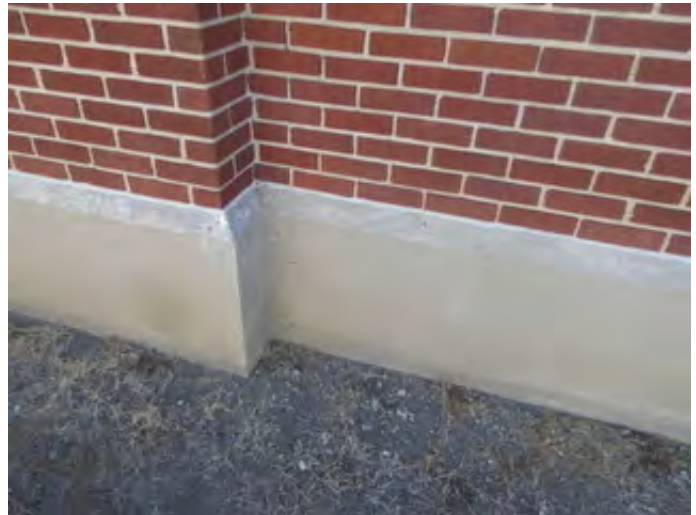
Typical Concrete Foundation of the 1930 Gymnasium Addition

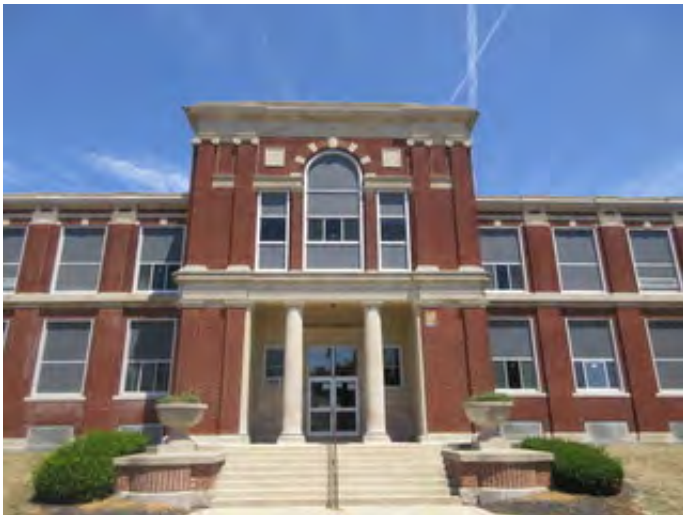
Description: The overall facility has a brick veneer on load bearing masonry wall system, which displayed minimal locations of deterioration, and is in good condition. The Original Construction was receiving some tuckpointing work during the assessment. The exterior masonry appears to have appropriately spaced and adequately caulked control joints in fair to poor condition. Control joints are not provided at lintel locations, at doors and windows, building corners, and wall offsets though they are not needed. The school does not contain expansion joints and none are needed, as there is no indication of exterior masonry cracking or separation. Exterior walls in the overall facility are inadequately insulated. Brick veneer masonry walls are not cavity walls. Weep holes and vents are not provided or required. The exterior masonry has not been cleaned and sealed in recent years, and shows evidence of mortar deterioration in the chimneys and above roof locations. Architectural exterior accent materials consist of stone, which is in good to fair condition. Exterior building fenestration in the Original Construction represents 16.10% of the exterior surfaces. Exterior building fenestration in the 1930 Gymnasium Addition represents 6.47% of the exterior surfaces. Exterior building fenestration in the 1951 Pre-Kindergarten Annex represents 32.85% of the exterior surfaces. Interior Corridor and demising walls in the Original Construction and 1930 Gymnasium Addition are glazed brick and plaster walls, project full height from floor to bottom of deck, and are in fair condition. Interior masonry appears to have adequately spaced and caulked control joints in fair condition. Interior soffits are of plaster type construction, and in fair condition. Interior Corridor walls in the 1951 Pre-Kindergarten Annex are metal stud partitions with gypsum board, do not project full height from floor to bottom of deck, and are in good condition. Interior demising walls in the 1951 Pre-Kindergarten Annex are concrete masonry units, project full height from floor to bottom of deck, and are in fair condition. Interior masonry appears to have adequately spaced and caulked control joints in fair condition. Interior soffits are of metal stud and gypsum board type construction, and in good condition. The window sills in the overall facility are stone, and are in good condition. The exterior lintels are steel, and are in good condition. Chimneys in the Original Construction and 1930 Gymnasium Addition are in poor condition, needing tuckpointing. There are no chimneys in the 1951 Pre-Kindergarten Annex. There are no canopies in the Original Construction and 1930 Gymnasium Addition. Canopies over entrances in the 1951 Pre-Kindergarten Annex are metal type construction, and are in good to fair condition. Exterior soffits in the Original Construction and 1930 Gymnasium Addition are of concrete type construction, and in good condition. There are no exterior soffits in the 1951 Pre-Kindergarten Annex. The school is not equipped with a loading dock.

Rating: 2 Needs Repair

Stone Accents & Details

Recommendations: Provide tuckpointing in all areas of mortar deterioration as required in the Original Construction. Provide masonry cleaning and sealing as required through the overall facility. Recaulk existing control joints in the 1930 Gymnasium Addition. Exterior wall insulation deficiencies are addressed in Item J.

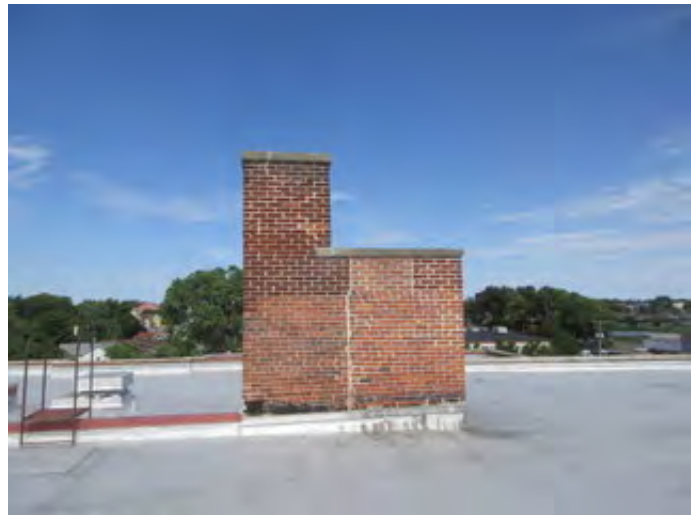
Chimney Tuckpointing Required

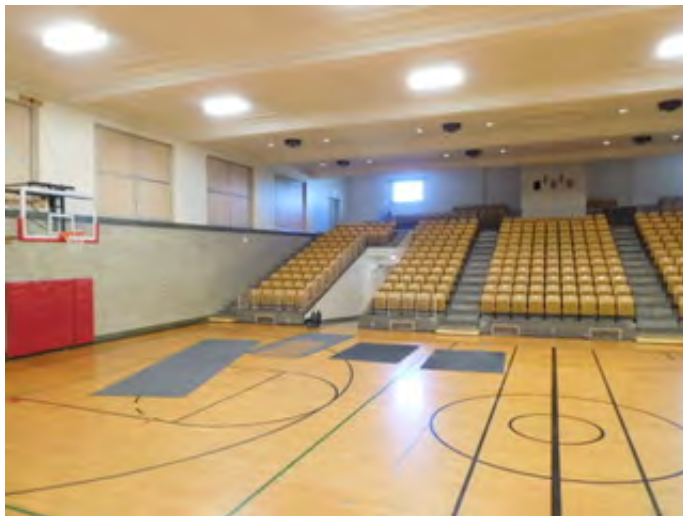
Rating:	3 Needs Replacement
Recommendations:	<p>Provide complete replacement of finishes and casework in the overall facility due to condition and installation of systems outlined in Items A, C, D, E, I, K, L, M, N, T, U, and W. Provide partitioning of Open Space Classrooms in the 1951 Addition per OSDM standards. Provide for replacement of interior doors in the 1913 Original Construction and 1930 Addition due to age and condition. Provide for replacement of one interior door in the 1951 Addition due to condition. Funding for replacement of door hardware in the 1951 Addition is provided for in Item O. Provide for the complete replacement of Warming Kitchen equipment due to age and condition. Provide for the replacement of walk-in cooler and freezer due to age and condition. Provide for replacement of an Art program kiln, with funding for ventilation system provided in Item C. Provide for terrazzo flooring repair due to age and condition. Provide for the replacement of toilet accessories. Provide for additional wall insulation. Remove Corridor transfer grilles, fill voids, and coordinate with adjacent finishes. Provide for appropriate sound attenuation acoustical surface treatments in the Gymnasium, Student Dining, Music Room, and Media Center. Provide for replacement of interior operable walls due to age and condition. Provide for the replacement of stage equipment due to age and condition. Provide for the replacement of Gymnasium flooring due to age and condition.</p>

Gymnasium Finishes

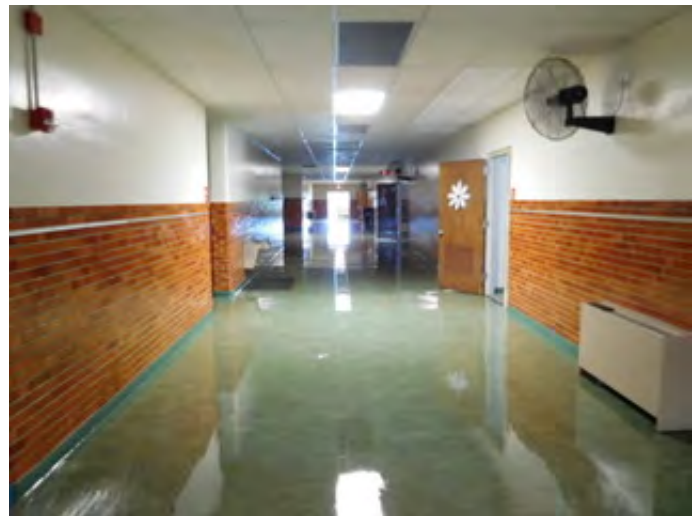
Typical Corridor Finishes

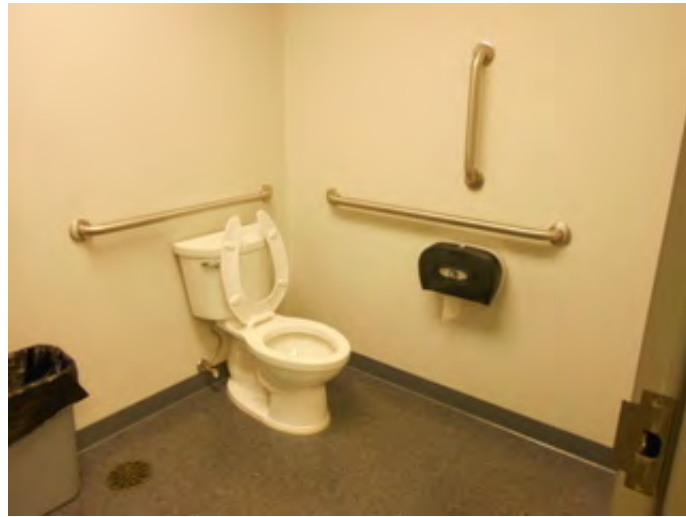
ADA Compliant Unisex Restroom

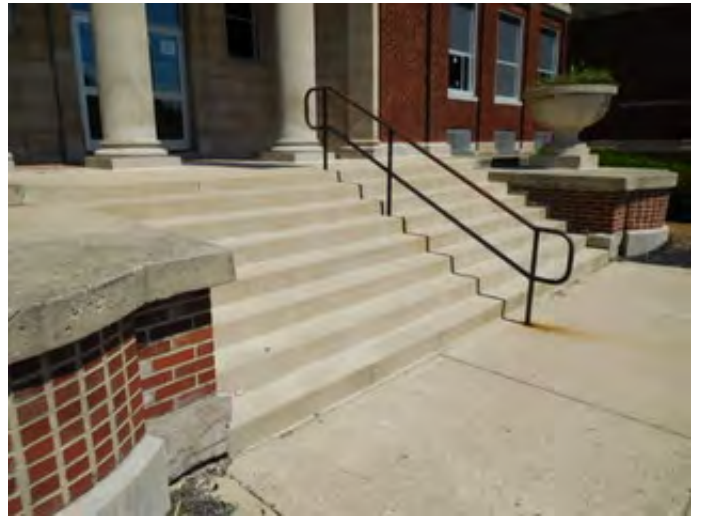
Concrete Steps to Main Entry

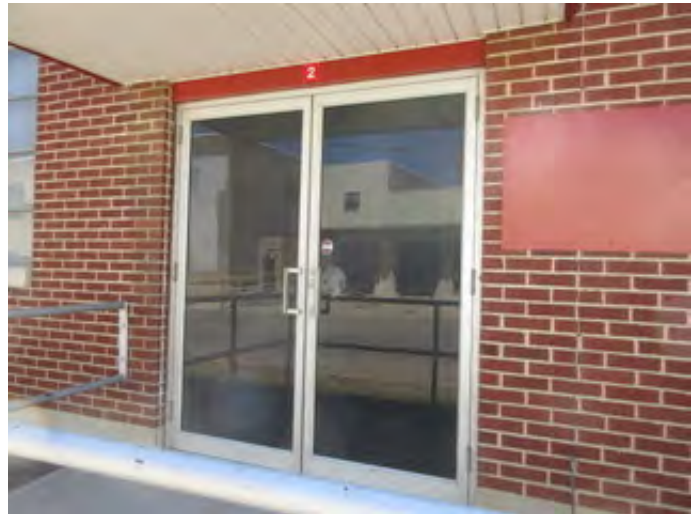
Rating: 2 Needs Repair

North Entrance Doors of the 1951 Pre-Kindergarten Annex

Recommendations: Replace the north exterior doors of the 1951 Pre-Kindergarten Annex, due to poor condition.

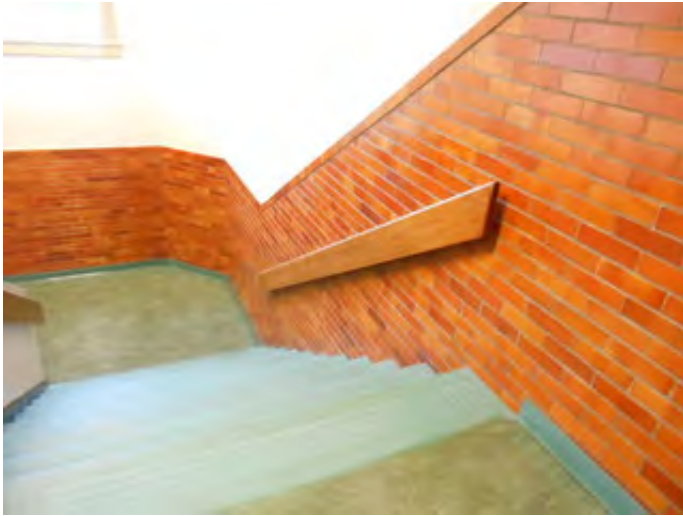
Non Compliant Stair Tower
