Building Information - Troy City (44925) - Kyle Elementary

Program Type	Classroom Facilities Assistance Program (CFAP) - Regular
Setting	Small City
Assessment Name	Kyle Elementary School (19372) FINAL
Assessment Date (on-site; non-EEA)	2016-08-06
Kitchen Type	Warming Kitchen
Cost Set:	2016
Building Name	Kyle Elementary
Building IRN	19372
Building Address	501 South Plum Street
Building City	Troy
Building Zipcode	45373
Building Phone	(937) 332.6770
Acreage	2.04
Current Grades:	K-5
Teaching Stations	22
Number of Floors	2
Student Capacity	360
Current Enrollment	245
Enrollment Date	2016-08-06
Enrollment Date is the date in which the current enrollment was taken.	
Number of Classrooms	18
Historical Register	NO
Building's Principal	Mr. Matthew Dillon
Building Type	Elementary

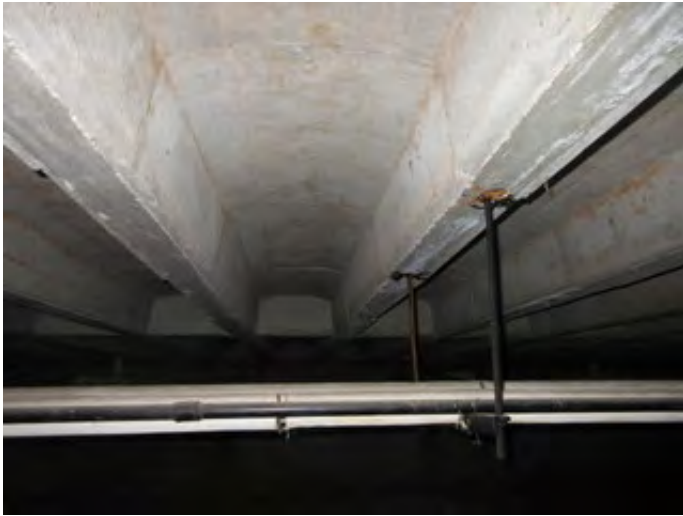
Typical First Floor Framing of the Original Construction

Recommendations: Existing conditions require no renovation or replacement at the present time.

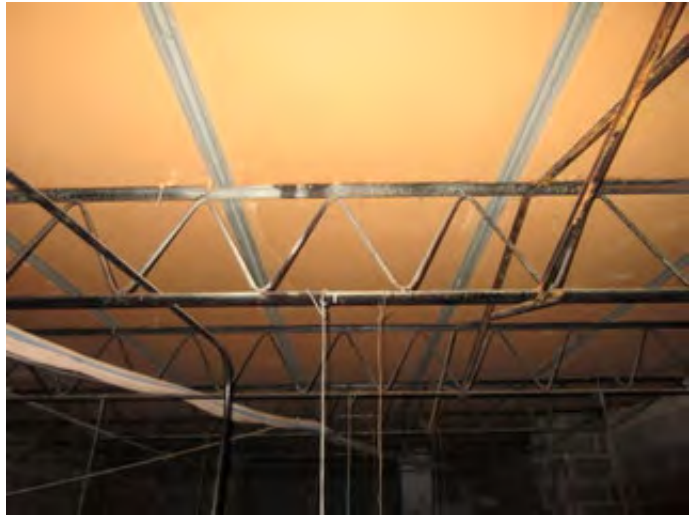
Typical Roof Structure of the Original Construction

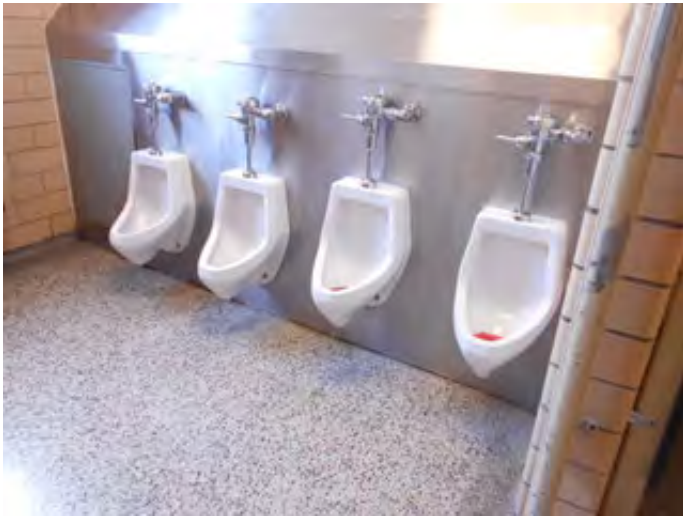
Urinals at ADA Compliant Height

Other: Non-Slip Tread Strips	\$400.00	unit		5 Required		\$2,000.00	Provide non slip tread strips on all stairways. Funding provided is per stairway.
Other: Reconfigure Toilet Room for ADA Compliance	\$10,000.00	per restroom		2 Required		\$20,000.00	Reconfigure existing restroom to meet ADA requirements. Includes fixtures, walls, door and hardware, supply lines, drains, full set of accessories and grab bars.
Other: Reconfigure Toilet Stall to meet ADA Compliance	\$2,500.00	per restroom		4 Required		\$10,000.00	Reconfigure existing toilet compartment to create ADA compliant stall. Includes fixture, accessories, grab bars, demolition, floor/wall repair and partitions.
Other: Wheelchair Stair Lift	\$15,000.00	per level		1 Required		\$15,000.00	Provide stairway chair lift. Includes lift, demolition, installation wall/floor repair.
Sum:			\$289,957.00	\$279,629.80	\$10,327.20

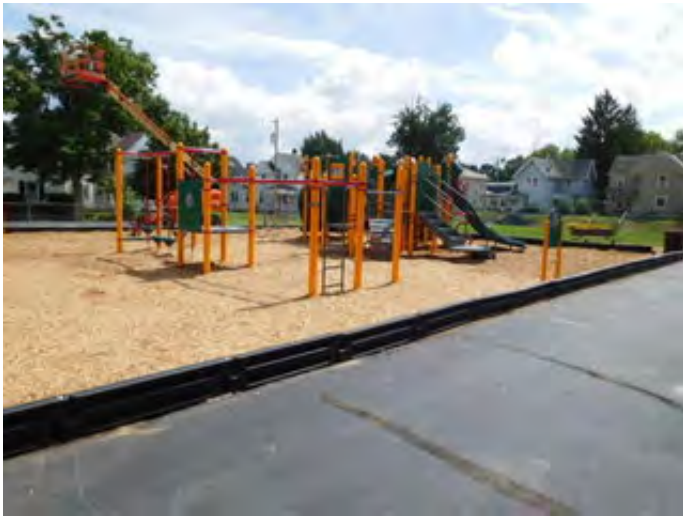
Playground Area

Other: Basketball Backboards	\$500.00	each		2 Required		2 Required		\$1,000.00	Provide for replacement of exterior basketball backboards due to age and condition.
Other: Exterior Furnishings	\$600.00	each		5 Required	1 Required	5 Required	1 Required	\$3,600.00	Provide for exterior furnishings for an outdoor learning environment.
Sum:			\$231,753.86	\$222,207.73	\$9,546.13

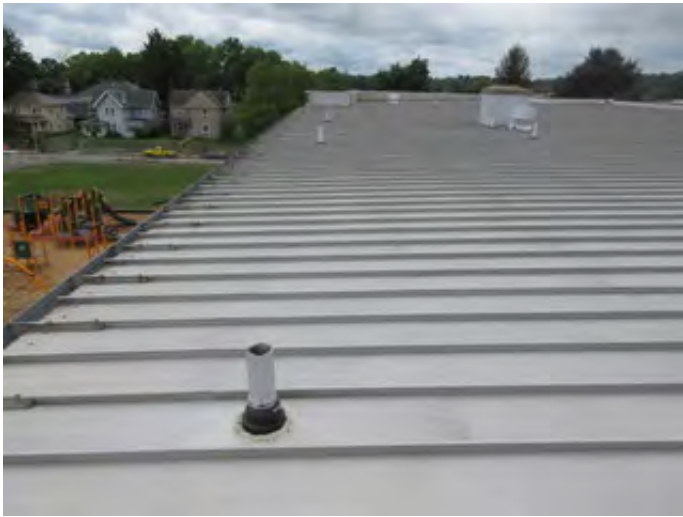
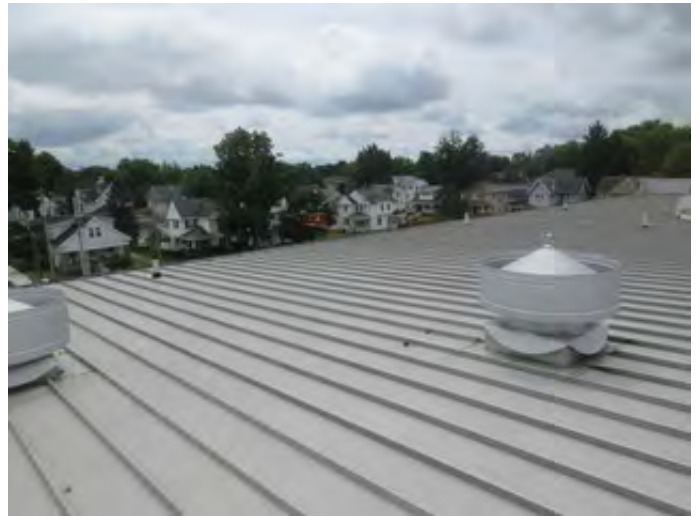
Waste Vent Piping

Recommendations: Existing conditions require no renovation or replacement at the present time.

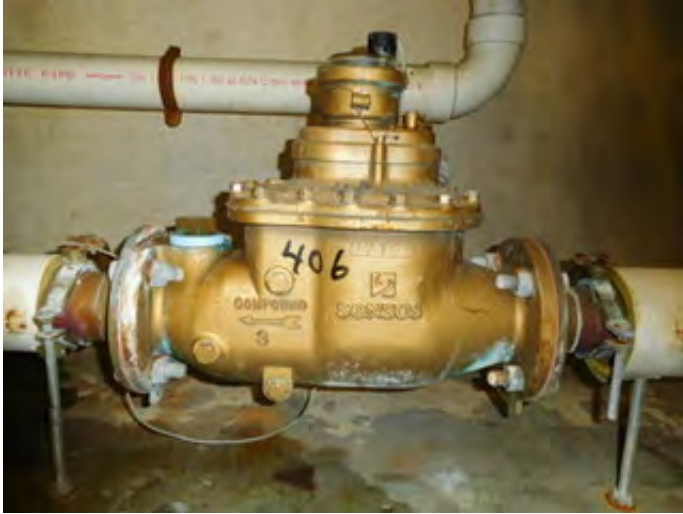
Incoming Domestic Water Service Meter

Recommendations: Provide a new city water supply line of adequate capacity to support the existing needs of the facility, as well as a future automated fire suppression system. Funding provided in Item U.

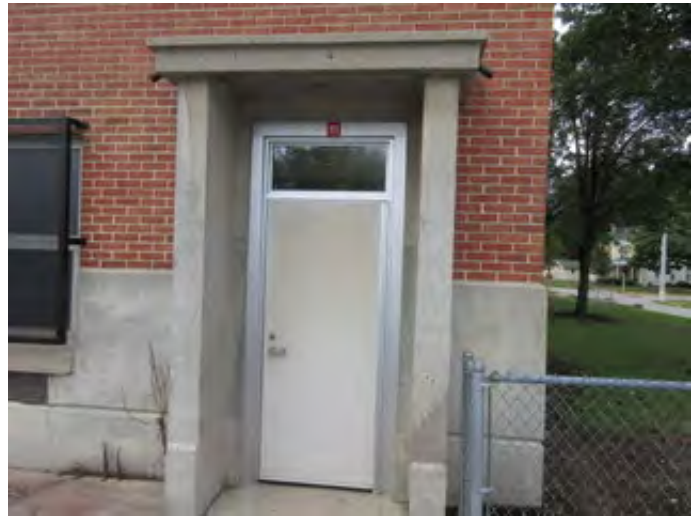
Typical Exterior Doors

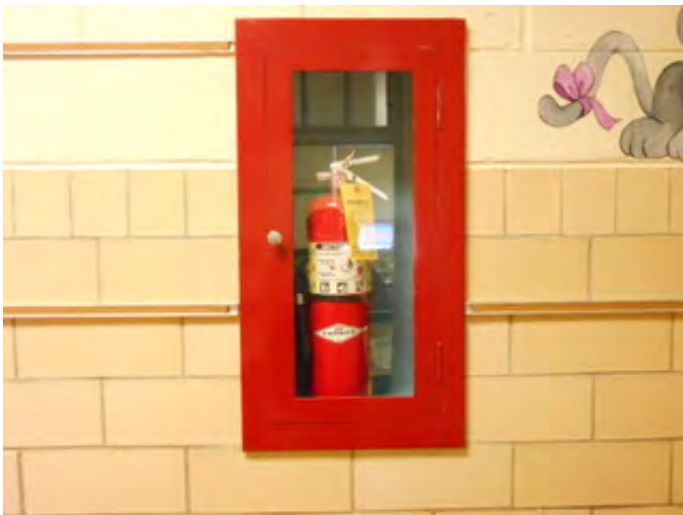
Compliant Fire Extinguisher

Recommendations: Provide new automated fire suppression system to meet Ohio School Design Manual guidelines. Provide increased water service of a capacity sufficient to support the fire suppression system, funding included in fire suppression funding. Provide new emergency generator, with funding provided via complete replacement of electrical system in Item D. Provide new handrails at all interior stairways in the overall facility. Provide fire-rated enclosure around 3 existing stair towers in the overall facility. Provide 2 additional fire extinguishers. Funding for replacement of Kitchen hood is provided for in Item J.

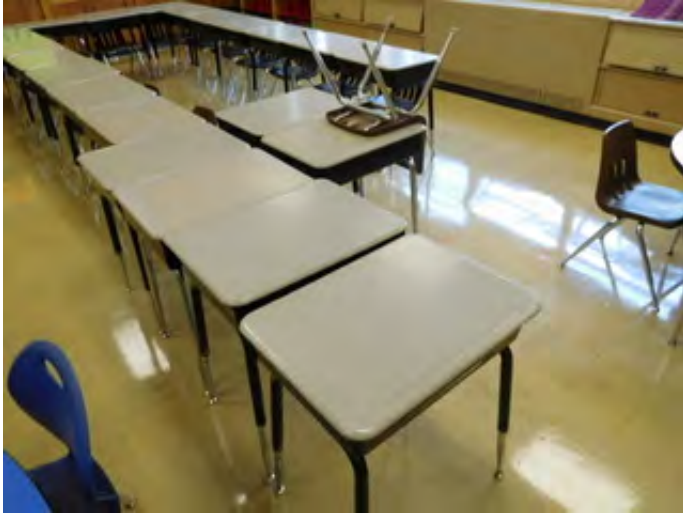
Typical Student Desk and Chairs

Recommendations: Provide for replacement of outdated or inadequate furnishings.

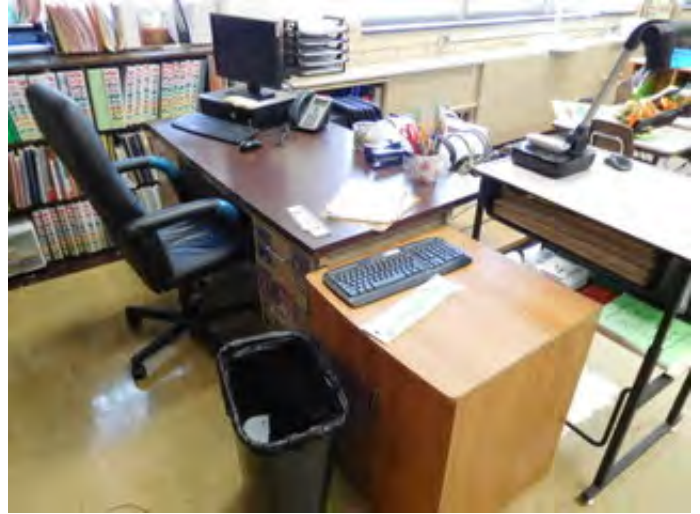
Typical Teacher Desk and Chair

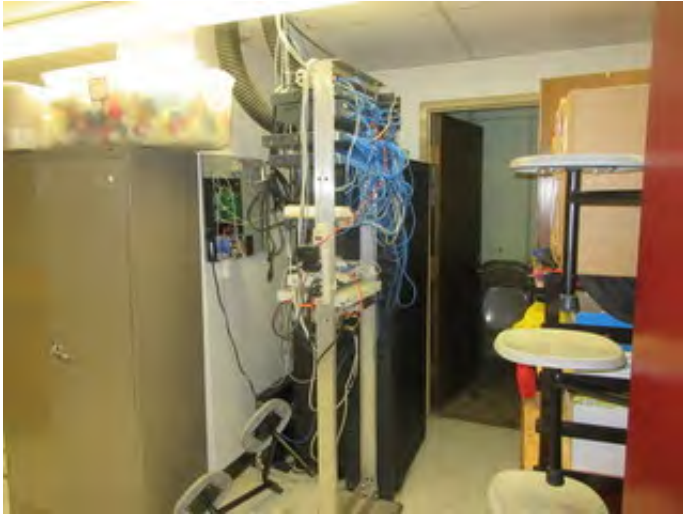
IT Data Rack

Recommendations: Provide complete replacement of technology systems to meet Ohio School Design Manual requirements.

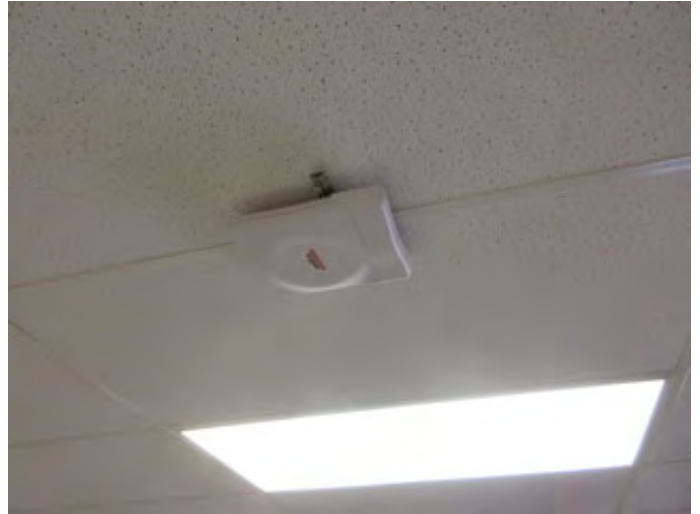
IT Wireless Access Point
